STAGE TRUSS ASSESSMENT & REPAIR REPORT

PROJECT: Outlaw Square  
DATE: February 25, 2022  
AE Project # 2018-405

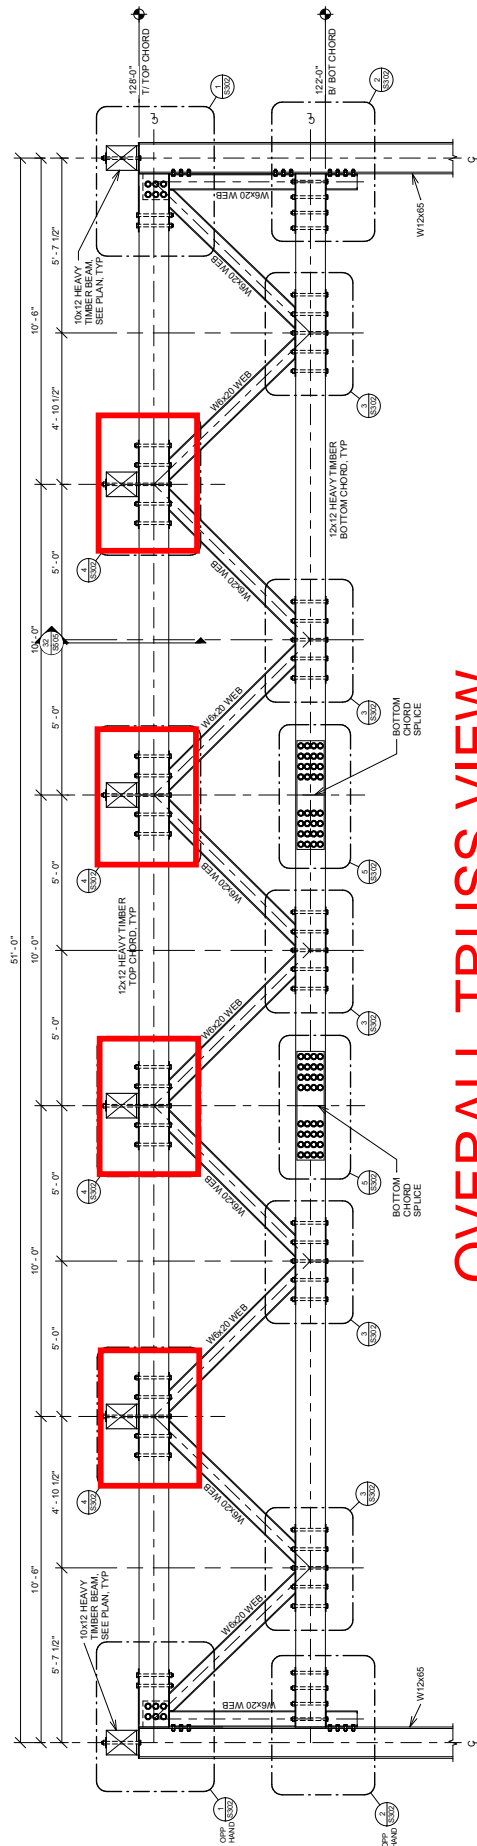
**OVERALL TRUSS VIEW**

Albertson Engineering was recently contacted by City of Deadwood personnel that the stage truss appeared to have a sag. After additional investigation, the sag was found to be approximately 2".

We believe the sag is related to the shrinkage in the top chord of the truss. The mechanics of the top chord rely on direct contact at splice locations. As the top chord has shrunk, the truss has slightly deflected until direct contact is again made at the splice locations.

- REPAIR STEPS.**
1. JACK UP TRUSS TO LEVEL POSITION. SHORE IN PLACE.
  2. ROUTE 3/8" THICK X 2-1/2" DEEP GAP ENTIRE TOP CHORD HEIGHT.
  3. INSTALL "T" PLATES EA SIDE OF TOP CHORD (8 TOTAL "T" PLATES).  
SEE ATTACHED DETAILS.
  4. REMOVE SHORING.
