**APPLICATION FOR
CERTIFICATE OF APPROPRIATENESS**

Address of Property Where Structure/Site Located: 100 Old Fitzhugh Road

“Phase I: Protection and Stabilization Program” to address & further investigate extensive repairs & deferred maintenance, arrest decay, stop water intrusion, correct declining & substandard performance of building foundation, structure, envelope, roof, electrical, plumbing & HVAC systems and yard utilities. See attached “Scoping List” with supporting “Property Inspection Report.”

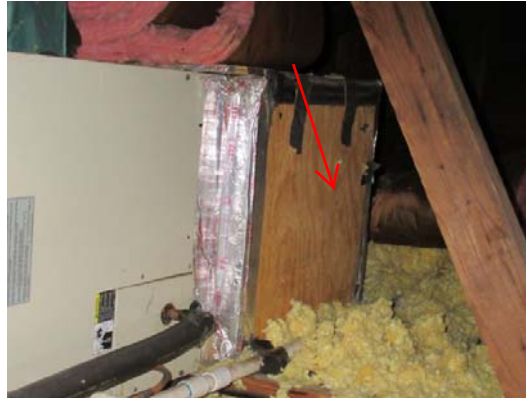
Note: Due to the significant rodent evidence observed in attic, some damage to ducting may be present in concealed areas. If you are concerned, I recommend further evaluation by HVAC contractor.
