## Stephenson High School

### **Feasibility Study**

Dripping Springs, Texas  
Hays County  
May 11th, 2020

AT Project No. 1970

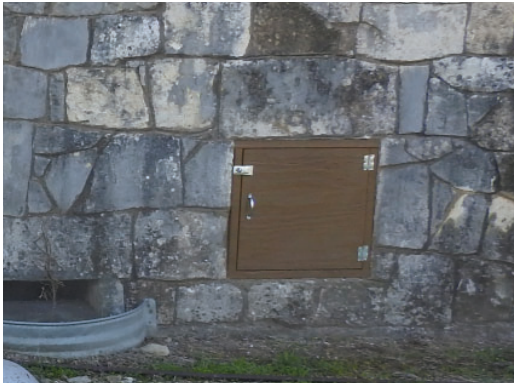
Figure 3.1: Crawl space access door, note biological growth

A crawl space access door is located on the north elevation of the building (see Figure 3.1), providing views of the foundation and floor structure underneath the stage. A wood flooring system is supported by a wood beam and limestone masonry pier foundation structure (see Figures 3.2-4). From the crawl space, the building's exterior load-bearing limestone masonry walls extend below grade, suggesting no foundation slab (see Figure 3.2). The single, load-bearing interior wall is supported by a built-up wood beam structure on limestone piers. The foundation has many ventilation openings with wire screens.

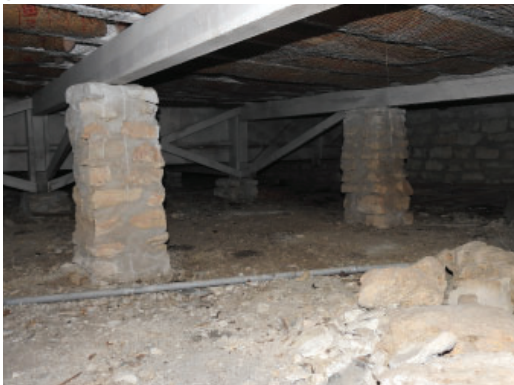
Figure 3.2: Limestone masonry pier and wood beam structure

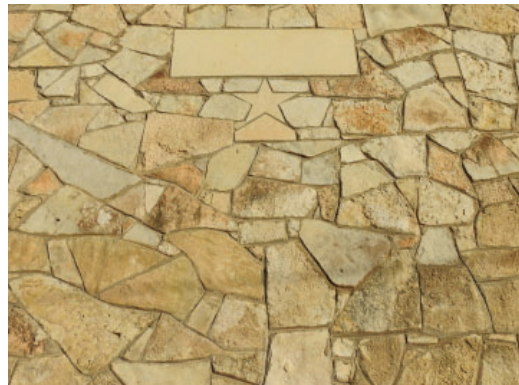
Figure 3.5: Exterior rough cut limestone masonry with V-groove mortar detail

The exterior walls are rough cut limestone masonry with a V-groove buff-colored mortar (see Figure 3.5). Smooth cut limestone quoining exists at the four corners of the building, the recessed entry opening, and all window openings excluding the window addition on the left side of the north elevation (see Figure 3.7). Mechanical and electrical equipment is located on the north and west elevations (see Figures 3.7-3.8).

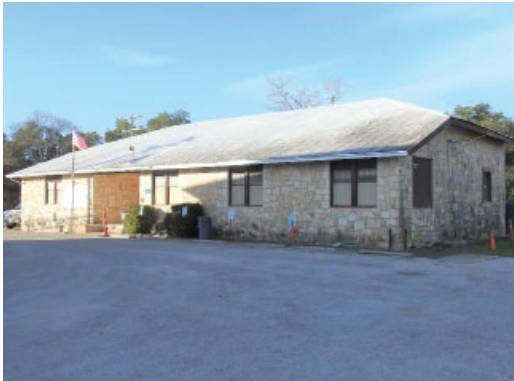
Figure 3.9: North elevation

The one-story building is covered with a clipped-gabled roof as built in 1939 (Ref. Figures 3.9). The current roof dates back to the original construction. The roof assembly is comprised of lapped, corrugated sheet metal with fascia on light wood construction. There is no sheathing or insulation underneath the sheet metal roofing. Expanded 2"x4" wood decking with V-joint framing make up the 1'-1" overhang covered with a 2"x6" wood fascia board (see Figure 3.10). Non-original aluminum metal gutters are located on the east elevation. The roof is structurally supported by a light, wood truss system with exposed 1"x2" and 1"x3" wood lathe ceiling structure(see Figures 3.11-3.12).

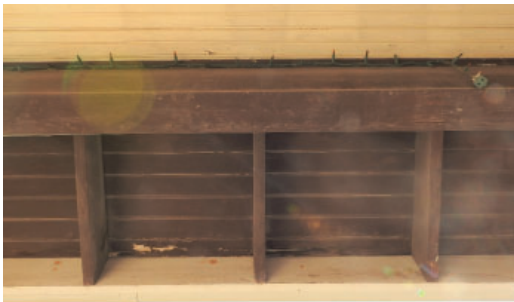
Figure 3.10: Rotted wood on underside of eaves

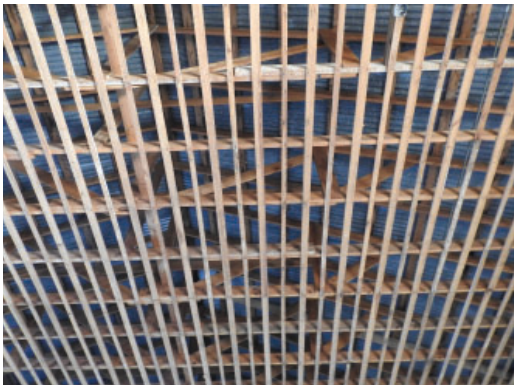
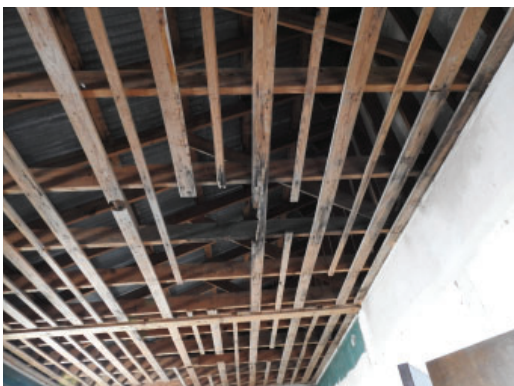
Figure 3.11: Wood trusses visible through ceiling

Figure 3.12: Wood trusses visible through ceiling

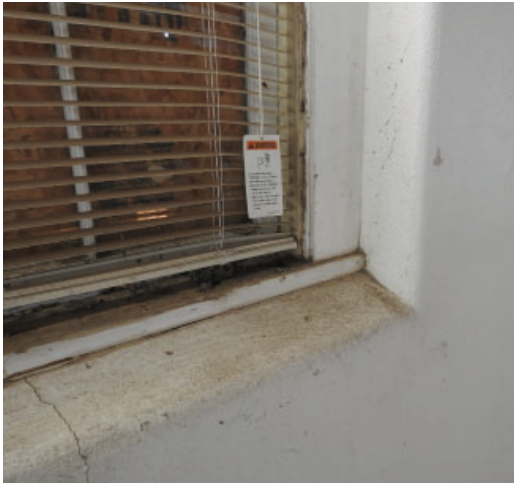
1. All windows have deteriorated paint coatings, sealants, and glazing putty. (see Figures 3.14-3.15).
2. All original windows are partially boarded-over with wood (see Figures 3.13-3.19).
3. One original window has been completely boarded-over on the exterior and has been covered by a furred-out restroom wall on the interior (see Figure 3.17).
4. Windows on the west elevation have several broken lites and vegetative growth on the exterior. On the interior, remnants of construction for dropped ceilings remains (see Figures 3.19-3.21).

Figure 3.16: Typical interior sill of windows

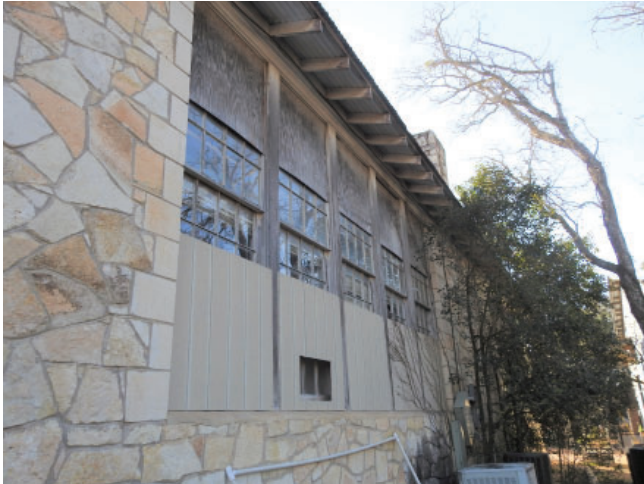
Figure 3.19: Set of 5 double-hung, 16-over-16 lite windows on west elevation

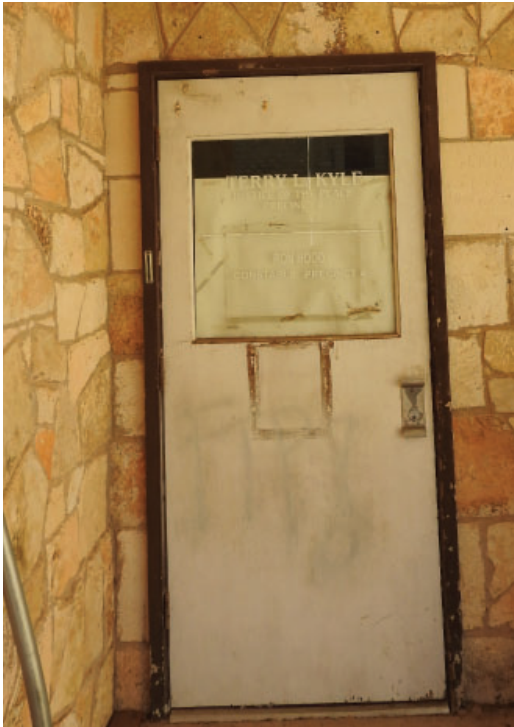
Figure 3.22: One of two main entry doors, non-original door in original opening

There are no surviving original exterior doors. The multiple alterations most likely resulted in the removal and replacement of original doors. All three exterior doors on the east elevation are wood doors with wood frames. The exterior door on the south elevation is a hollow metal door with a hollow metal frame. The doors are all painted white, while the frames are painted brown or white. The two, mirrored main entry doors in the recessed entrance are in original masonry openings, with a single lite and metal hardware (see Figure 3.22). The third entry's masonry opening in the recessed entrance is non-original and the door has a peep hole and metal hardware (see Figure 3.23). The single exterior door on the south entrance is also in a non-original masonry opening, with metal hardware (see figure 3.24).

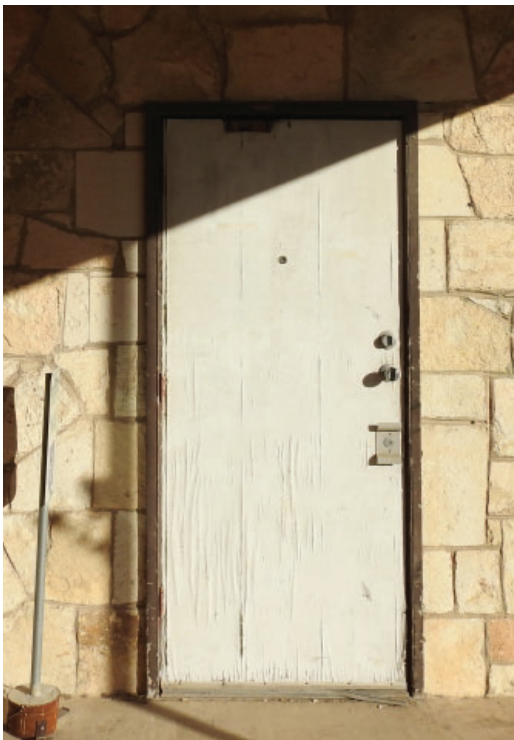
Figure 3.23: Non-original wood door in non-original masonry opening

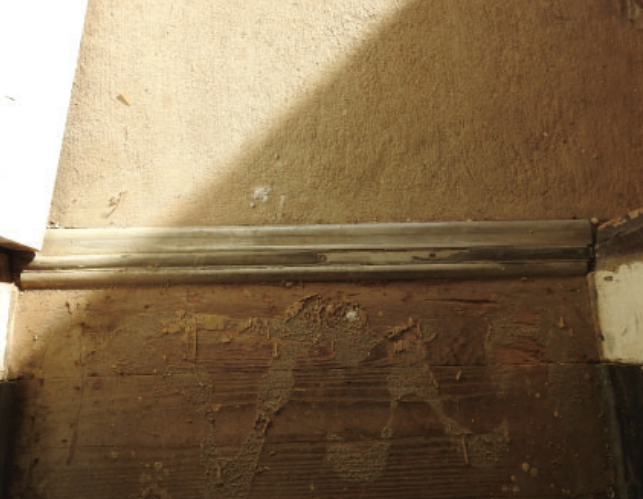
Figure 3.25: Typical metal threshold at front entry

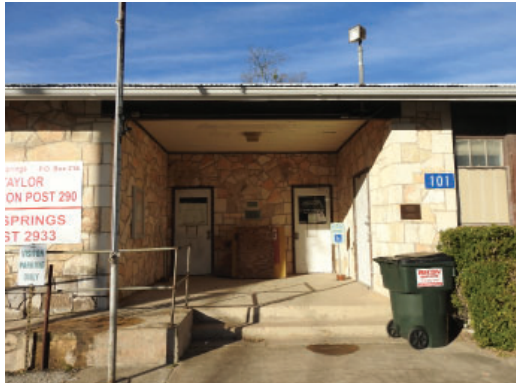
Figure 3.27: Recessed, covered entrance on east elevation

The original east elevation recessed entry remains with minor alterations including; concrete foundation, ramp, and steps (see Figure 3.27). The ceiling of the recessed entry is painted, wood beadboard with a single ceiling mounted light fixture (see Figure 3.30). Two original plaques are centered on the recessed entry limestone wall. The upper plaque recognizes the construction and completion of the building under the WPA federal program in 1939. The second plaque is in memorium of the student and namesake of the Allen Stephenson High School.

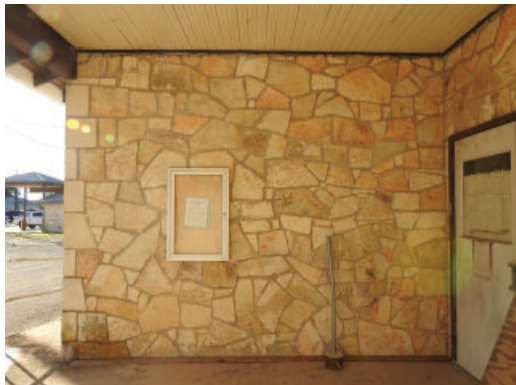
Figure 3.28: South face of recessed, covered entrance

1. A non-original enclosed notice board has been mounted on the south side of the recessed entry (see Figure 3.28).
2. A non-original door opening was added on the north side during one of the remodeling phases (see Figure 3.29).
3. The original wood beadboard ceiling is in fair condition with minimal damage (see Figure 3.30).
4. The lower sections of the masonry walls in the recessed entry have biological growth (Ref. Figure 2.8).

1. *Prior to any renovation work, an environmental report should be complete to determine the presence, if any, of lead containing paint. Lead paint should be properly abated/encapsulated per current regulatory requirements.*
2. *Remove non-original enclosed notice board. Repair masonry at mounting locations.*
3. *Restore original wood beadboard ceiling, repaint.*
4. *Replace existing ceiling mounted light fixture.*

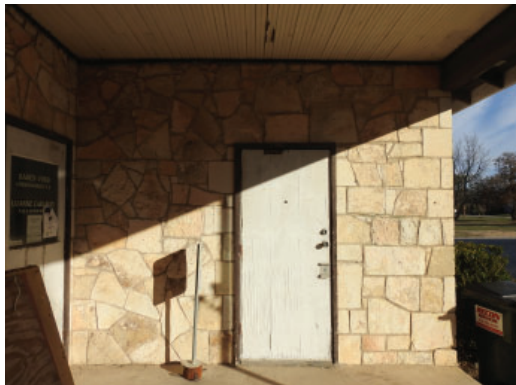
Figure 3.29: North facade of recessed, covered entrance

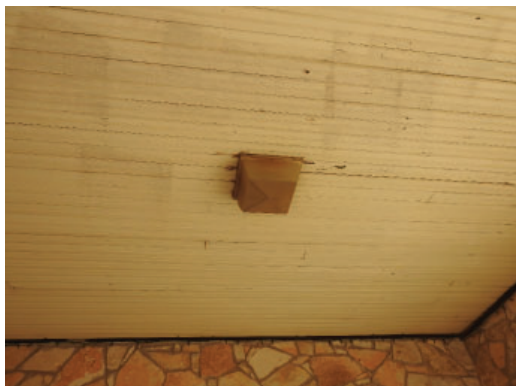
Figure 3.30: Ceiling and light fixture of recessed, covered entrance

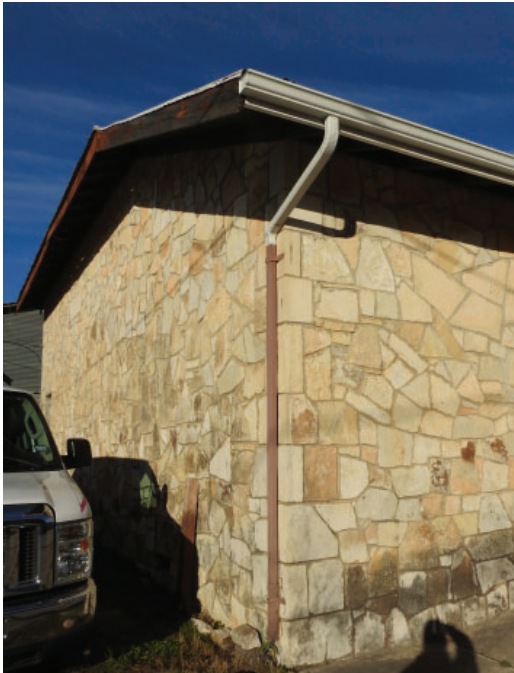
Figure 3.31: Single metal gutter at southeast corner

The roof has a non-original ogee gutter on the east elevation draining to a single downspout on the southeast corner of the building (see Figures 3.31-3.32). The painted aluminum metal gutter is attached to the 2"x6" wood fascia board.

The existing gutter system appears to be in fair to poor condition. The downspout is missing the lower section, causing water to drain along the face of the building which allows water to pool around the corner foundation instead of draining away from the building. The west elevation has no gutter system, allowing water to splash back onto building, which has caused vegetative growth along the building face. The west elevation has electrical equipment mounted to the exterior wall, having water splash back onto this equipment is a potential hazard.

1. *Replace gutter system with 6-inch galvanized half-round gutters at east elevation and provide gutter system at west elevation.*
2. *Replace missing gutter "elbow" and provide new splash block.*

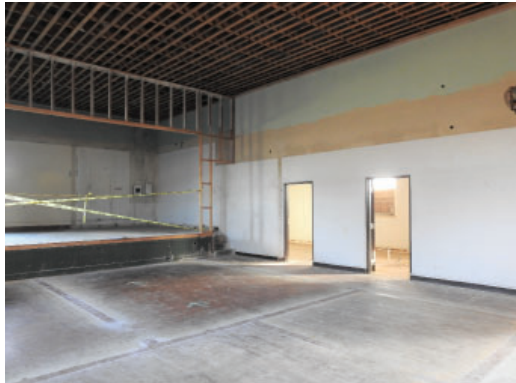
Figure 3.33: Main auditorium space. Note original wood flooring and load bearing interior wall. Stage to the left

The building has one continuous load-bearing interior wall that separates the main auditorium space from two smaller classrooms on either side of the recessed covered entry (see Figure 3.33). This wall is constructed of 2"x6" wood studs at 16 inches on center with three coats of plaster and lathe on both sides (see Figure 3.34). The main space can be separated by an original, sliding accordion door partition on a floor rail system. The exterior walls were plastered over on the interior to match the finish of the interior walls. The walls have been painted over several times with multiple remodels and tenants. The different paint colors are apparent where two different dropped ceiling were installed during different remodels (see Figure 3.34). Original 1"x6" wood base remains in the north portion of the building.

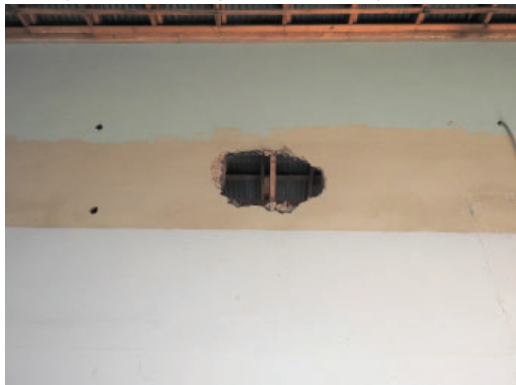
Figure 3.34: Original interior wall. Note three paint colors, signifying the addition of two dropped ceilings

1. The existing interior load-bearing wall has damage where two dropped ceilings were previously installed, leaving open penetrations and other damage (see Figures 3.34-3.35).
2. Original 1"x6" wood base has been damaged by wall partition additions (see Figure 3.36).
3. Original interior walls have been furred-out in south portion of building (see Figures 3.38, 3.40-3.41).

1. *Prior to any renovation work, an environmental report should be complete to determine the presence, if any, of lead containing paint. Lead paint should be properly abated/encapsulated per current regulatory requirements.*
2. *Remove all non-original walls and furr-outs in south portion of building as well as mechanical room and restrooms.*
3. *Repair original interior wall finishes from dropped ceiling penetrations, furr-out installation, previous additions, etc. Paint.*
4. *Repair existing wood base where damaged and provide 1"x6" wood wall base where missing to match original, paint.*

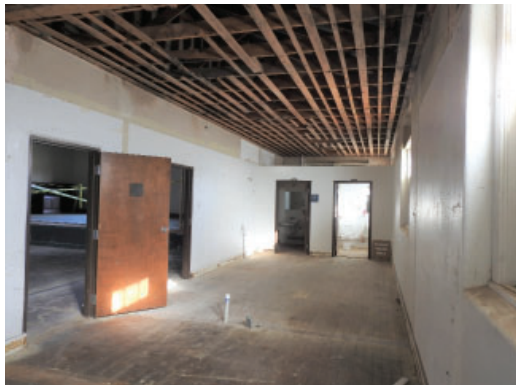
Figure 3.35: Classroom with non-original restrooms built at back of room

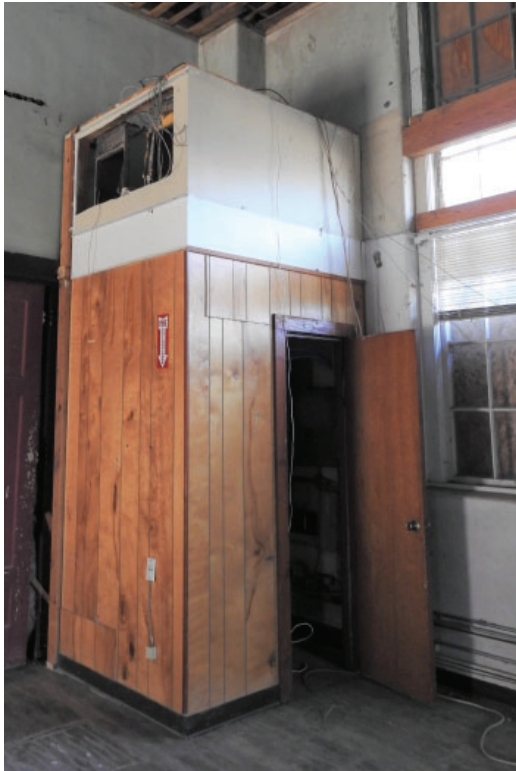
Figure 3.37: Non-original mechanical room addition. Note original chimney floor behind

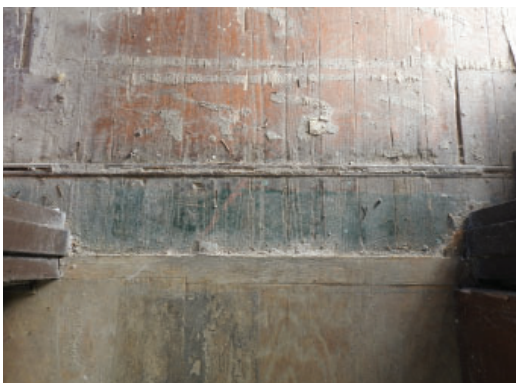
Figure 3.39: Threshold between remodeled space and main auditorium

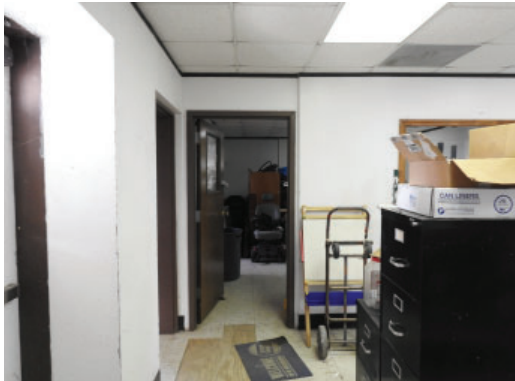
The original flooring throughout is 1×4 tongue and groove, long leaf pine (see Figure 3.33). The wood flooring was previously covered with carpeting in the north portion of the building and covered with wood particle board and VCT tile flooring in the south portion of the building including the restrooms (see Figures 3.38-3.41).

Figure 3.40: Occupied space. Note non-original VCT tile flooring, dropped ACT ceiling, and furred-out wall

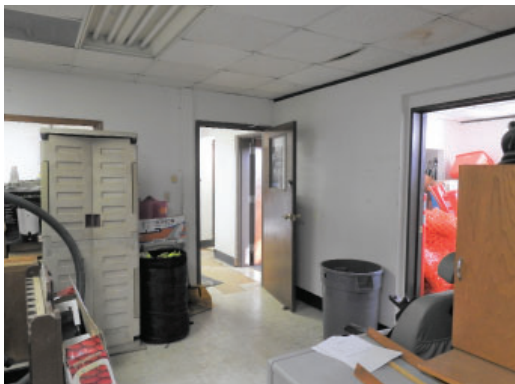
Figure 3.41: Occupied space. Note non-original VCT tile flooring, dropped ACT ceiling, and furred-out wall

The ceilings were noted to be in fair to poor condition. The panel board ceiling finish is missing from the north portion of the building and remnants remain of damaged panel board in the south portion (see Figure 3.42). The non-original 2'x2' ACT ceiling system has various locations of water damage and staining (see Figure 3.41).

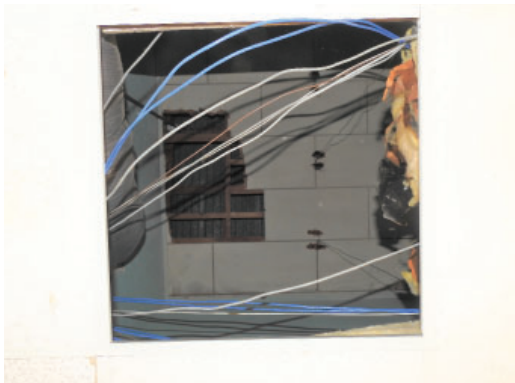
Figure 3.42: Original ceiling panel finish found above dropped ceiling

The original ceiling was constructed of panel board fixed on 1"x2" and 1"x3" wood lathe (see Figure 3.42). The panel board was discovered only in the south portion of the building above a non-original existing dropped ACT ceiling. Only the 1"x2" and 1"x3" wood lathe ceiling structure remains in the north portion of the building, (see Figures 3.33-3.35). The south portion of the building has a non-original, dropped 2'x2' ACT ceiling with batt insulation above.

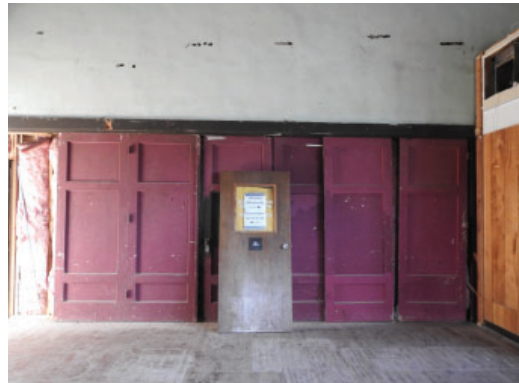
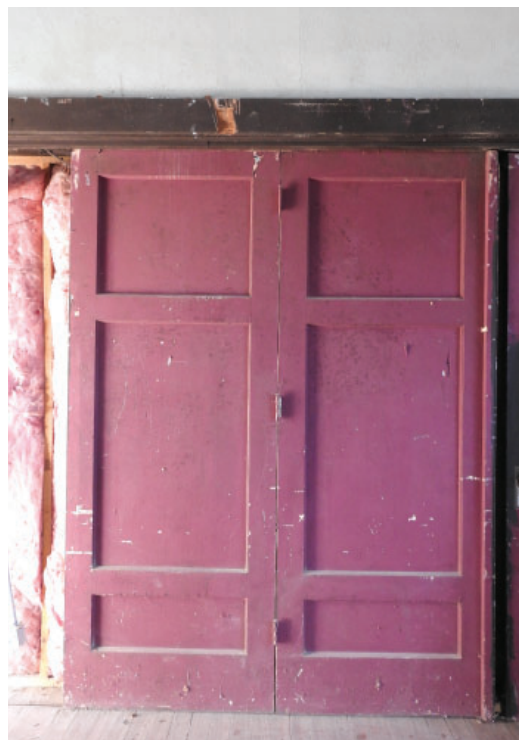
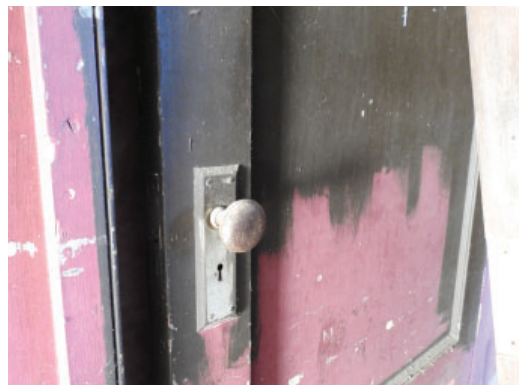
Figure 3.43: Sliding accordion door partition system

Figure 3.44: Three panel wood doors with original hardware

Figure 3.45: Original hardware

1. Two of the assumed nine doors are missing.
2. Some original hardware is missing.
3. The rail system is damaged, placing some doors on and off the rail; the folding and sliding doors are not operable.
4. The wood doors and trim above are scratched and damaged (see Figures 3.43-3.45).

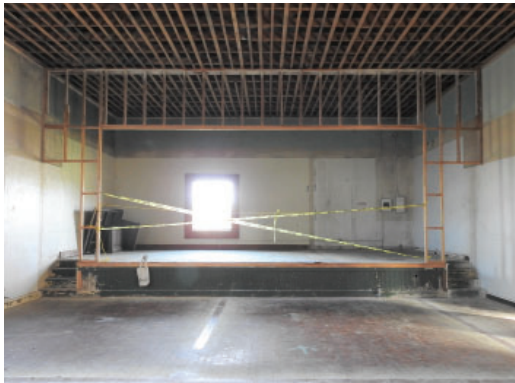
Figure 3.46: Wood stage at north end of building

1. The wood flooring is damaged and has been painted in some locations, as well as both stair entries (see Figures 3.46-3.49).
2. The beadboard proscenium has paint damage and open penetrations into the crawl space (see Figure 3.47).
3. The stage framed wall is unfinished (see Figure 3.46).
4. The wall mounted electrical equipment needs to be evaluated further.
5. The existing paint is loose (see Figures 3.46-3.48).

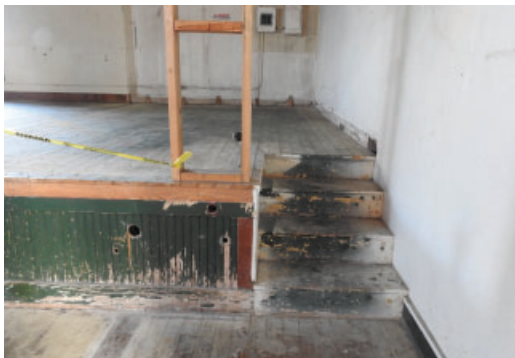
Figure 3.47: Stairs to stage. Note wood beadboard proscenium

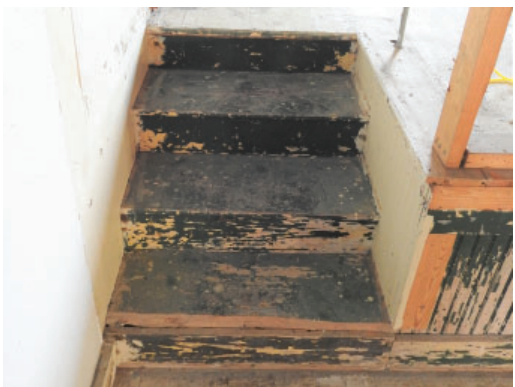
Figure 3.48: Stairs to stage

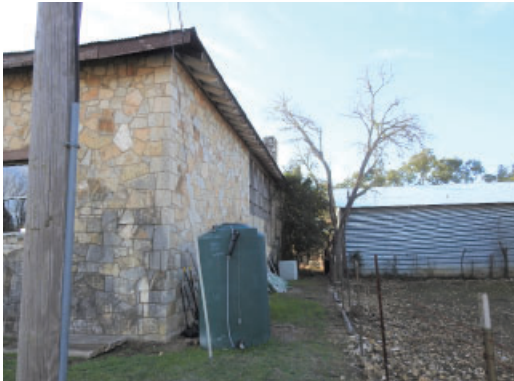
Figure 3.50: West side of building at the edge of the property. Note MEP equipment.

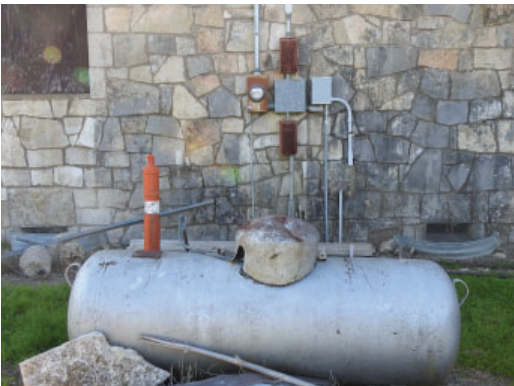
Figure 3.51: West side of building at the edge of the property. Note MEP equipment.

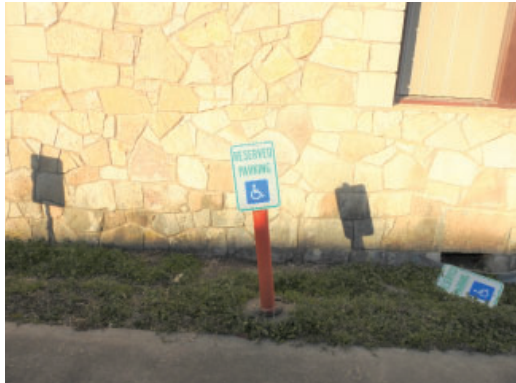
Figure 3.52: Handicap signage

The asphalt parking area leads up to the east side of the building with a 3 foot sidewalk leading to the main entrance. There are concrete curb stops to indicate parking spaces. Handicap parking signage is displayed on short metal poles and traffic cones (see Figure 3.52).

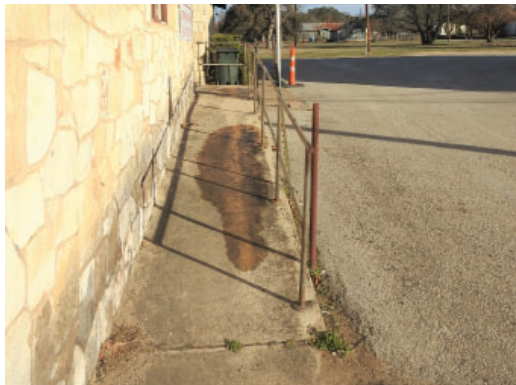
Figure 3.53: Ramp leading to concrete platform

The building has two entry locations; the recessed covered entry and the entry at the southwest corner. The recessed covered entry is accessed either by a single concrete step up to the concrete landing or a concrete ramp with a metal handrail (see Figure 3.53). The southwest corner entrance is accessed with a concrete stair and landing (see Figure 3.54).

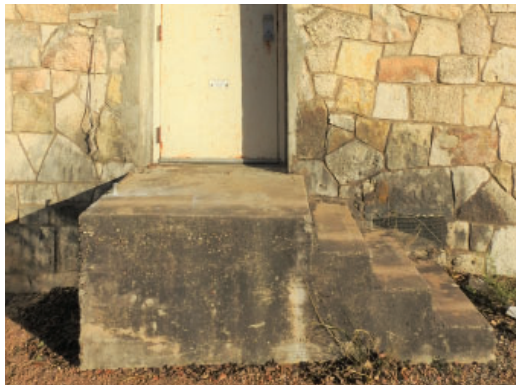
Figure 3.54: Concrete steps up to entrance landing
