**Re: Pump Inspection & Televising Report – Dyersville Well #4**

# Well Televising Report

| Project Name | Dyersville Well #4 |

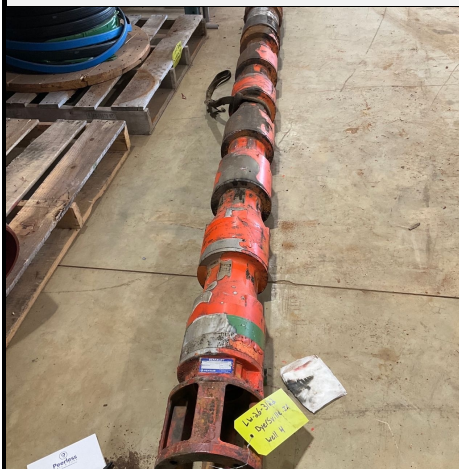
- The 6" x 8" swage nipple coming out of the pitless spool is corroded and will need to be replaced.
- **Recommendation:** Replace 8 sections of column pipe completely and have the remaining 15 sections cut and rethreaded. All couplings, check valves, and the swage nipple are in rough shape and will need to be replaced.

4. Swage Nipple Corrosion
