Intersection Road Safety Audit

SR 17 AT SANDHILL ROAD / MARLOW ROAD

EFFINGHAM COUNTY | GEORGIA

December 2016

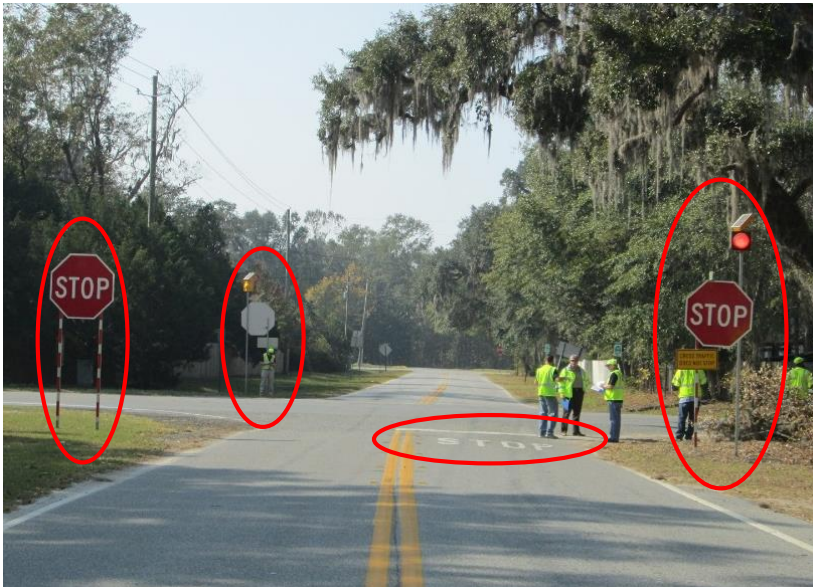
Over the past several years, GDOT District 5 and Effingham County have made improvements to help facilitate safer movements through the intersection. These include the addition of rumble strips on Marlow Road, double-indicated stop ahead signs on Marlow Road, and large 48"x48" stop signs on Marlow Road at SR 17. A Traffic Engineering Study was conducted in March of 2015. The study concluded that the intersection did not meet 2009 MUTCD signal warrants and that driver speed was a major cause of concern at the intersection. Since that time, GDOT District 5 forces have made improvements to the traffic control devices at the study intersection. In November 2015 a supplemental flashing red beacon was installed on top of the right side of the stop sign on both side street approaches (Sandhill Road and Marlow Road). In June 2016, upgrades were made to the signs, pavement markings, and rumble strips. Raised reflective rumble strips were added to the westbound approach on Marlow Road, along with "Cross traffic does not stop" plaques on the stop signs at the intersections, reflective strips on the stop sign posts, and a "STOP" word pavement marking at the stop bar on the Marlow Road (westbound) approach to the intersection.

FIGURE 4-1. VIEW LOOKING ALONG WESTBOUND MARLOW RD TOWARD INTERSECTION WITH SR 17. NOTE THE RECENTLY INSTALLED OVERSIZED STOP SIGNS, SUPPLEMENTAL FLASHING BEACONS, AND PAVEMENT MARKINGS
