## Folsom City Council Staff Report

| <b>ITEM TITLE:</b> | Resolution No. 11693 – A Resolution Authorizing the City Manager to Execute Amendment No. 2 to the Agreement (Contract No. 173-21 24-039) with West Yost & Associates, Inc. for \$402,886 from the Water Operating Fund (Fund 520) for Additional Construction Management and Inspection Services for the Tower Tank Rehabilitation Project (Project WA2402) and Appropriation of Funds |

| <b>Report #</b> 06052026 | | | |
| <b>Project Name:</b> | Misc. Tank Rehab Project – Tower Tank | <b>Inspector:</b> | Igor Tutelya |

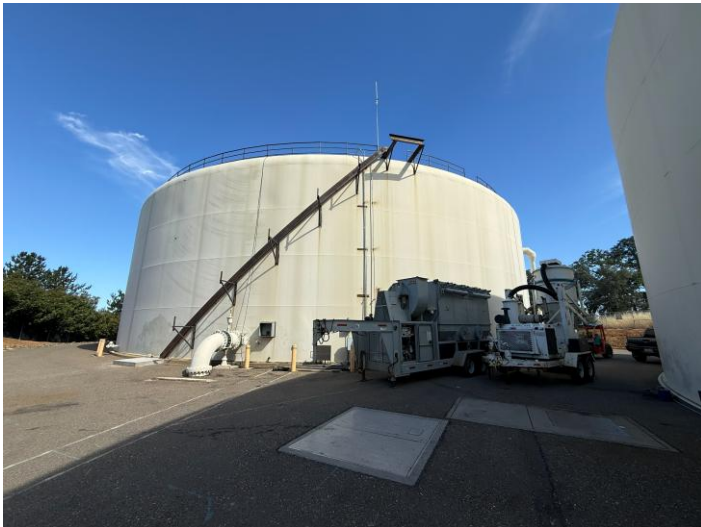
Foothill Tank Project.

During today's operations, ESM crew members completed the second finish coat application on the Tower Tank exterior roof handrails and continued spot repair operations on the exterior shell. A preliminary blast inspection of the Foothill Tank interior floor revealed coating blistering, disbondment, and brittle coating failure in multiple locations.

BACC recommends complete removal of the existing floor coating system prior to installation of a new coating system.
