**FLORIDA DEPARTMENT OF TRANSPORTATION**  
**BRIDGE MANAGEMENT SYSTEM**  
**Inspection/CIDR/Bridge Profile Report**  
**Inspection**

**Structure ID: 494096****DISTRICT: D3 - Chipley****INSPECTION DATE: 7/30/2020 NNHH**

BY:	CONSOR Engineers, LLC	STRUCTURE NAME:	Not recorded
OWNER:	2 County Hwy Agency	YEAR BUILT:	1959
MAINTAINED BY:	2 County Hwy Agency	SECTION NO.:	49 000 005
STRUCTURE TYPE:	4 Steel Continuous - 10 Truss-Thru	MP:	3.293
LOCATION:	5.0 Mi N of US98/SR30	ROUTE:	00000
SERV. TYPE ON:	1 Highway	FACILITY CARRIED:	Mill Road
SERV. TYPE UNDER:	5 Waterway	FEATURE INTERSECTED:	Trout Creek

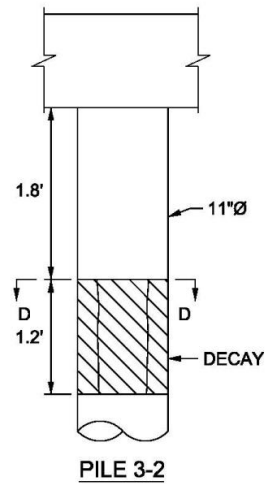
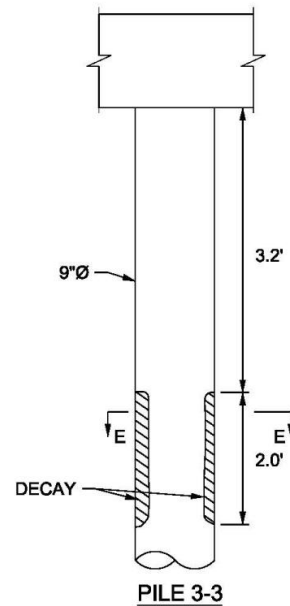
228 TIMBER PILE

- 4) Pile 2-2 has decay. (10" diameter) This pile does not provide pile to cap bearing (See Photo 17 and Sketch 2). (4000 - 1 EA)
- 5) Pile 3-2 has decay. (11" diameter) This pile does not provide pile to cap bearing (See Photo 17 and Sketch 3). (0.03 ft gap) (4000 - 1 EA)

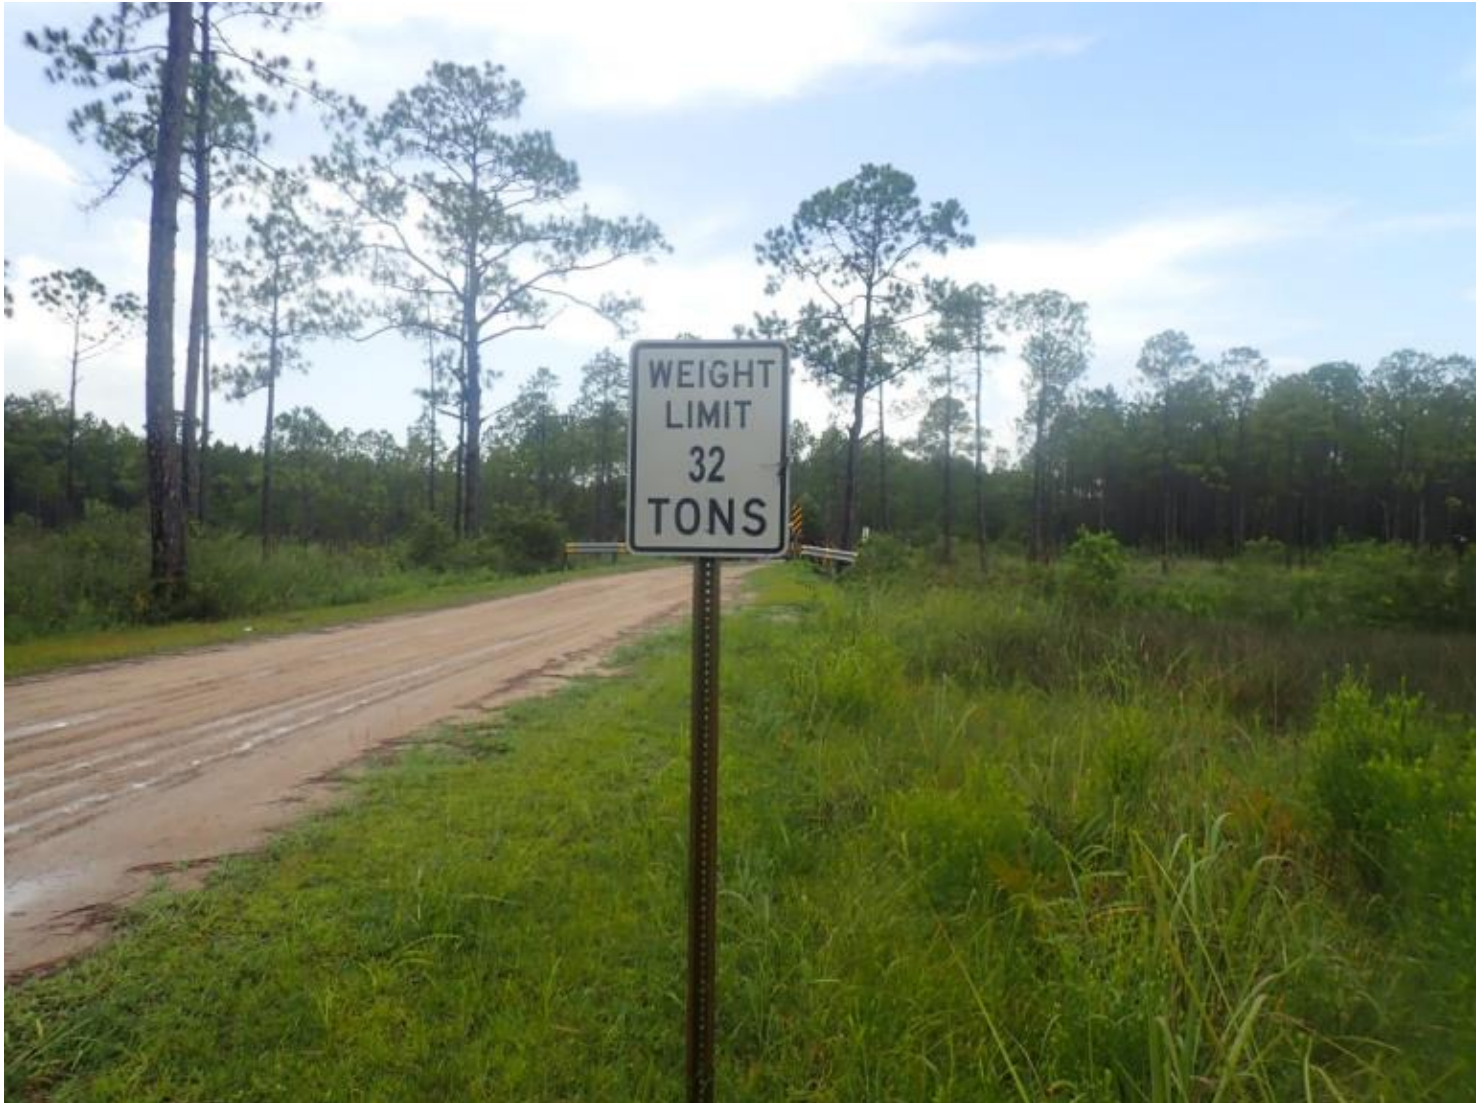
Near Posting Sign

- 1) The near posting sign is missing.
