June 16, 2023

**Re: Report of Limited Structural Assessment  
219 Spring St, Green Cove Springs, FL 32043**

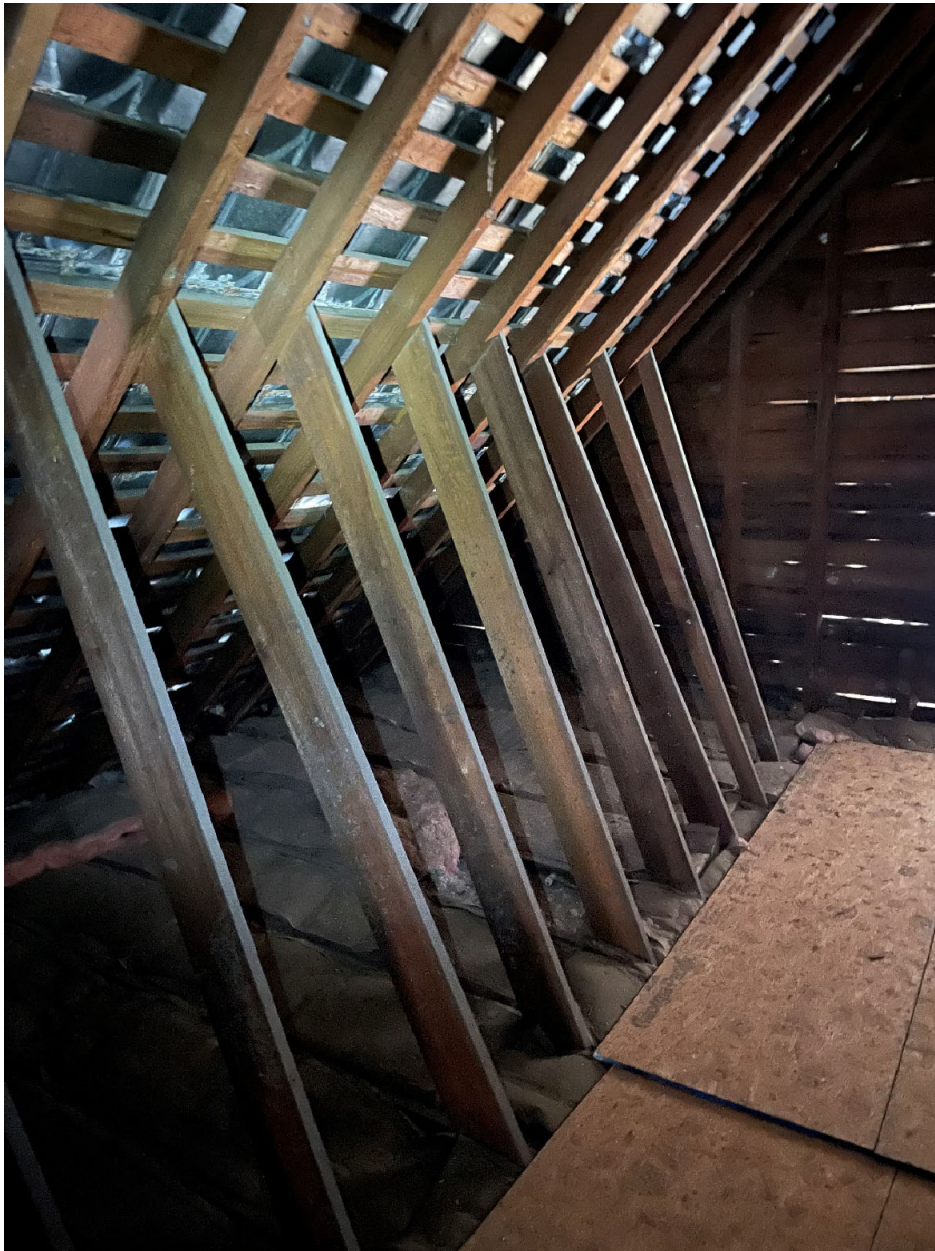
Photo 3: Attic

window and door openings. The roof rafters within the attic appeared to be in good condition with no obvious signs of distress; however, the spaced boards used to support metal roof covering were observed to have multiple areas of rot from the exterior. The metal roofing displays signs of rust. The ground floor framing generally felt sturdy when walking around the home. This is consistent with our observations of the crawl space beneath the main home, which revealed conditions to be expected under a home of this age (i.e. evidence of minor termite damage, isolated areas of moisture-related damage, etc.), but no significant structural deficiencies. From the exterior, multiple areas of rotten and/or damaged wood siding were observed around the perimeter of the home.
