## **Architectural Assessment Report**

**Address** - 14841 Washington Street Haymarket VA 20169

**Date** - 7/9/2025

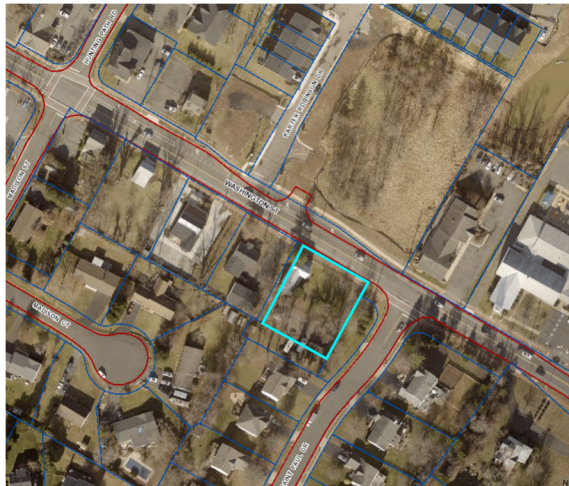
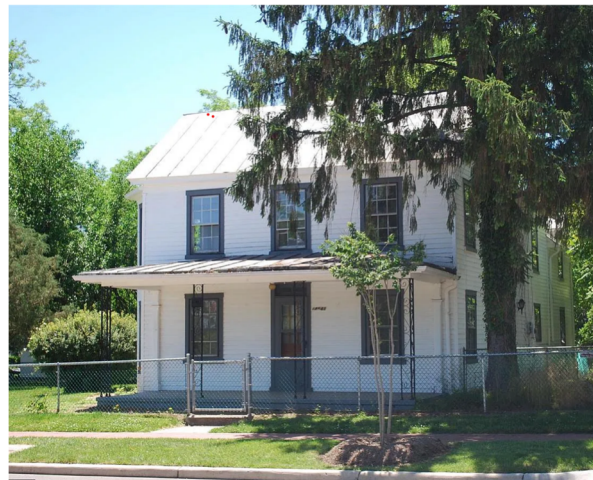
This report is based on the property's advanced state of deterioration, structural and life-safety deficiencies, and the owner's intent to responsibly redevelop the site in accordance with local planning goals.
