**TOWN OF HIGHLAND BEACH
BEACH RESTORATION FEASIBILITY STUDY
2023**

**Prepared By:
Aptim Environmental & Infrastructure, LLC
6401 Congress Avenue, Suite 140
Boca Raton, FL 33487**

January 2024

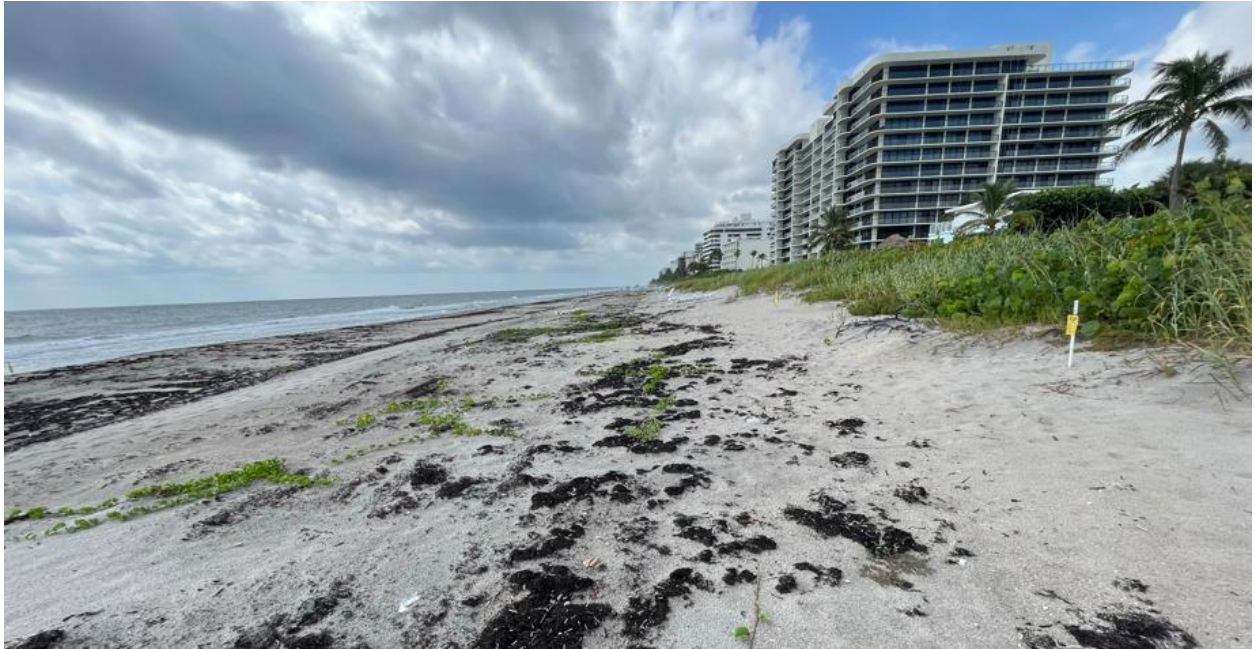
Photo 4. Southerly view of the beach berm and dune near R-192.

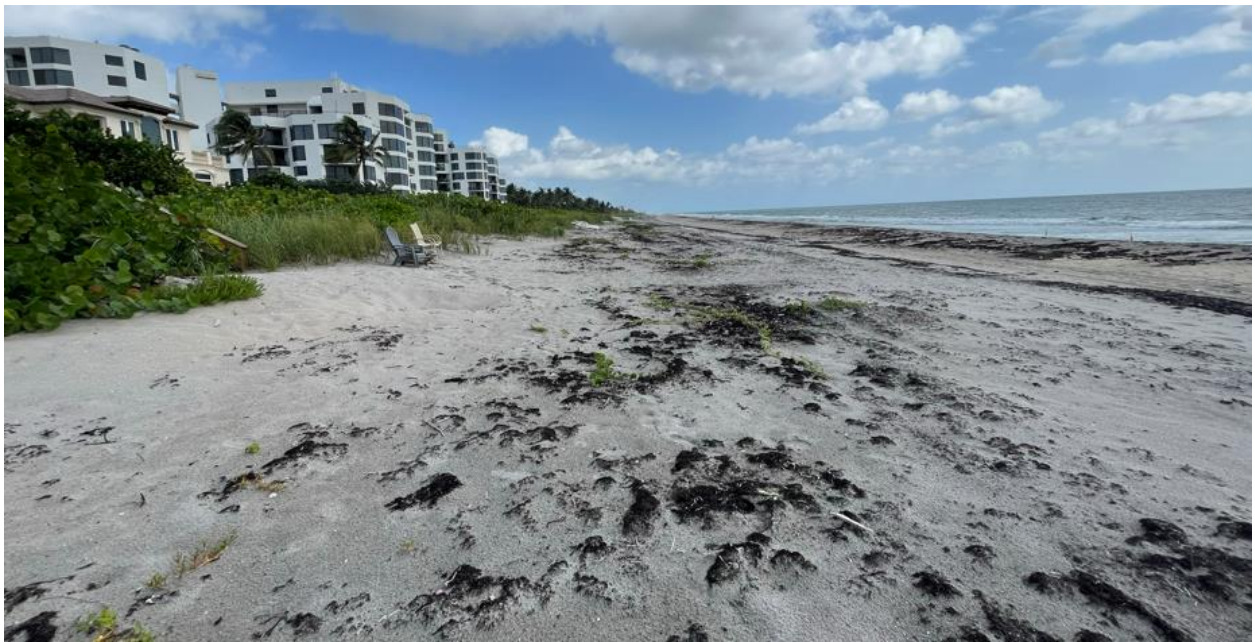
Photo 5. View of the beach berm and dune near R-192 looking north.

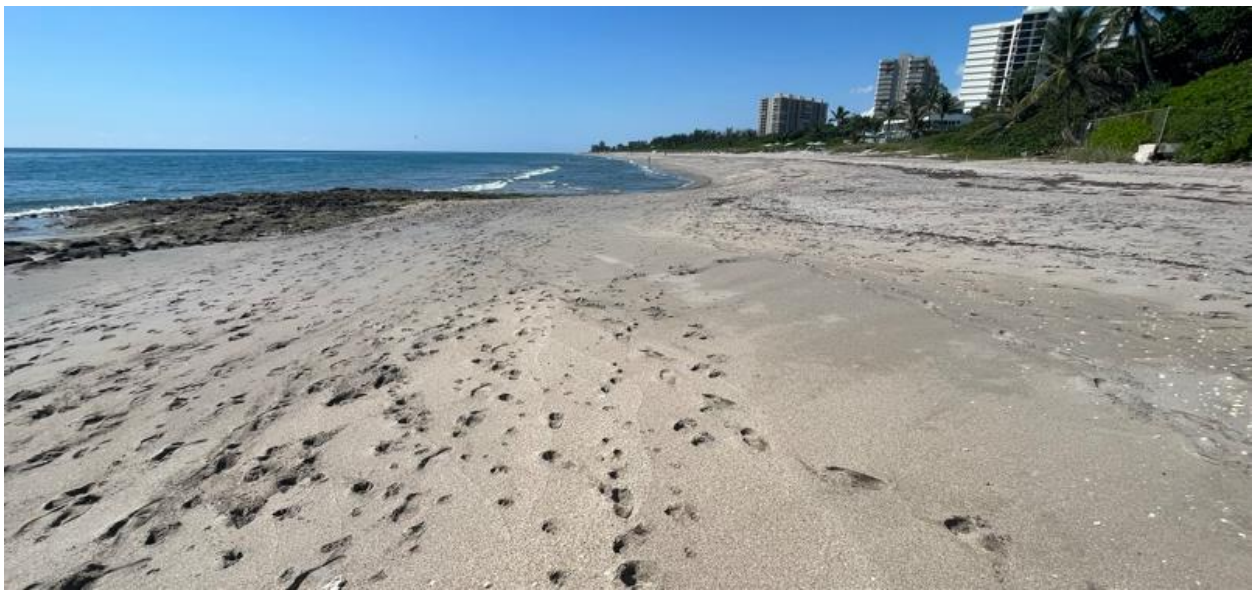
South of Yamato Rock, the beach is stable and healthy, and the three properties (4713, 4715 and 4801 South Ocean Boulevard) have a 50-foot-wide vegetated dune and an approximate 80 to 100-foot beach in front of the structures (Photo 13). Historically, this section of beach has benefited from the North Boca Raton Beach nourishment projects constructed in 1988, 1998, 2010, 2014, and 2020.

Photo 13. View of the beach looking south at Yamato Rock.

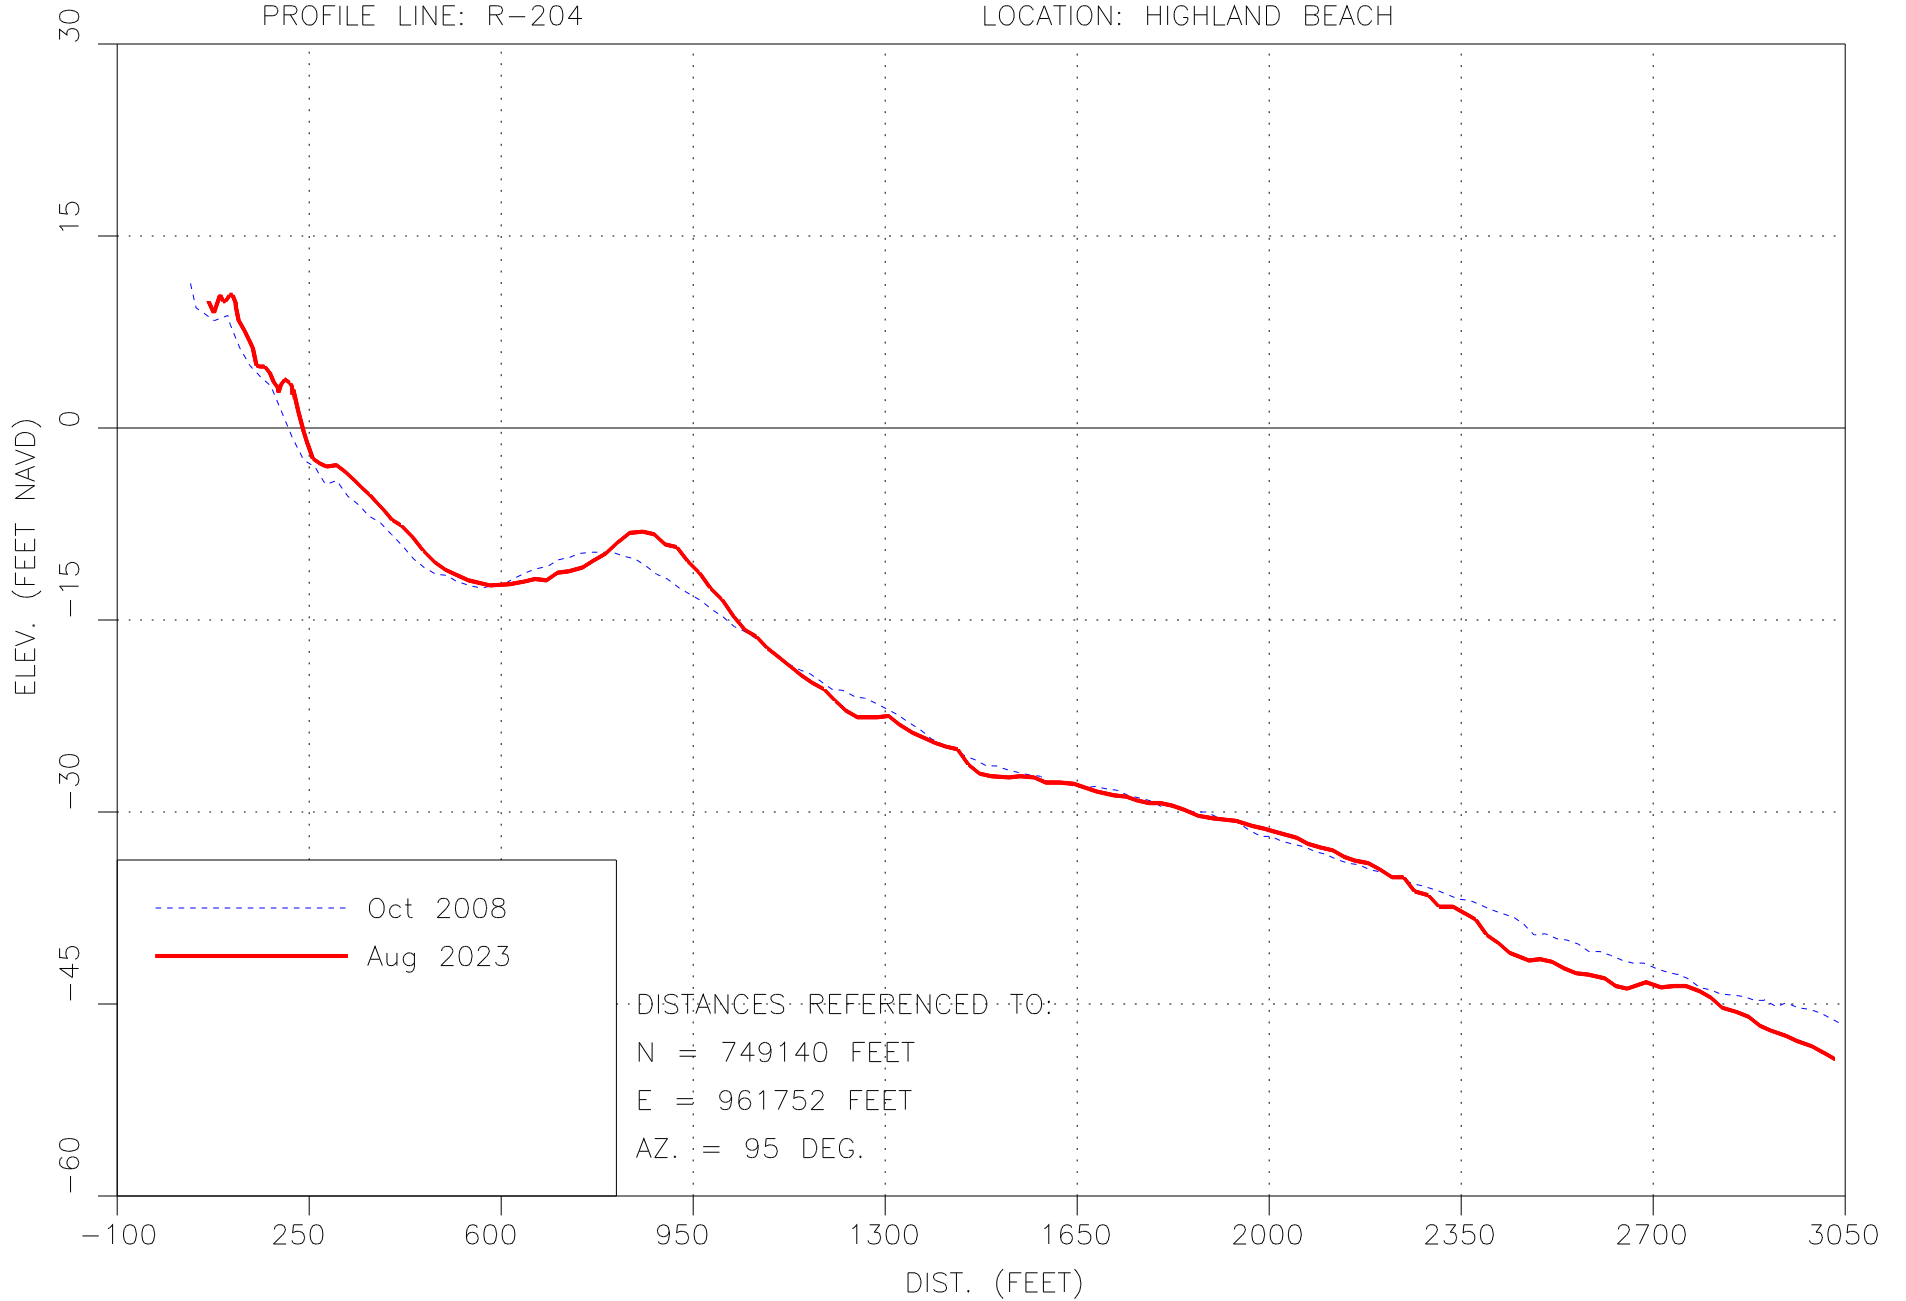
PROFILE LINE: R-204

The beach access for the Admiral Walk Towers is at the limits of Highland Beach, with a 100-foot-wide vegetated dune with no structures present on this beach parcel. While the dune is wide in this area, the dune crest is at approximately +10 feet, NAVD (FDEP profile R-204, Appendix A), which is the lowest dune in Highland Beach. The dune crest is at the elevation of 100-year return period storm surge (Photo 14).

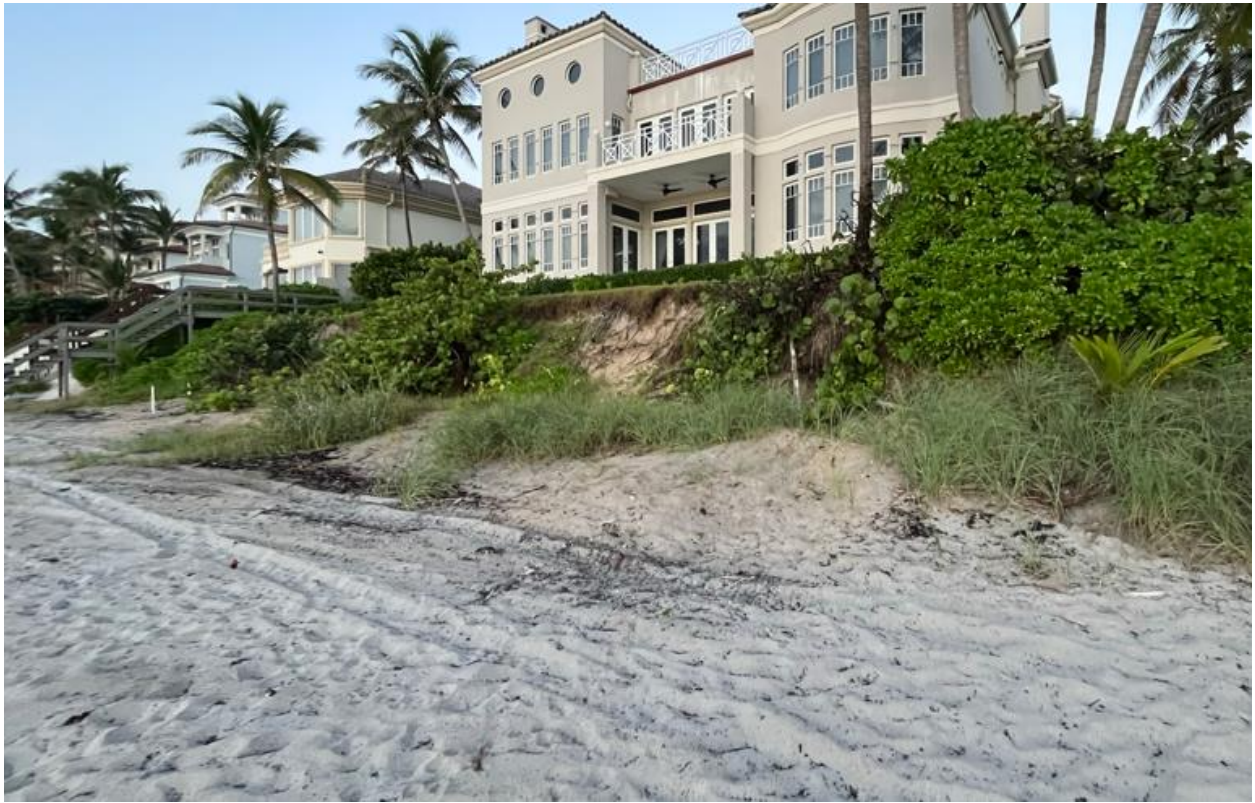
Beach Naupka is an exotic invasive plant that grows well on the dune face in Palm Beach County (Photo C-1). It is characterized by oval (or club shaped) shiny green leaves. It should be removed from all dune ecosystems as it crowds out and shades native dune species. Any FDEP permit issued will require its removal.

Photo C-1. Seagrapes at the left center of the photograph and Beach Naupka on the right side of the photograph.
