# Eaglecrest Ski Area

## Facility Condition Assessment

January 14th, 2025

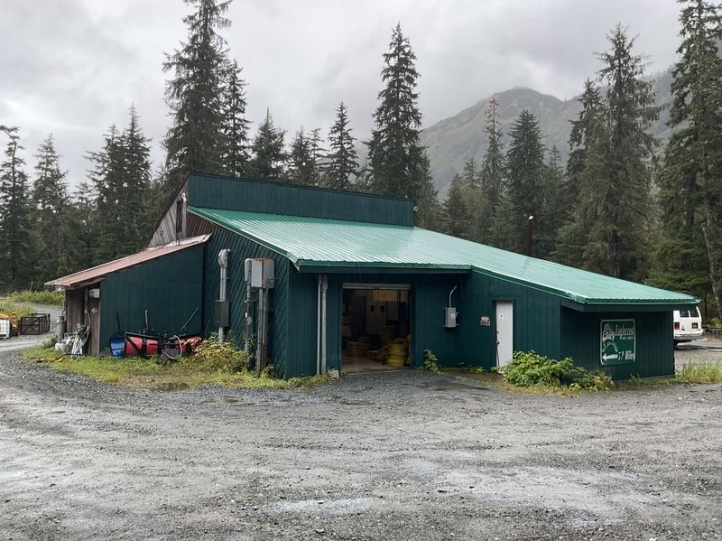
Table 6: Facility Description: Eaglecrest Ski Area - Brown Maintenance Shop

The fluorescent lighting was in fair condition due to observed inadequate lighting. The electrical branch wiring is beyond its recommended useful life. The service and distribution system was in good condition.

The metal and wooden doors were in good condition. The single-pane windows were in good condition. The wood siding walls were in good condition. The metal panel roof covering was within its recommended useful life.

The finished concrete floor finishes were in good condition; however, the hardwood floors were in fair condition due to observed deterioration. The plywood paneling and protective wall covering wall finishes were in good condition. The plastic covered insulated batts ceiling finishes were in fair condition due to observed damage.

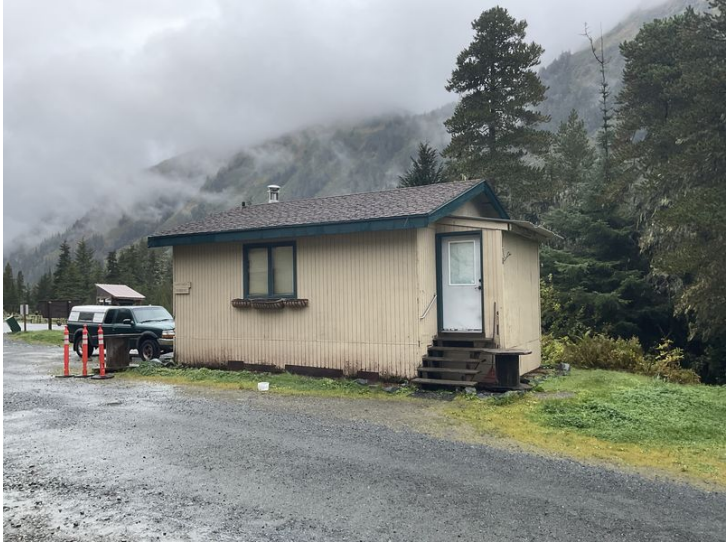
Table 12: Facility Description: Eaglecrest Ski Area - Caretakers Cottage

The metal door was in fair condition due to observed damage on the panel. The double-pane windows were in good condition. The wood siding walls were in good condition. The metal panel roof covering was within its recommended useful life.

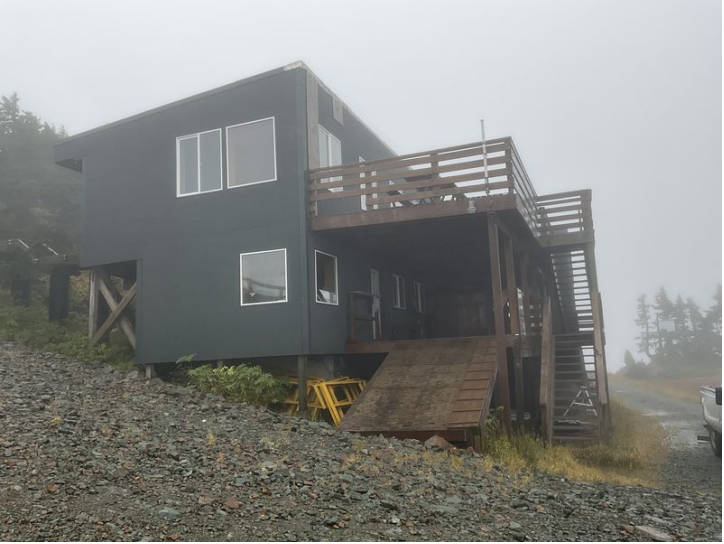
Table 18: Facility Description: Eaglecrest Ski Area - Eagles Nest

- A support pillar is shifting under the north portion of the building.
- Water penetration is occurring due to sideways rain getting between roof decking and metal paneling for the roof.
- The southeast corner of the building has damaged metal siding due to a vehicle mishap.
- The building underwent renovations in 2012.

The metal doors were in fair condition due to observed damaged frames. The double-pane windows were in good condition. The metal paneling walls were in fair condition due to observed damaged finishes. The metal panel roof covering was within its recommended useful life.

The laminate wood floor finishes were in fair condition due to observed damage, and the resilient floor finishes were in poor condition due to observed damage. The painted wall finishes were in fair condition due to observed stains. The painted ceiling finishes were in fair condition due to observed stains.

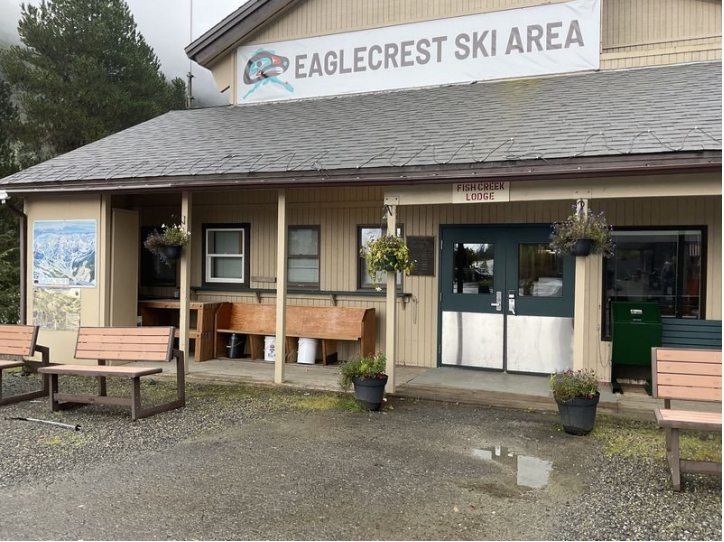
Table 24: Facility Description: Eaglecrest Ski Area - Fishcreek Lodge

- The lodge was expanded in 1984.
- Water is draining from adjacent slope and settling under the building.
- The outer deck that doubles as a roof for the locker rooms is leaking.
- The fire alarm system is tied into the Porcupine Lodge next door.
- The windows on the southeast side of the building that face the upward slope have been boarded up due to snow drifts having previously damaged them.

The LED lighting was in good condition; however, the fluorescent lighting was in poor condition due to observed inadequate lighting and non functioning fixtures. The electrical branch wiring is within its recommended useful life; however, a portion of the system is beyond its recommended useful life. The service and distribution system was in good condition; however, a portion of the system was in fair condition due to observed outdated panels. The emergency and exit lighting is within its recommended useful life.

The metal doors were in fair condition due to observed damaged panels. The single-pane windows were in poor condition due to damaged panes and boarded up windows. The wood siding walls were in poor condition due to observed damaged finishes. A portion of the asphalt shingle roof covering was within its recommended useful life; however, a portion of the asphalt shingle roof was beyond its recommended useful life, and another portion of the asphalt shingle roof was in poor condition due to observed evidence of leaks.

The carpet floor finishes were in good condition; however, a portion of the carpet floors and resilient floors were in poor condition due to observed damage and stains. The painted wall finishes were in fair condition due to observed damage. The painted ceiling finishes were in good condition.

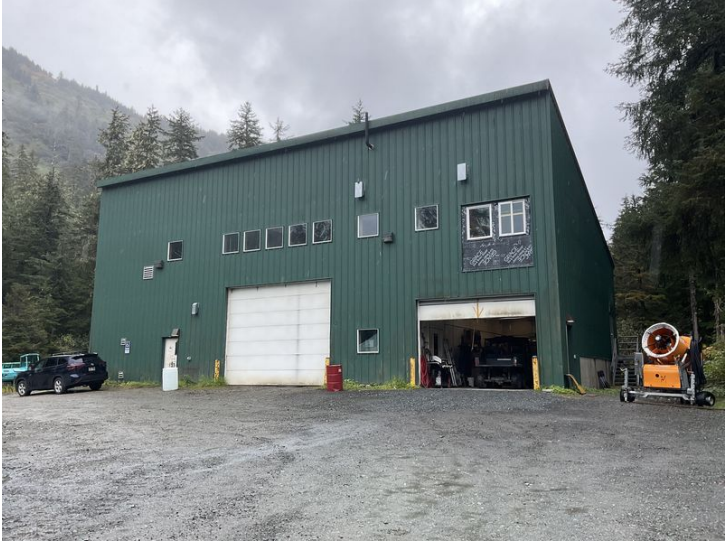
Table 30: Facility Description: Eaglecrest Ski Area - Main Maintenance Shop

The metal doors were in fair condition due to observed . The double-pane windows were in good condition. The metal paneling walls were in fair condition due to observed damaged finishes. The metal panel roof covering was within its recommended useful life.

The finished concrete floor finishes were in fair condition due to observed damage. The painted and plastic covered insulated batts wall finishes were in good condition. The plastic covered insulated batts ceiling finishes were in good condition.

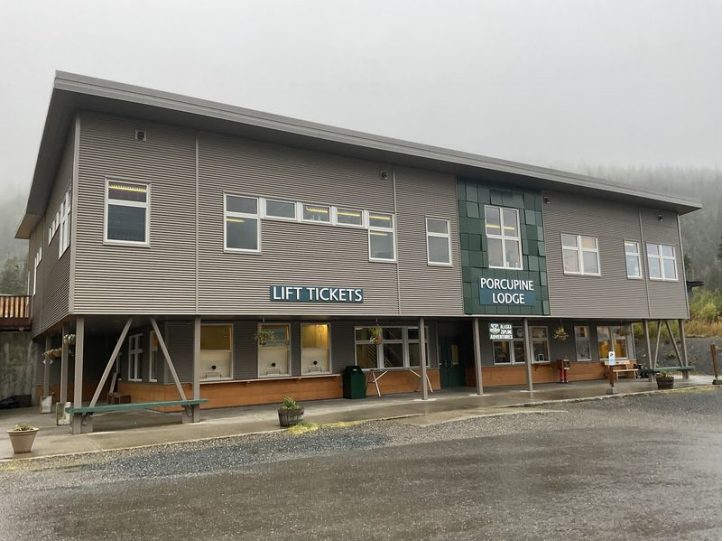
Table 36: Facility Description: Eaglecrest Ski Area - Porcupine Lodge

- The server room overheats due to inadequate cooling.
