**STAFF REPORT
HISTORIC PRESERVATION COMMISSION
MEETING OF NOVEMBER 2nd, 2021**

PROJECT: Formula Sports/Former Post Office A-Frame Historic Building Demolition

FILE NUMBER: H21-079

LOCATION: 460 N Main Street (Ketchum Townsite: Block 5: Lots 3 & 4)

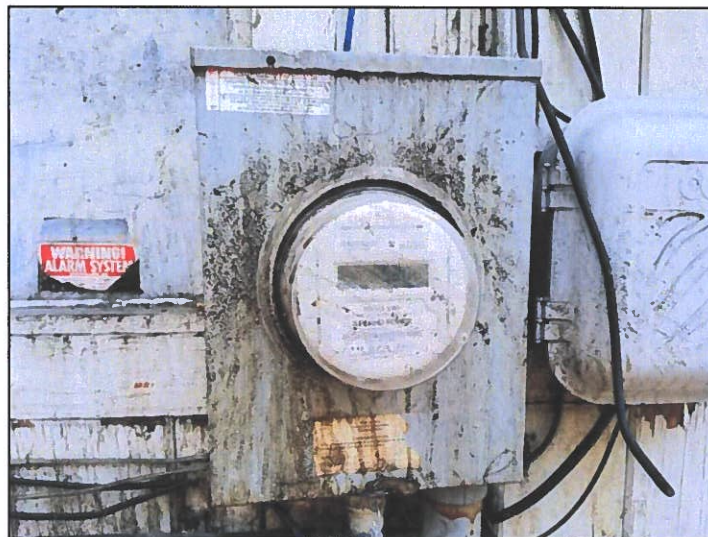
- No major system safety or function concerns noted at time of inspection.
- Meter base and Main disconnect noted at exterior wall of structure.

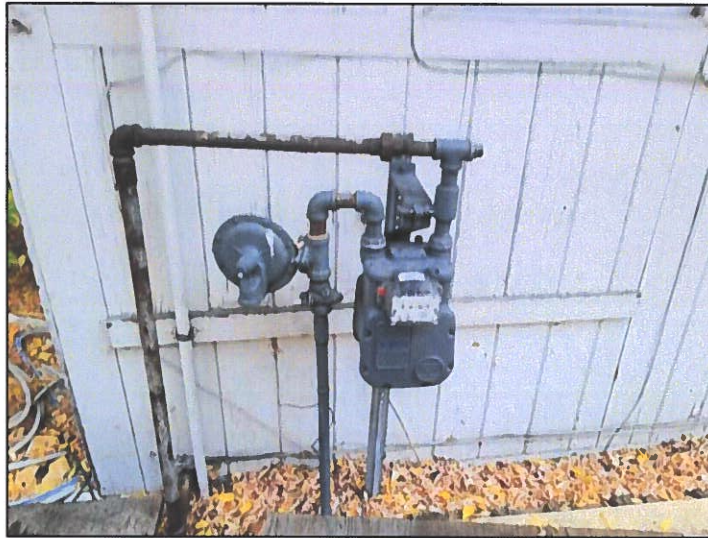
- Meter located at exterior. All gas appliances have cut-off valves in line at each unit. No gas odors detected.
- Main Gas isolation valve is located at meter piping.

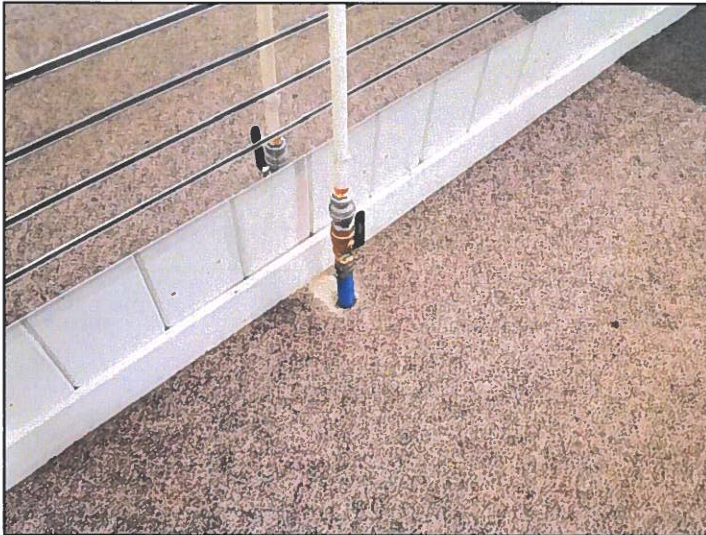
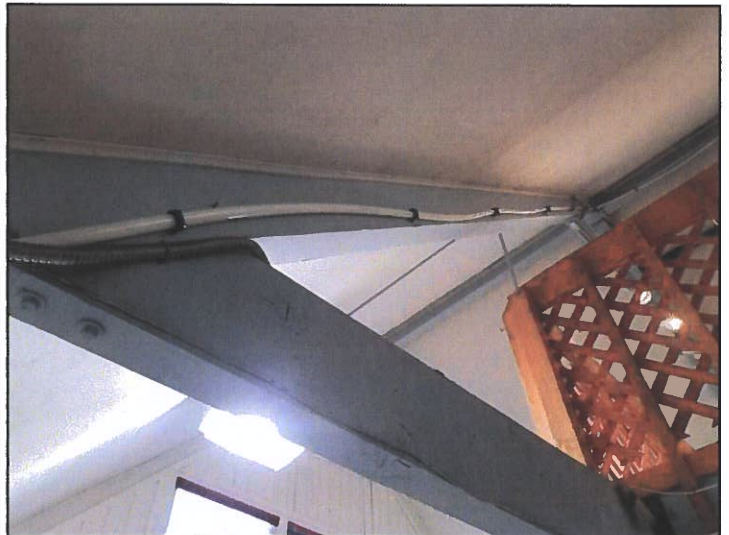
- Water shutoff located in main space.
- Water line is routed through visible interior space.

Water line is routed through visible interior space.

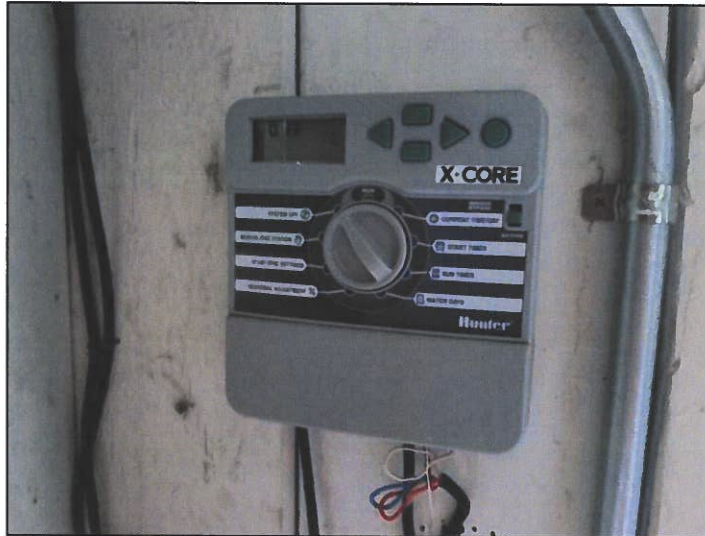
- Structure is equipped with an underground sprinkler system. The inspector recommends client consult with owner for operation instructions and proper winterizing information. Sprinkler systems are beyond the scope of an Inspection, due to most of its parts/piping not visible for inspection.
- The sprinkler system operates with a control panel located on exterior wall.

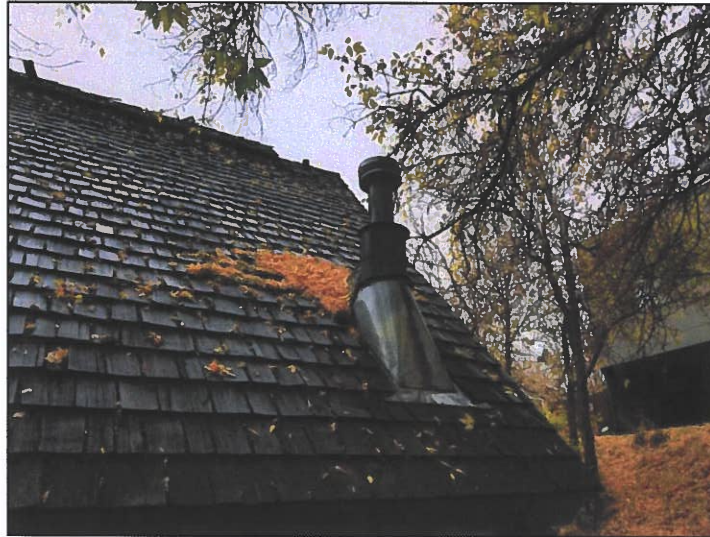
- No major system or function concerns noted at time of inspection.

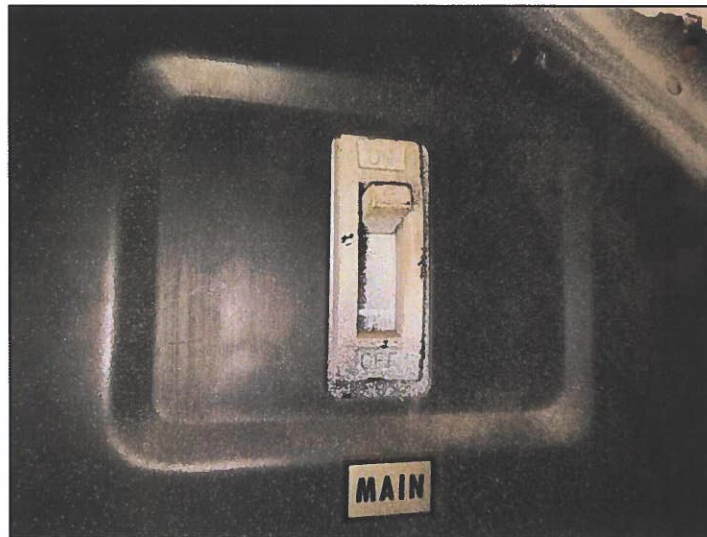
- Main disconnect located at meter base.
- 200 amp

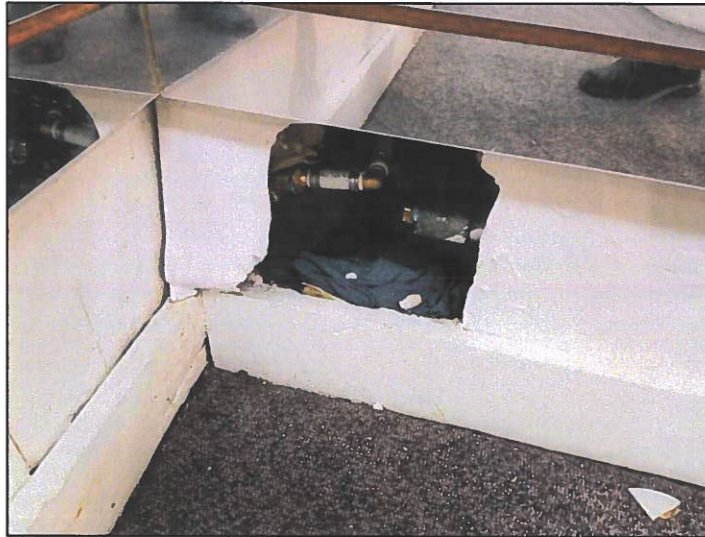
- Damage to walls noted in numerous locations. All surfaces covered with damaged glass and damaged hanger system. Recommend removal and repair.

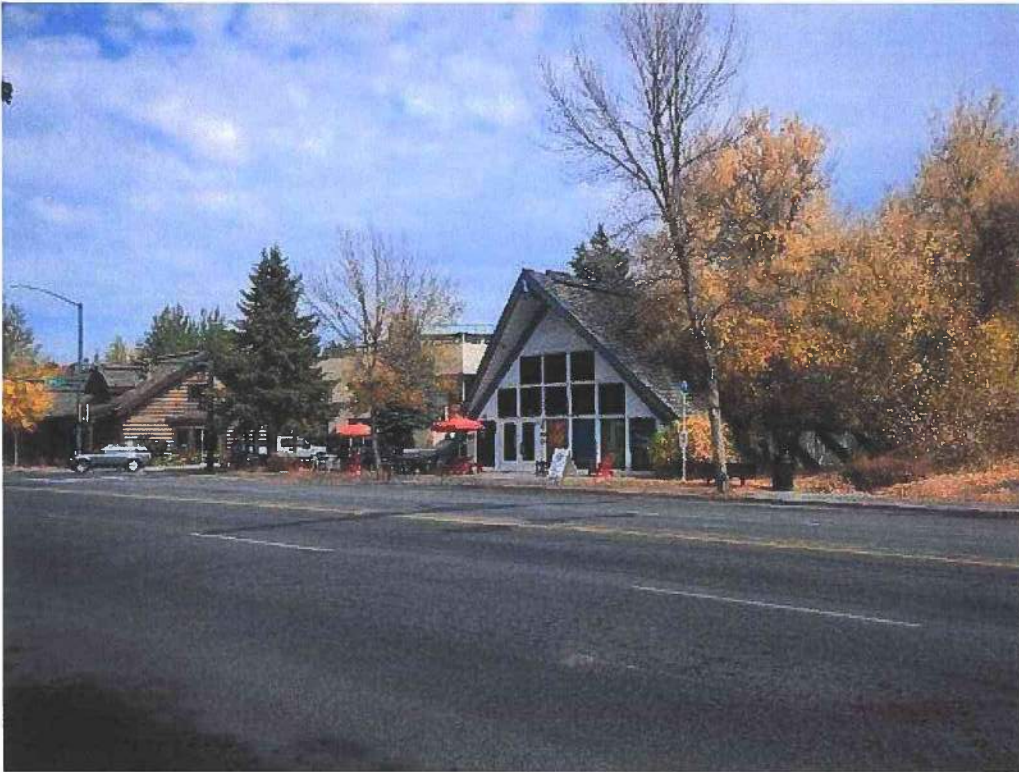
Photo 1: Looking N toward subject property from across Main Street
Note: elevated concrete curbing; slope of land; water spigot near S corner

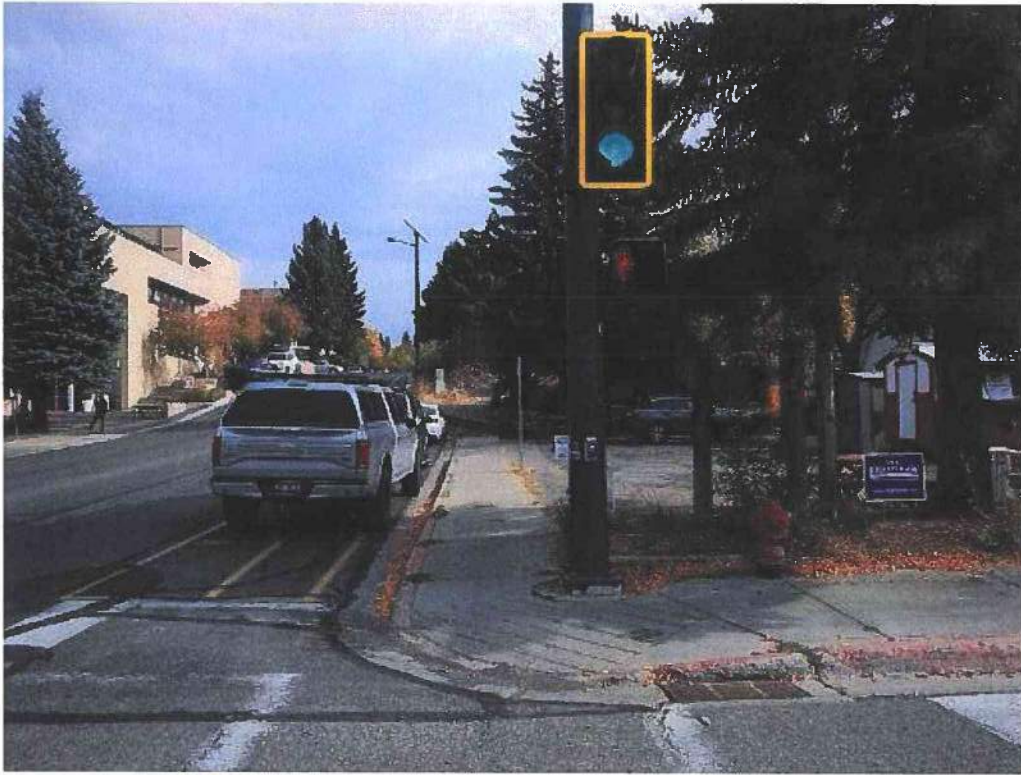
Photo 3: Looking NE toward from corner of Main and E 5th Streets
Note: nearest storm drain at corner; area slope

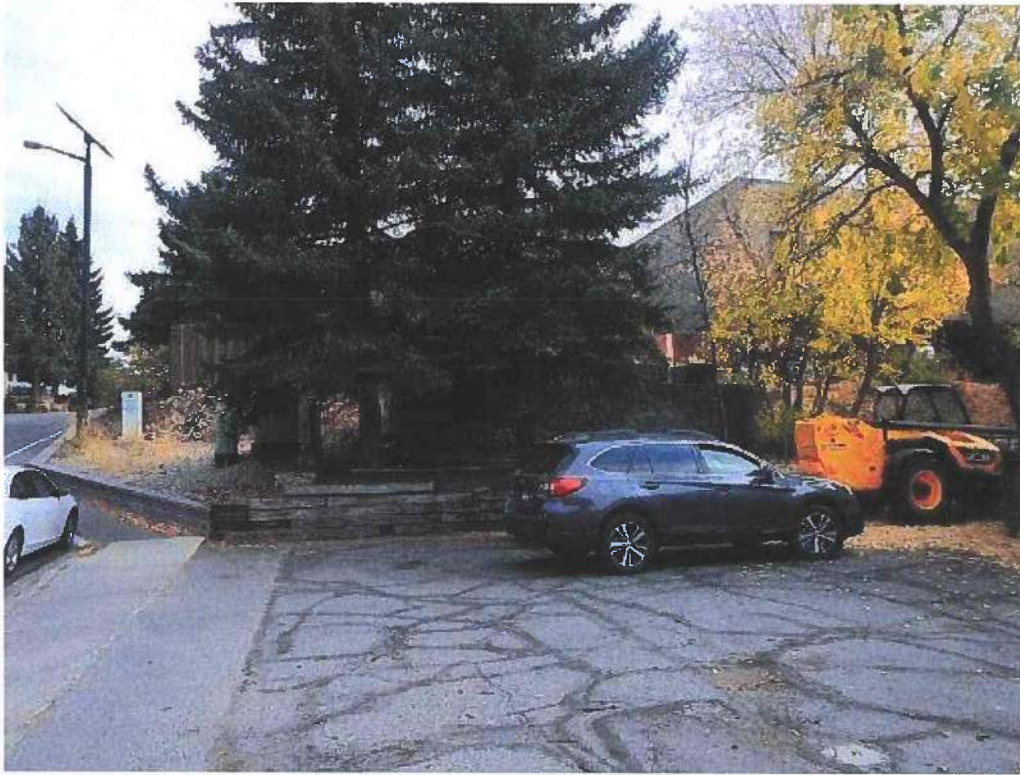
Photo 5: Looking NE toward property corner post (in front of green Cox box)

Note: slope of land to the NE; railroad tie retaining wall; concrete wall hides electric transformers

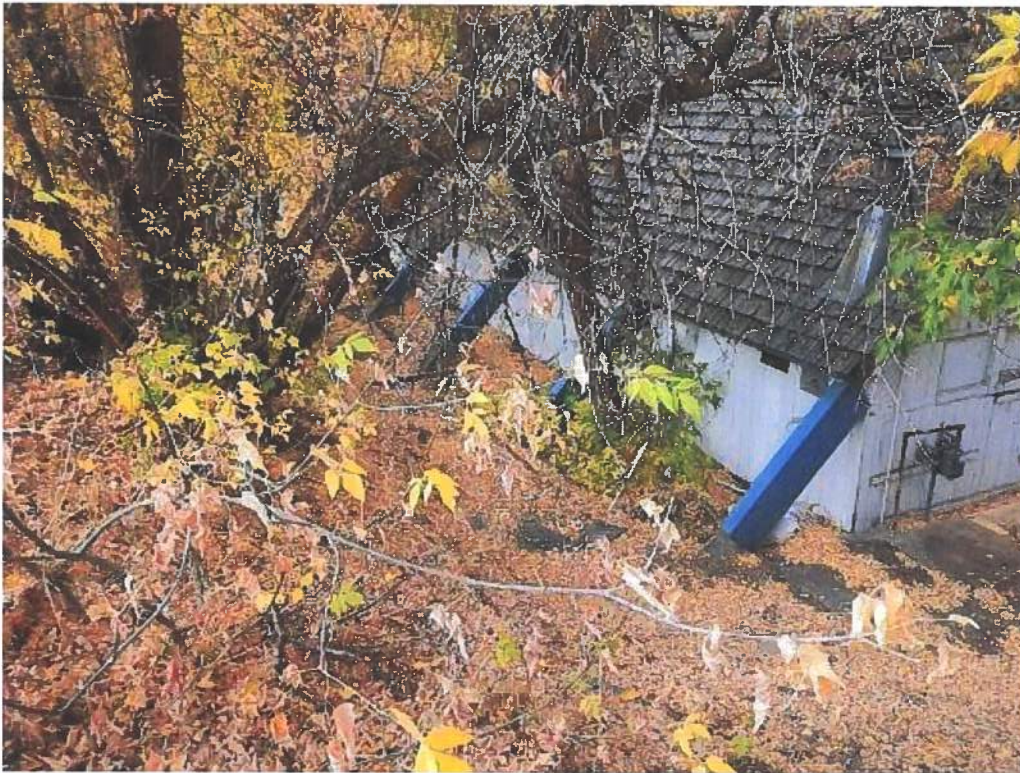
**Photo 8: Looking W toward E corner of subject building
Note: slope from adjacent property; gas meter; numerous leaves blocking visibility of ground**

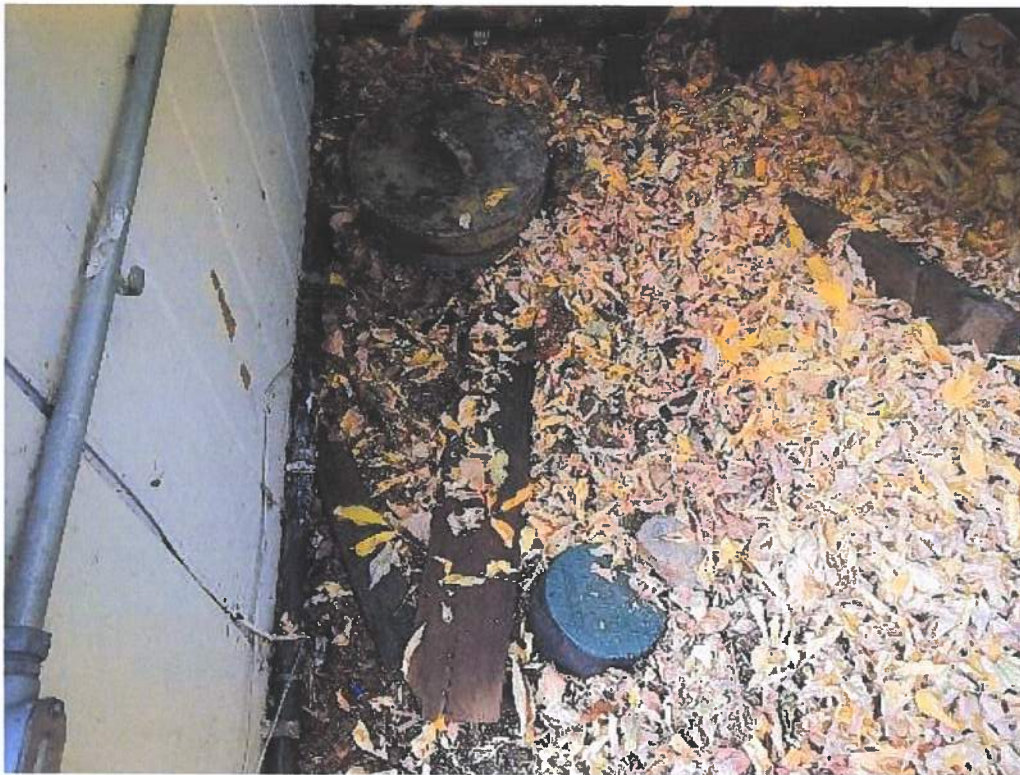
Photo 9: access conduits observed outside rear corner of building
Note: appear to be water related

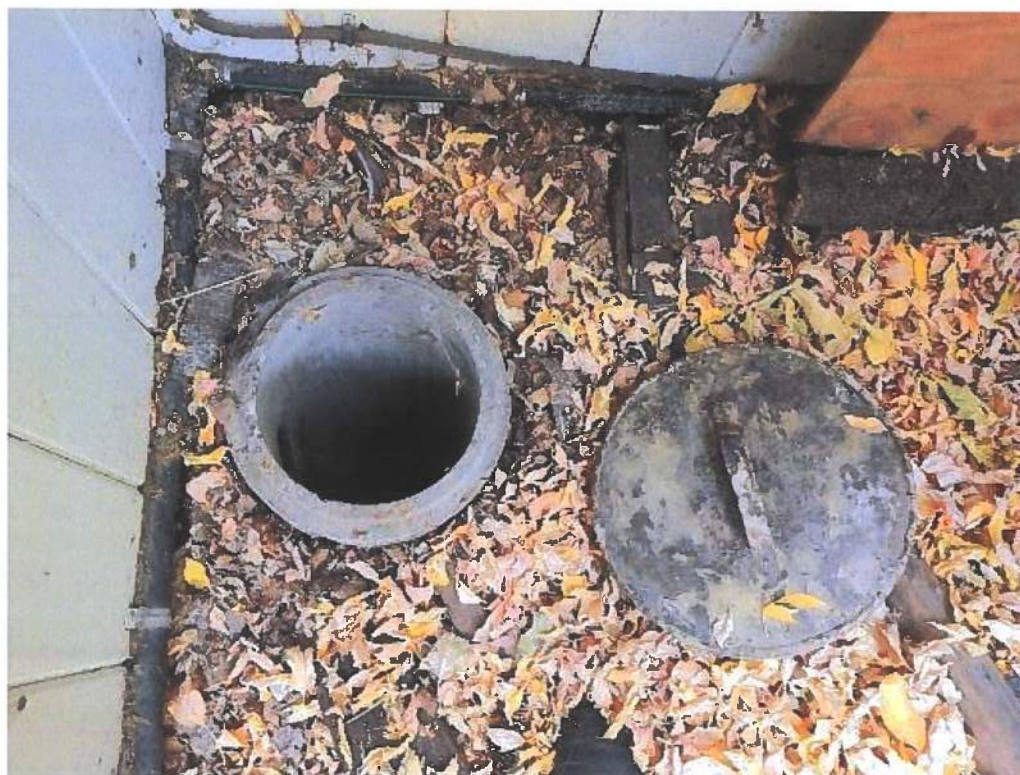
Photo 10: View inside concrete conduit behind building
Note: metal valve key likely for water shut off

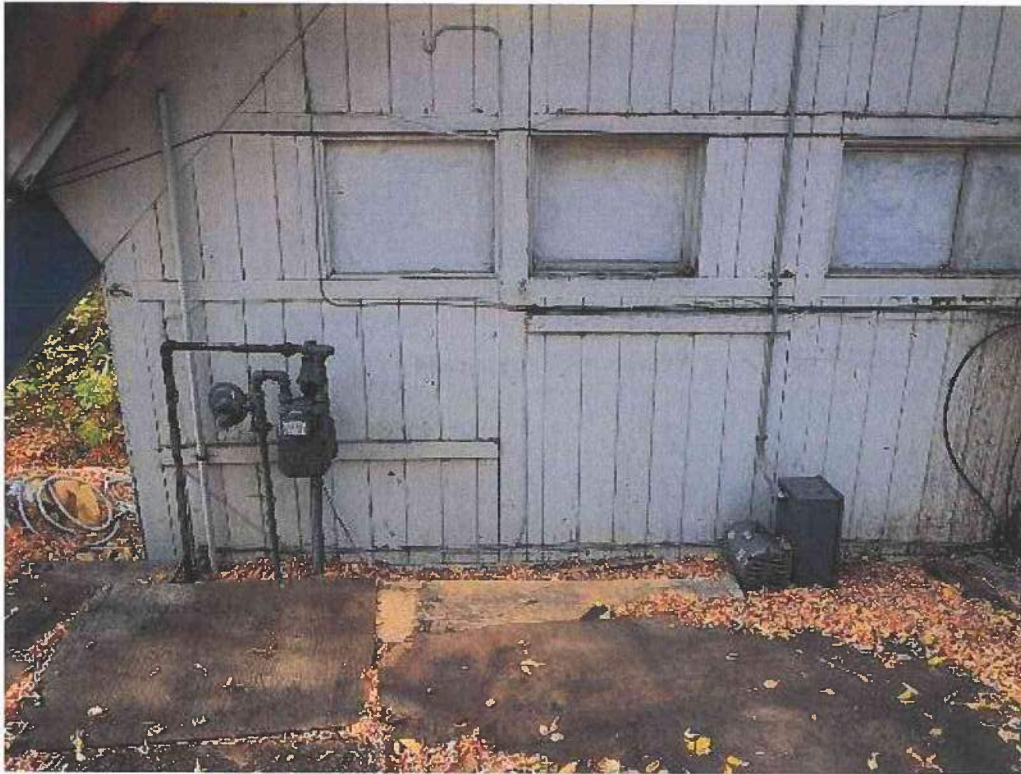
Photo 11: Outside rear of subject building

Note: gas meter; vent pipe; compressor; electric meter; layers of plywood and fiberboard prevented visual observation of ground

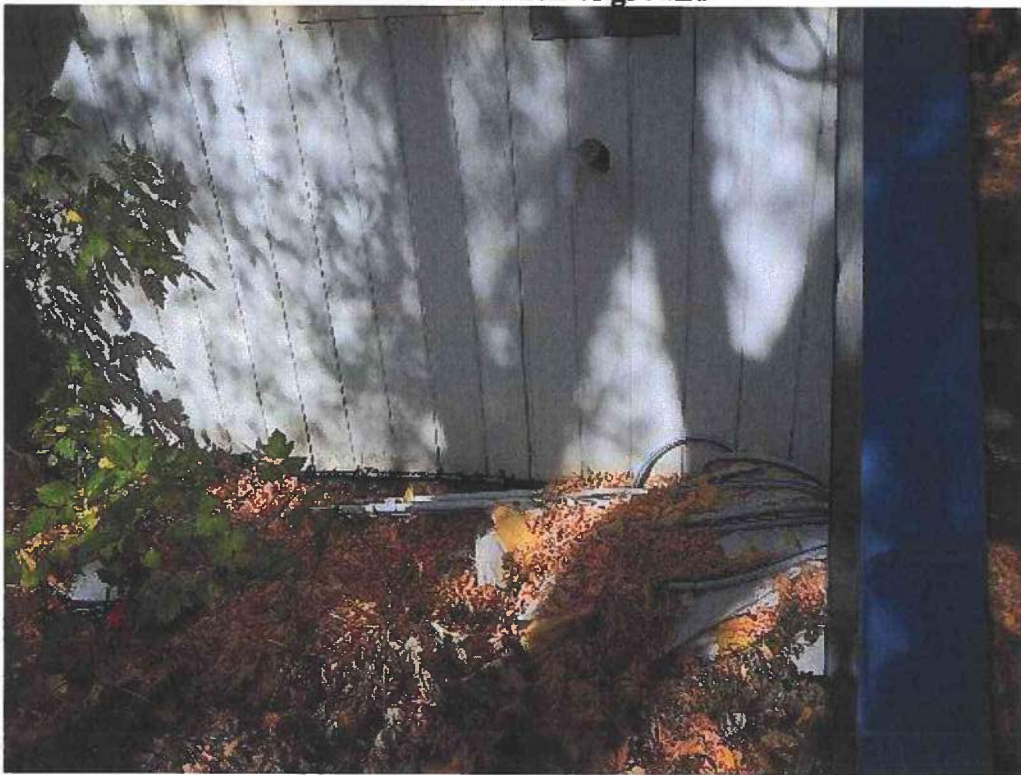
Photo 12: Outside east corner of building

Note: piles of piping, tarp, leaves prevented visual observation of ground

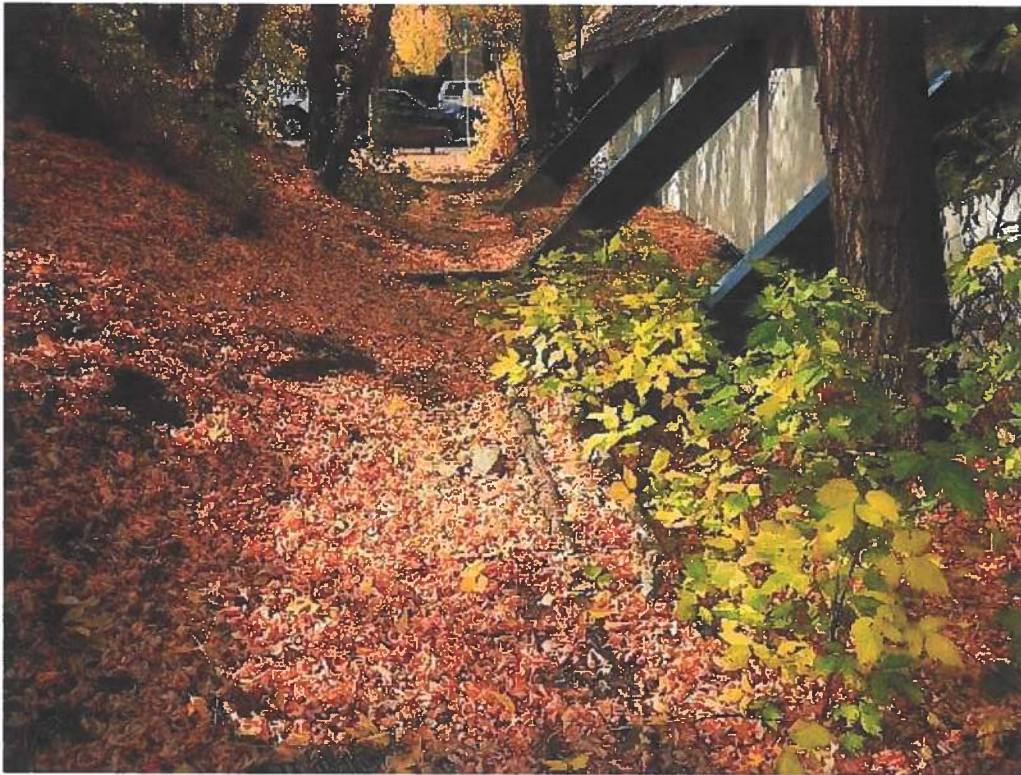
Photo 13: View outside SE side of building

Note: leaves prevented view of ground but several pipes and pieces of wood observed below leaves

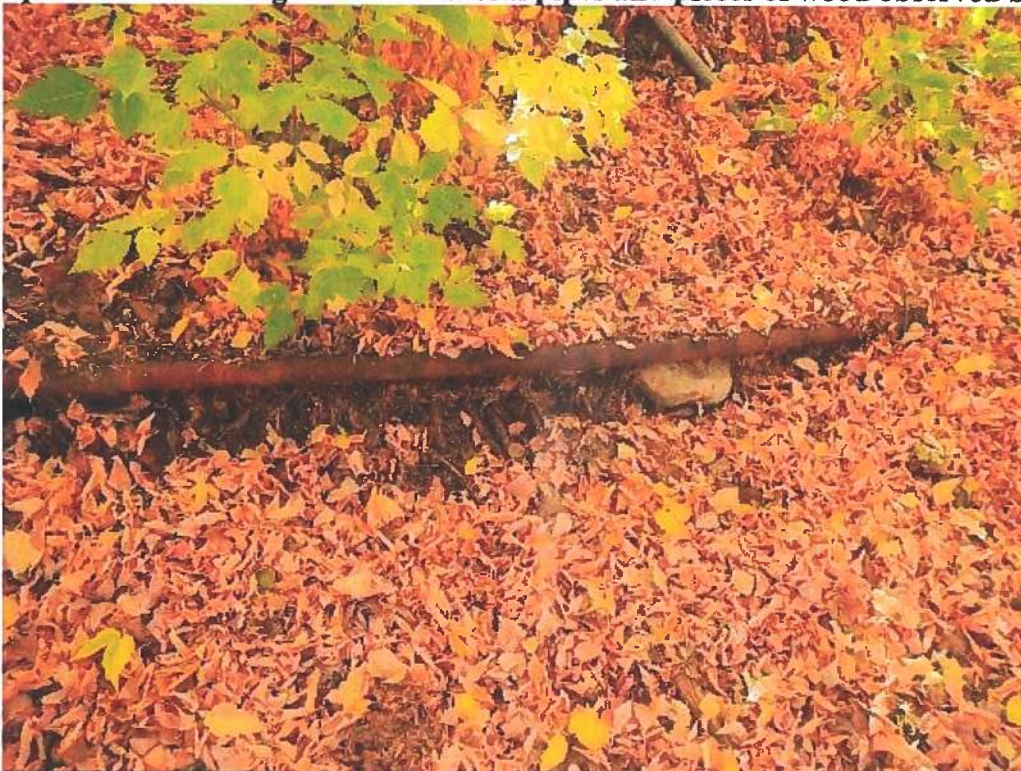
Photo 14: View of iron pipe observed along hillside outside SE side of building

Note: appears to continue up the hill to the east

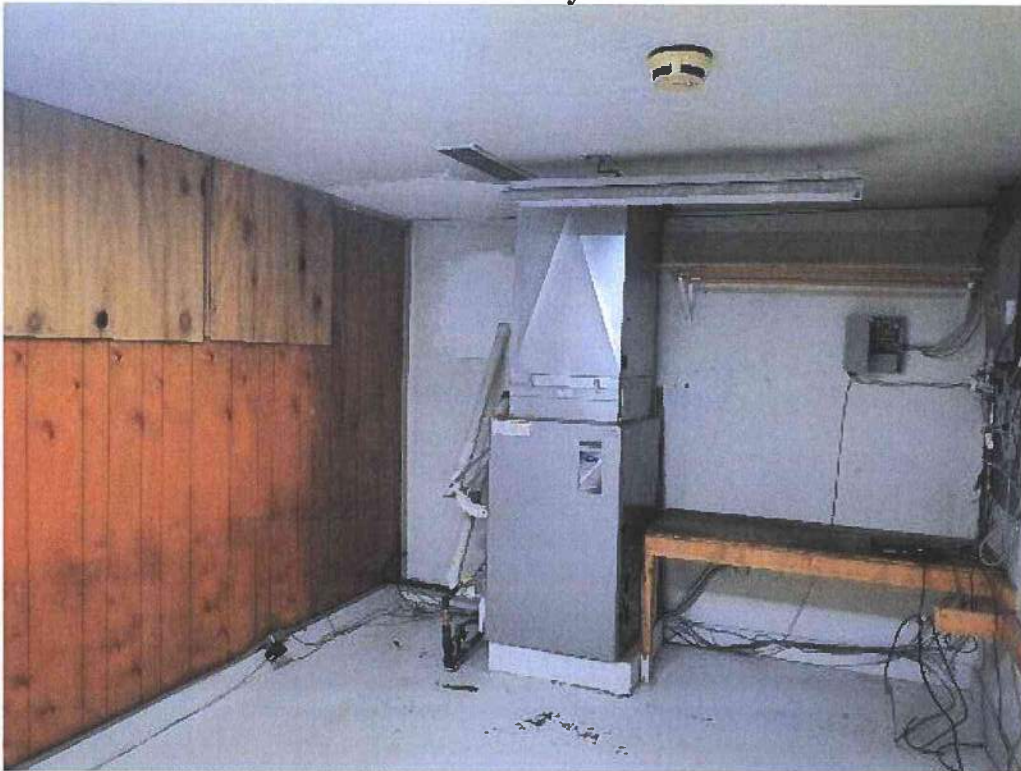
Photo 20: Gas furnace in furnace room
Note: strong diesel (heating oil) odor; concrete floor

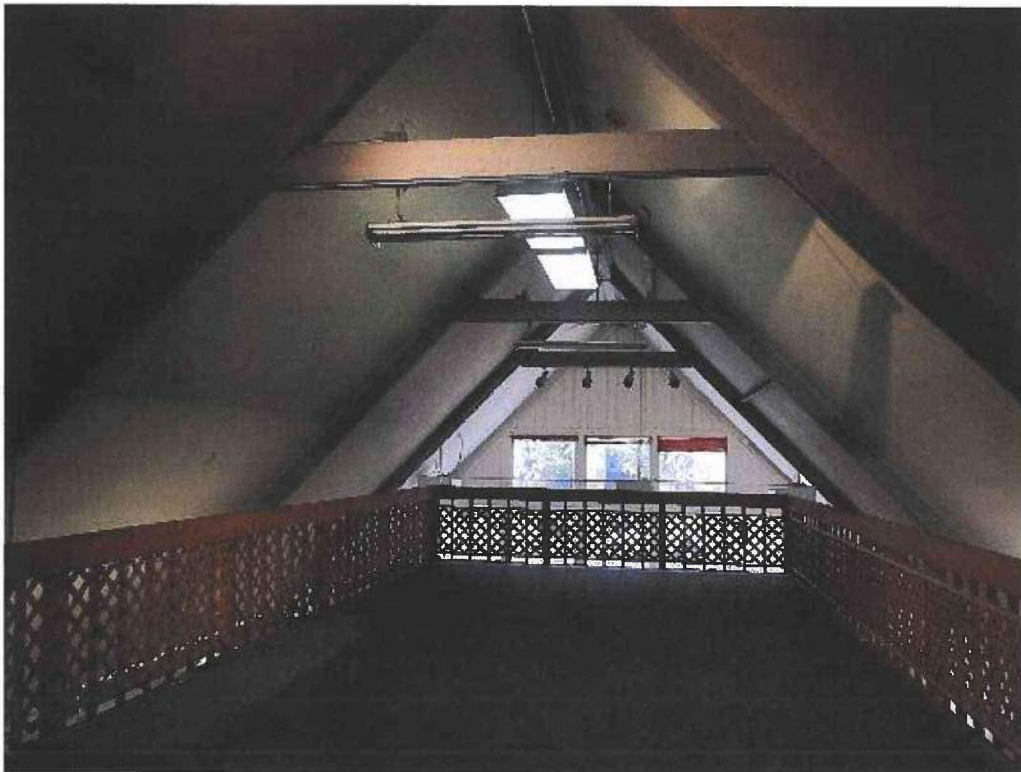
Photo 22: View of mezzanine

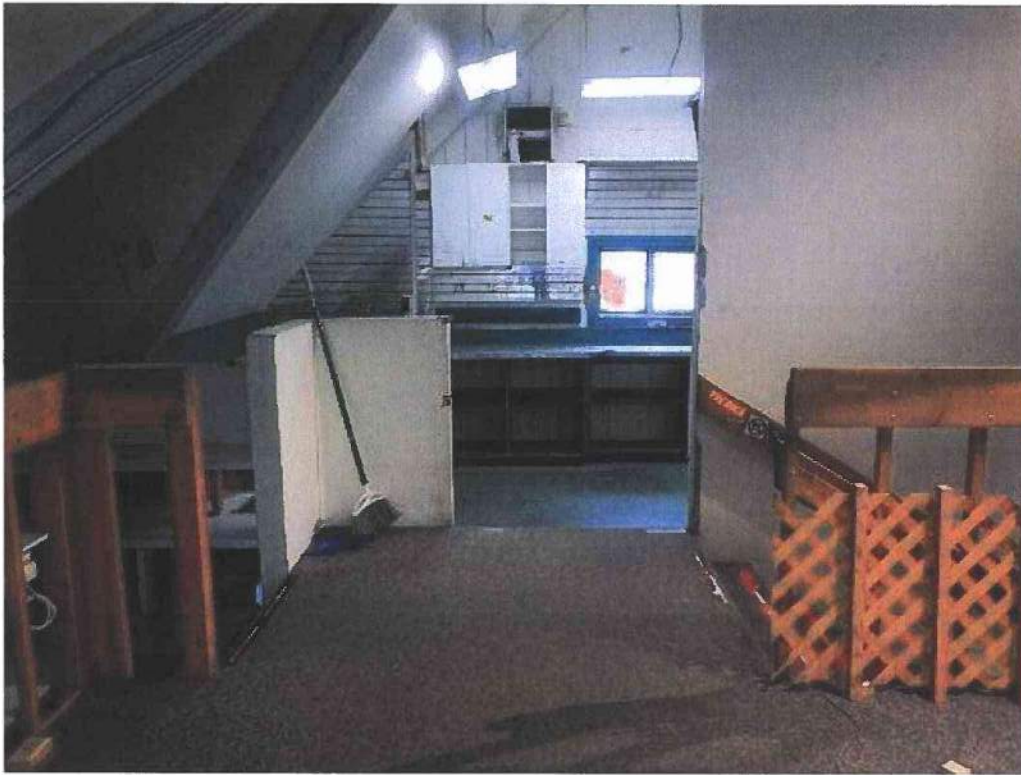
Photo 23: Work room on mezzanine level
Note: sheet vinyl floor, fan and exhaust piping

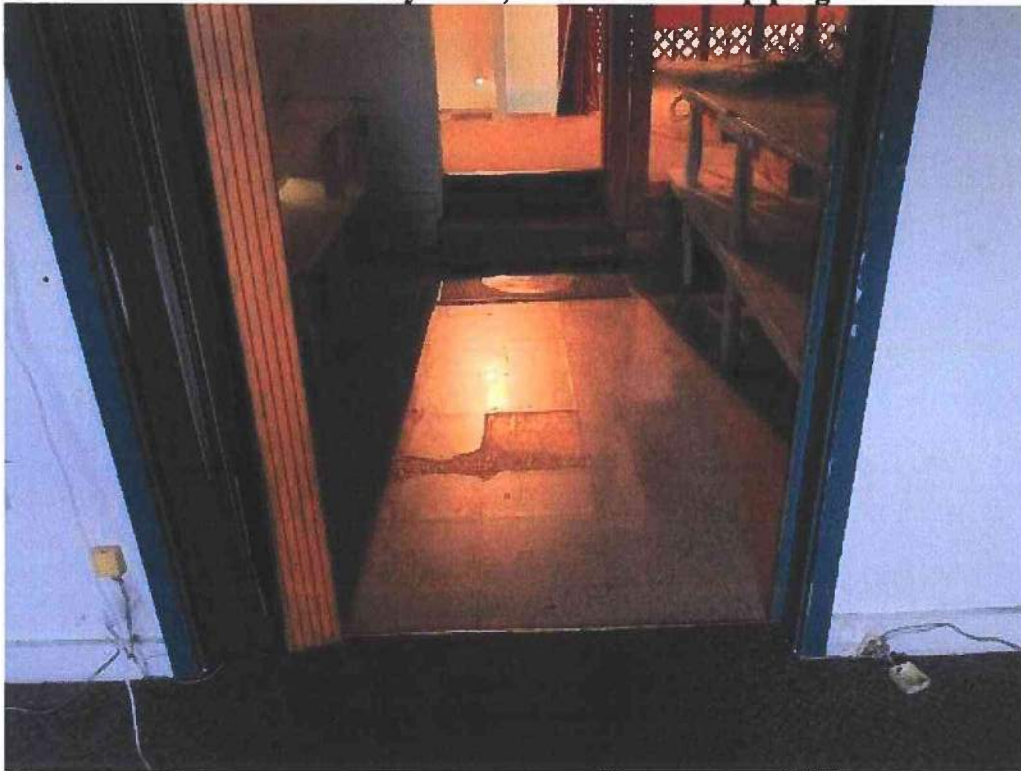
Photo 24: Hallway on mezzanine level with vinyl floor tile
