June 11, 2024

Subject: **Report of Structural Condition Survey for Damaged Truss Members**  
**The Woman's Club of Lake City**  
257 SE Hernando Ave,  
Lake City, FL 32025  
NOVA Project No: 10124-2524088

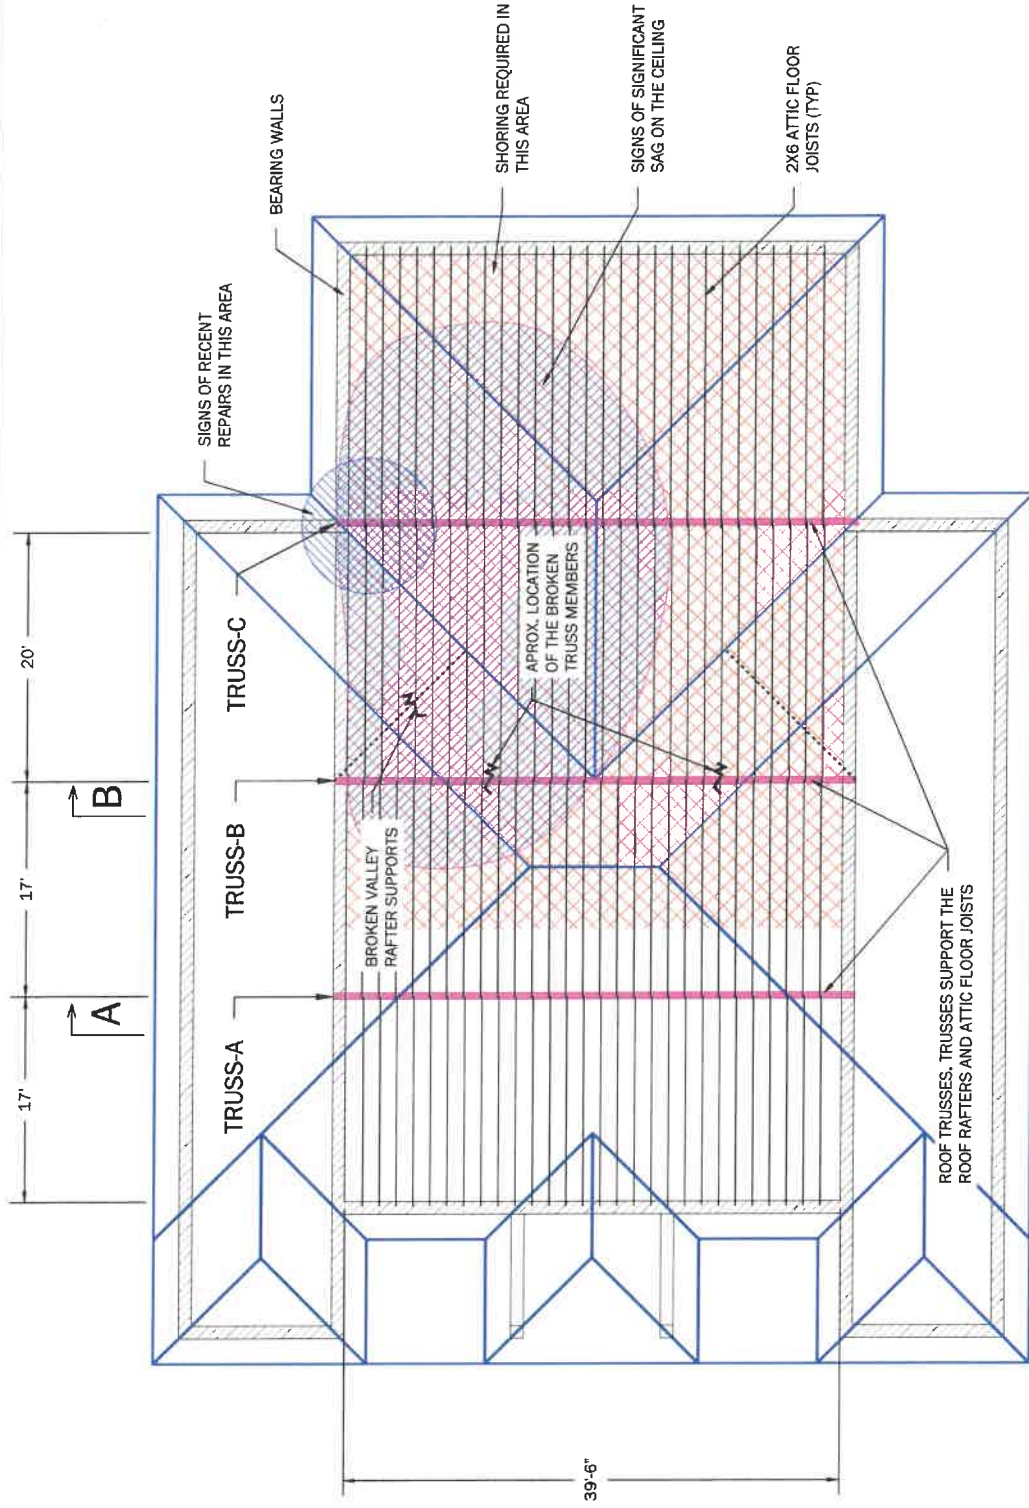
1 ROOF PLAN

- Truss-B appeared to be damaged. The top chord member of the truss was broken (see attached drawings for location). The broken top chord members have displaced laterally (buckled) which indicates a failure mode of the truss top chord members in compression. The top chord of the broken truss appeared to be not laterally braced and the existing vertical 2x6 braces of the hip rafters were disconnected from the rafters. The unbraced length of the top chord was approx. twenty-two (22) feet.

- An x-brace between Truss-A and Truss-B was present and both x-bracing members were broken. These bracing members were approx. nineteen (19) feet long and did not appear to be braced. The broken x-brace indicates significant horizontal and/or vertical differential displacement between these trusses.

- Shore the attic floor joists, and roof rafters supported by Truss-B to decrease the load on the roof framing (main trusses) and provide safe access to the attic. Do NOT attempt to lift the attic joists/trusses. We recommend the shoring be designed by a professional engineer and installed by a licensed framing contractor.
- Once the main roof truss and attic joists have been shored, it is possible to further investigate and evaluate the roof framing. This evaluation is recommended to determine whether it is more feasible and cost-effective to repair or replace the roof framing.
- Further investigate the top of the perimeter wall, to ensure the presence of a bond beam at top of the wall is recommended. If no bond beams are present, we recommend the installation of a bond beam to provide continuity and mitigate the observed cracks on the masonry walls.
