# PAVEMENT MANAGEMENT FINAL PROJECT REPORT

**LAKE PARK, FL**

**Monday, June 20, 2022**

**Pavement Management Group**

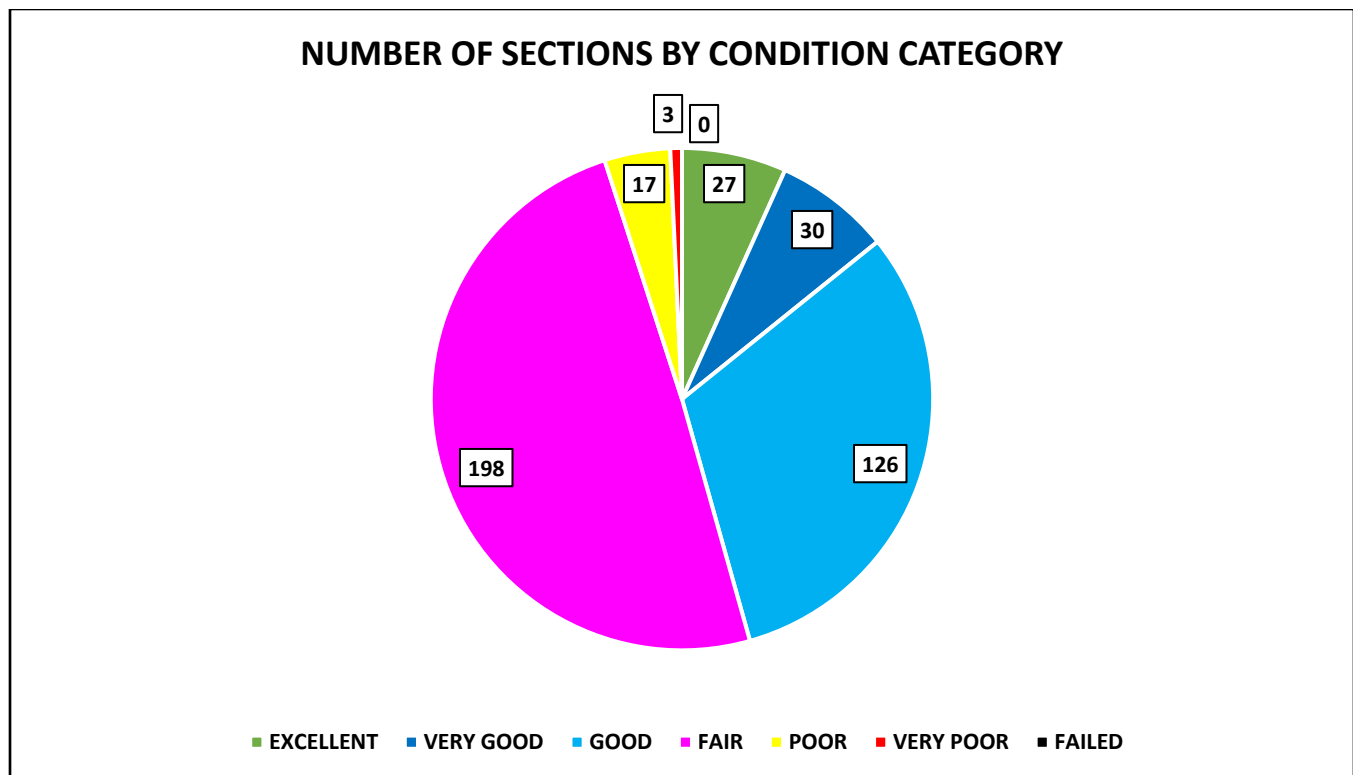
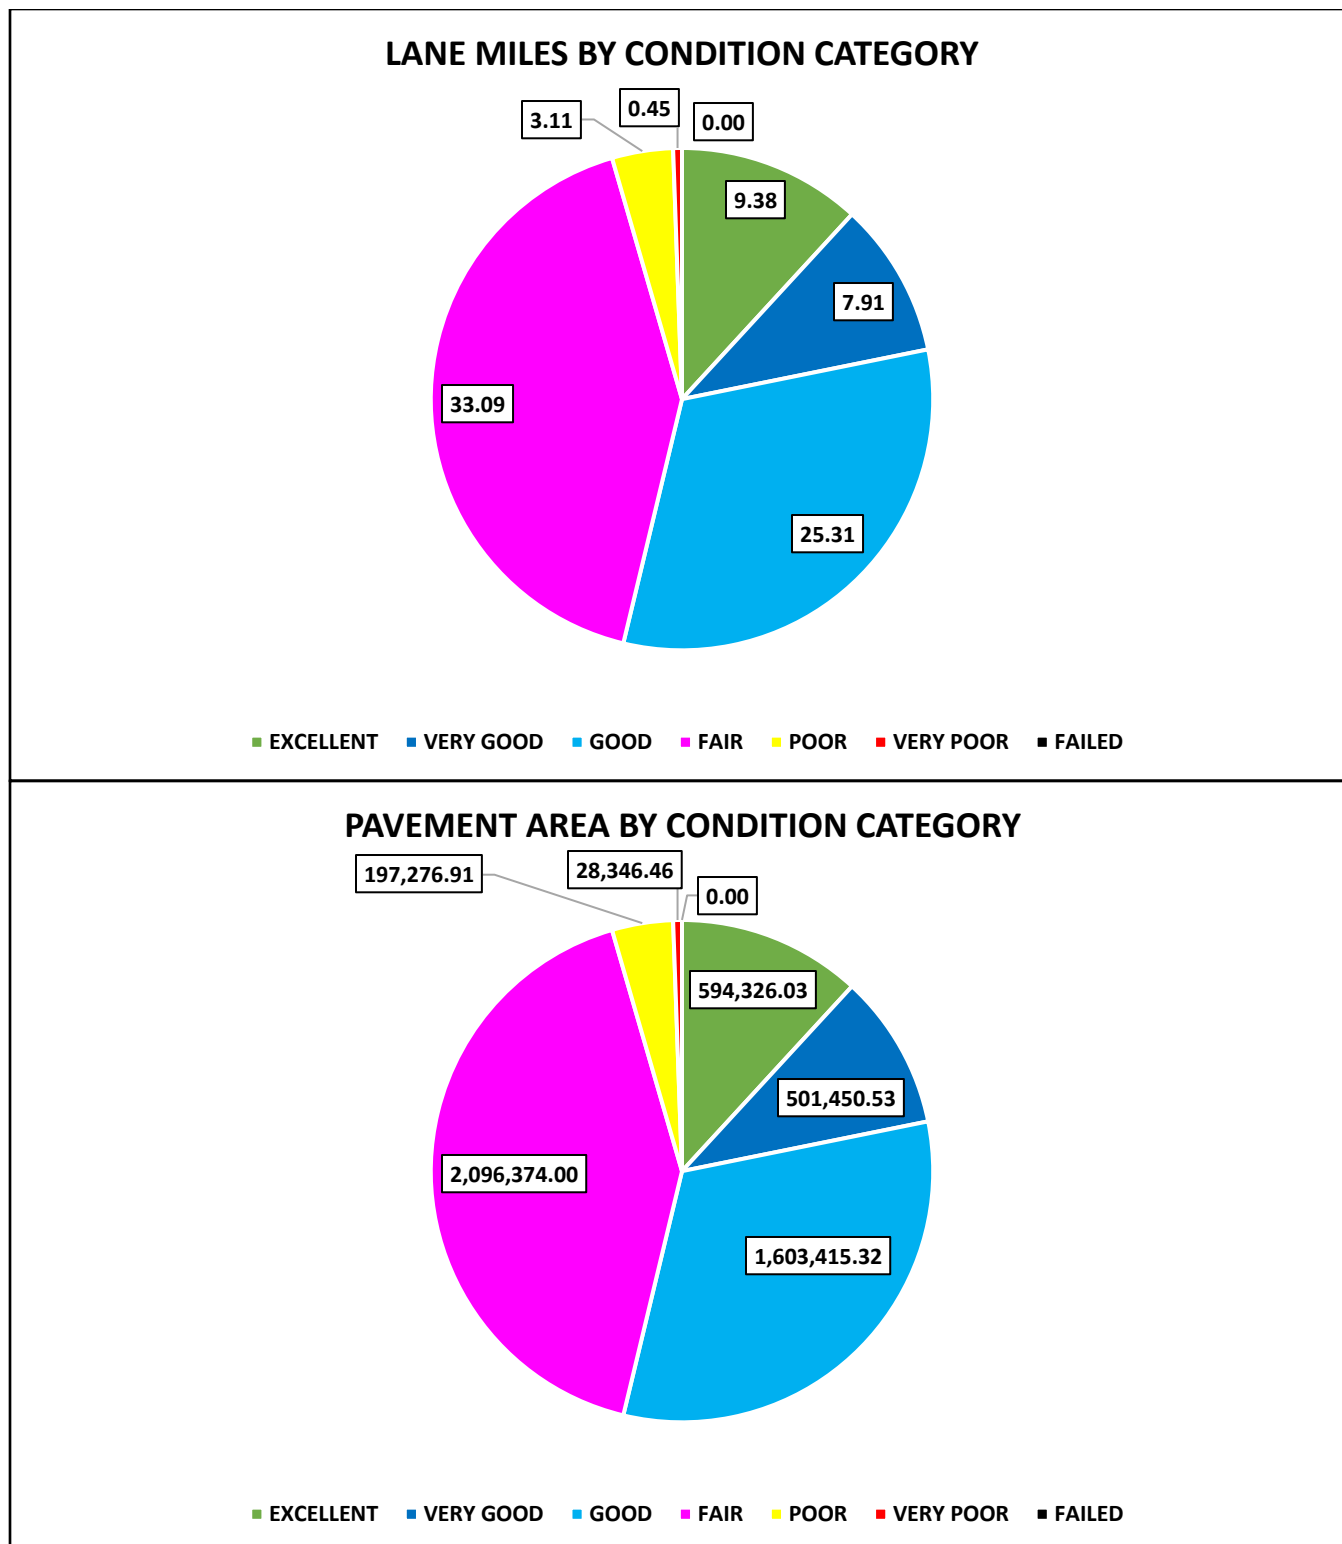
Figure 3. Sections, Lane Miles, and Pavement Area by Condition Category

After completion of the 2022 pavement management project, PMG has determined that the average PCI for Lake Park's 79 lane mile (37 Centerline Mile) roadway network is a 68 and considered to be in Good condition. Table 2 displays the condition summary data by category across the network while Figure 3, illustrates the condition by pavement area breakdown in graph form. A complete Inventory and Condition Report in Excel spreadsheet was provided as a part of this project deliverable.

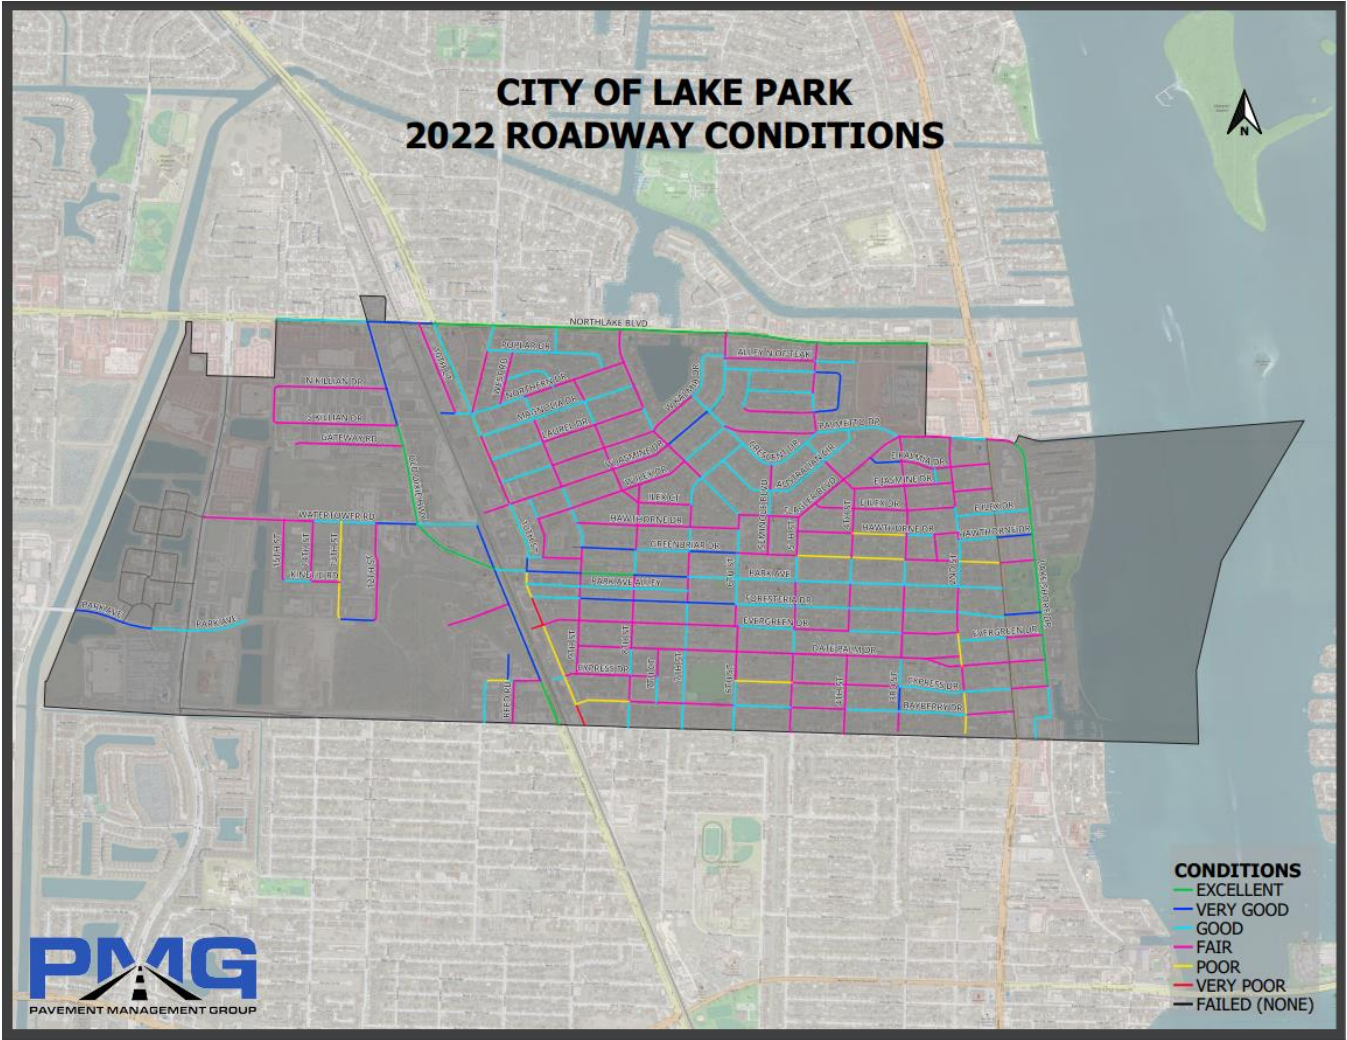
Figure 4. Roadway Section Latest Condition maps

PMG assigned all pavement management data to GIS and will provide the shapefile to the agency. This allows for a wide variety of mapping options within both ESRI's ArcGIS and Google Earth. The following shows an example of a Latest Condition Map that has been created in both GIS and Google Earth for illustrative purposes. An ANCI Size C plot ready pdf version has been provided as a part of the project deliverable.
