# CAPITAL IMPROVEMENT PLAN UPDATE

2023 Pavement Plan

07.13.23

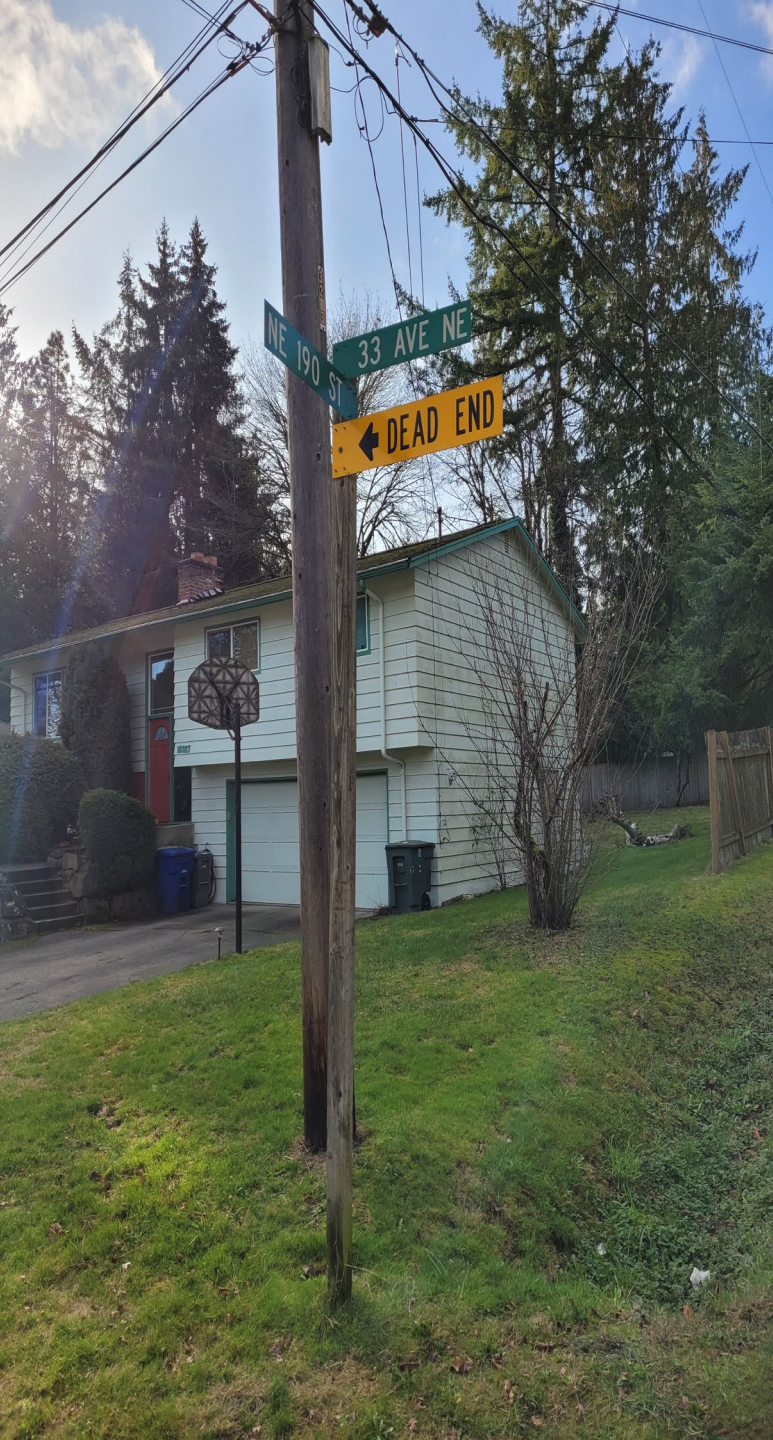
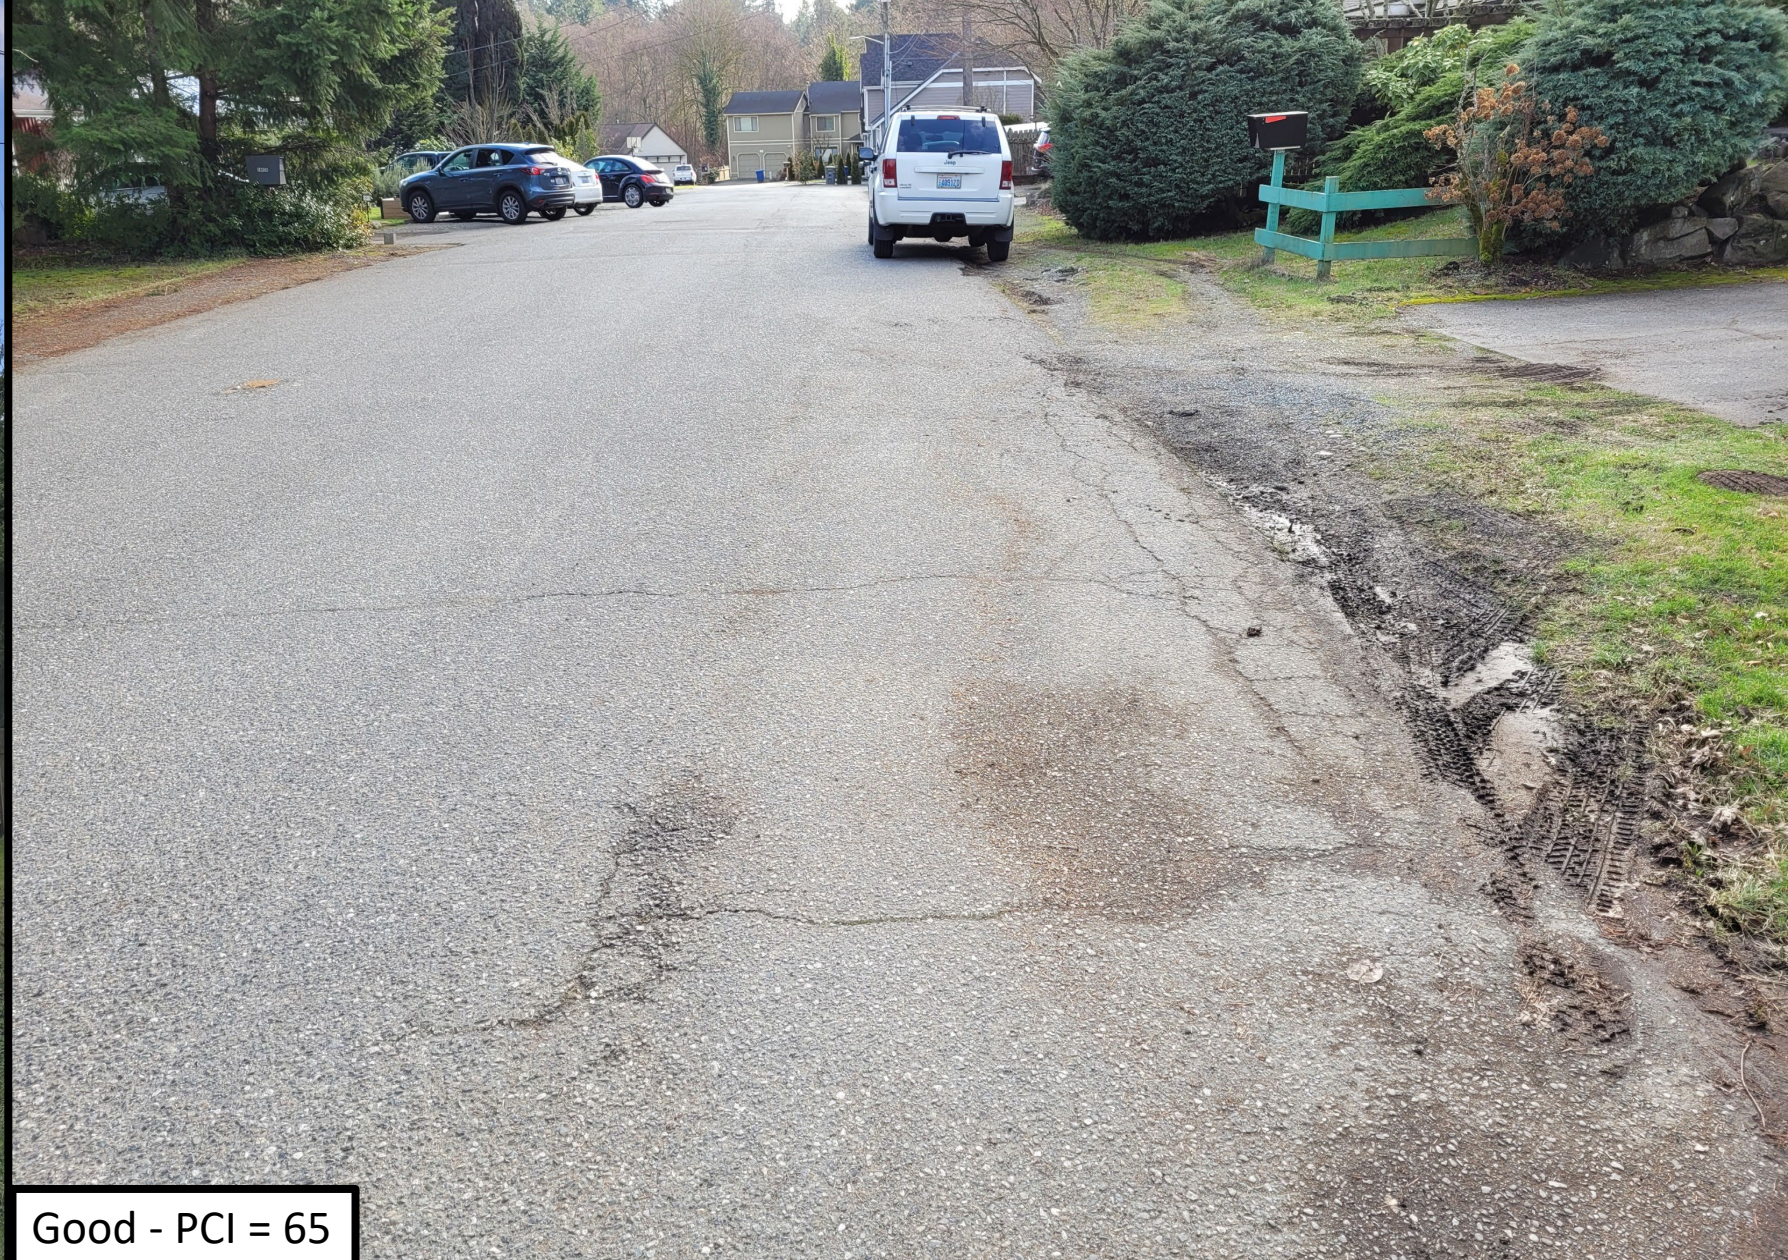
Good - PCI = 65

Generally stable, **minor areas of structural weakness evident. Cracking is easier to detect**, patches evident, patched but not excessively. Deformation more pronounced and easily noticed. **Ride qualities are good to acceptable.**

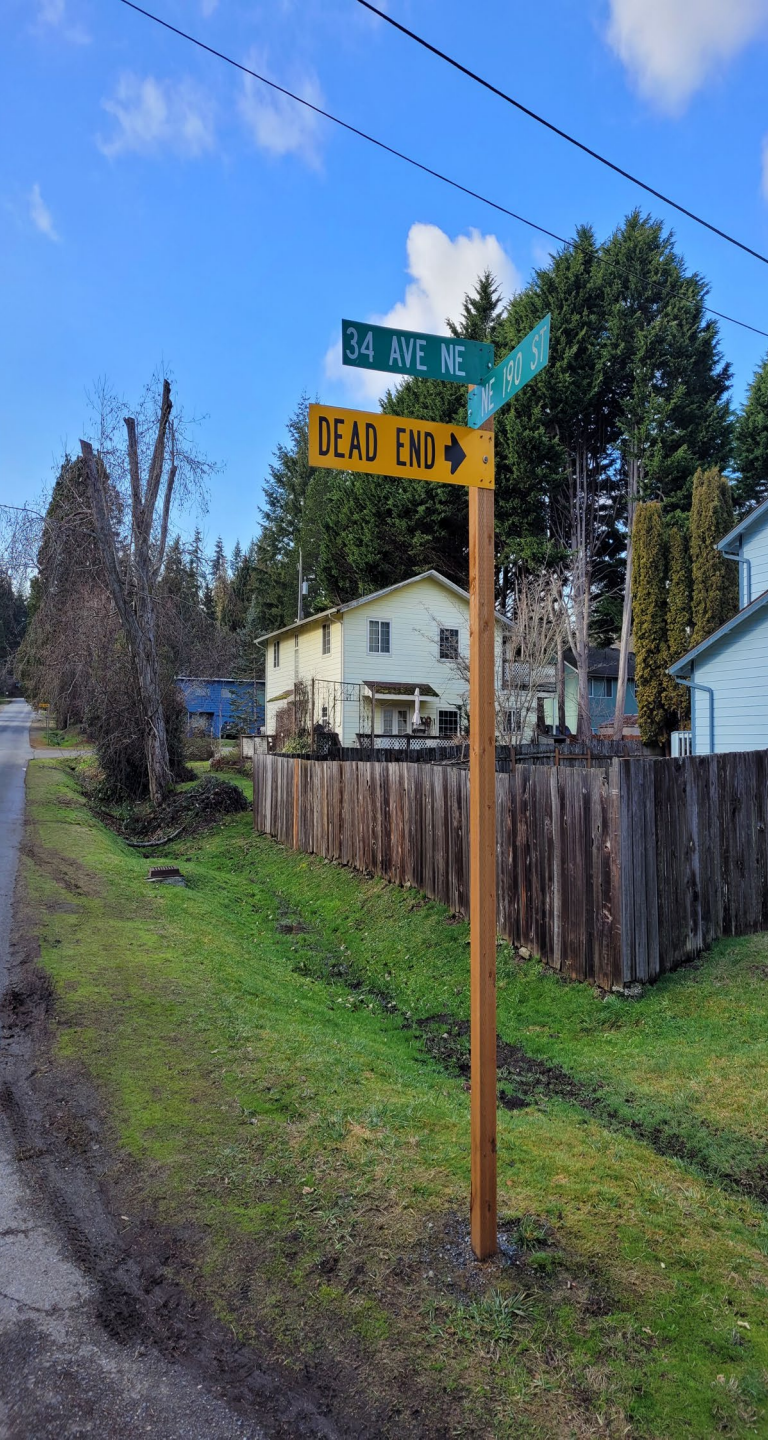
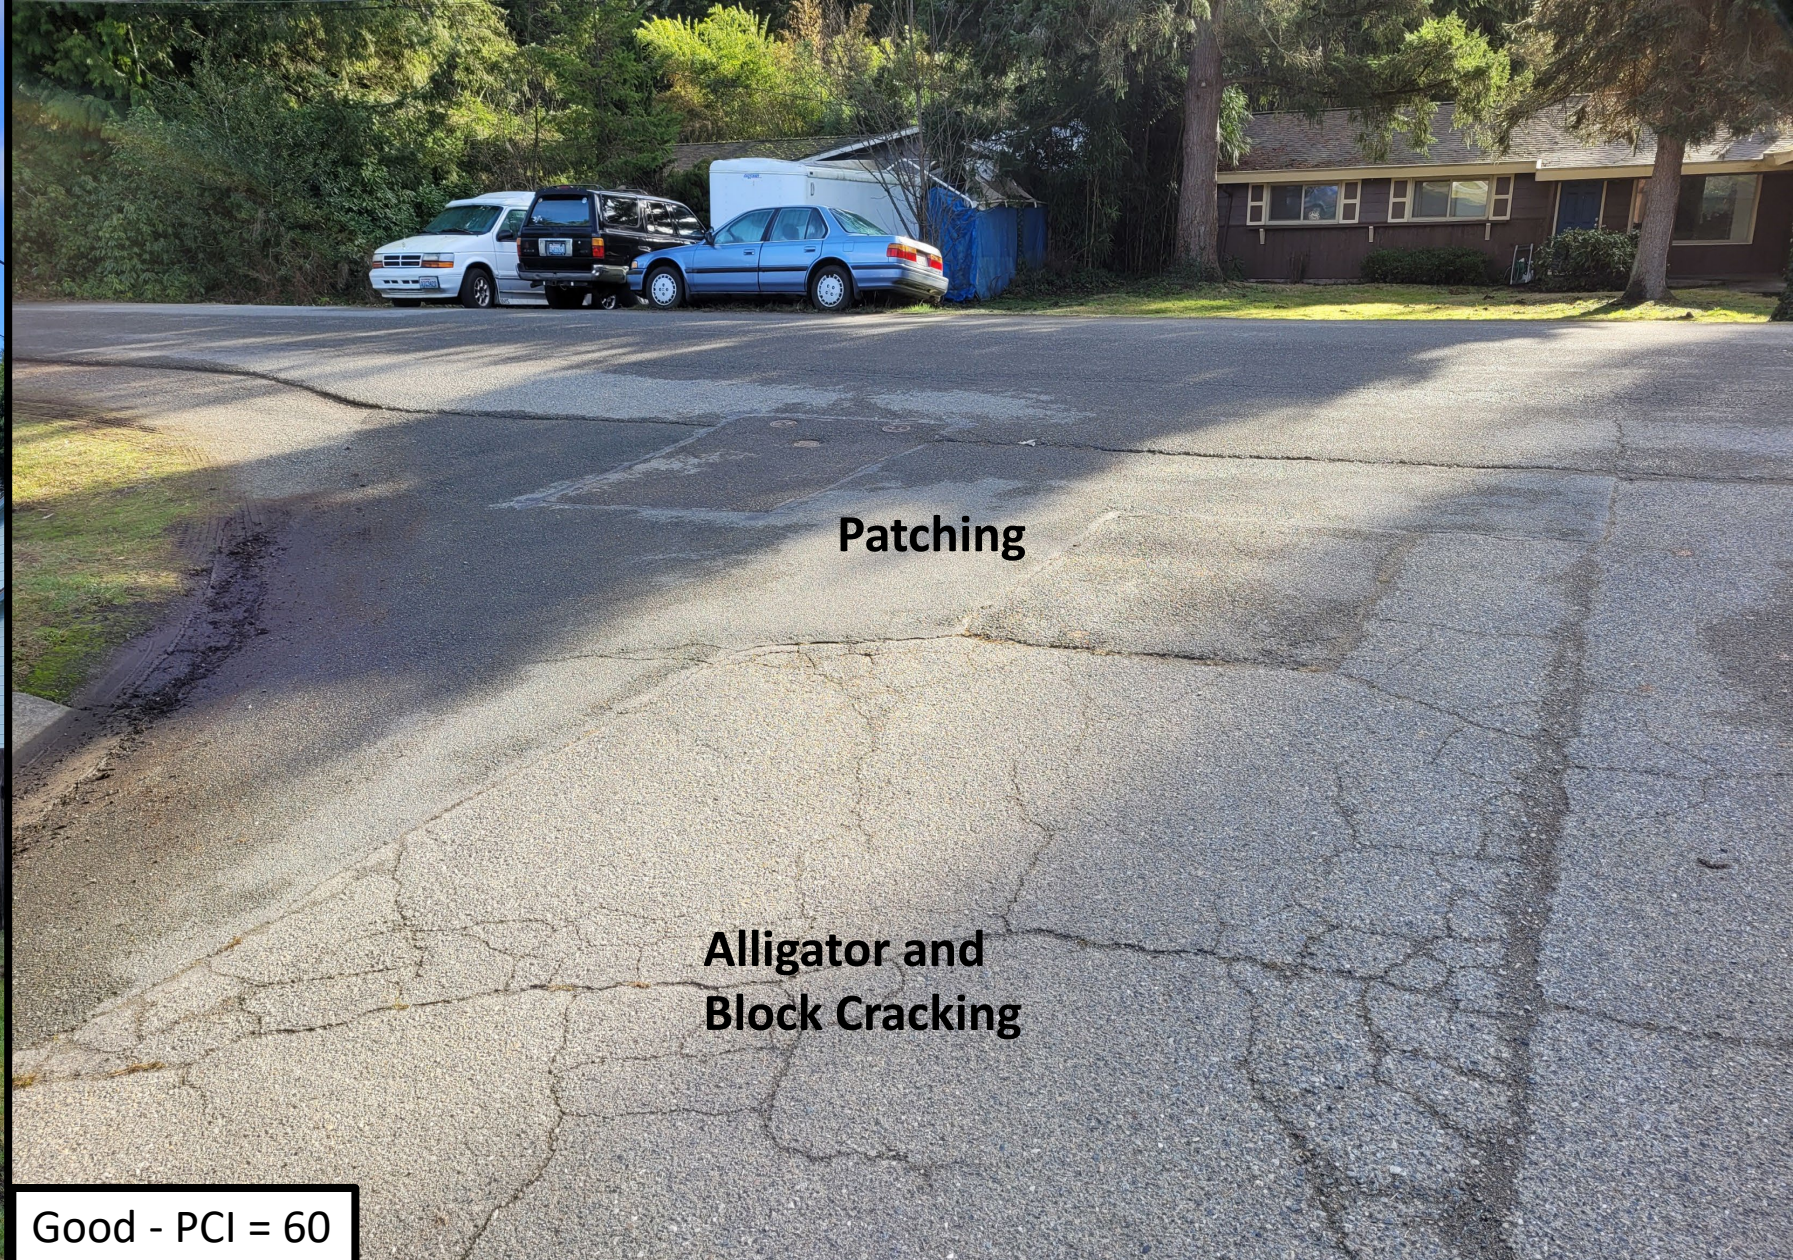
Good - PCI = 60

Generally stable, **minor areas of structural weakness evident**. **Cracking is easier to detect**, patches evident, patched but not excessively. Deformation more pronounced and easily noticed. Ride qualities are good to acceptable.

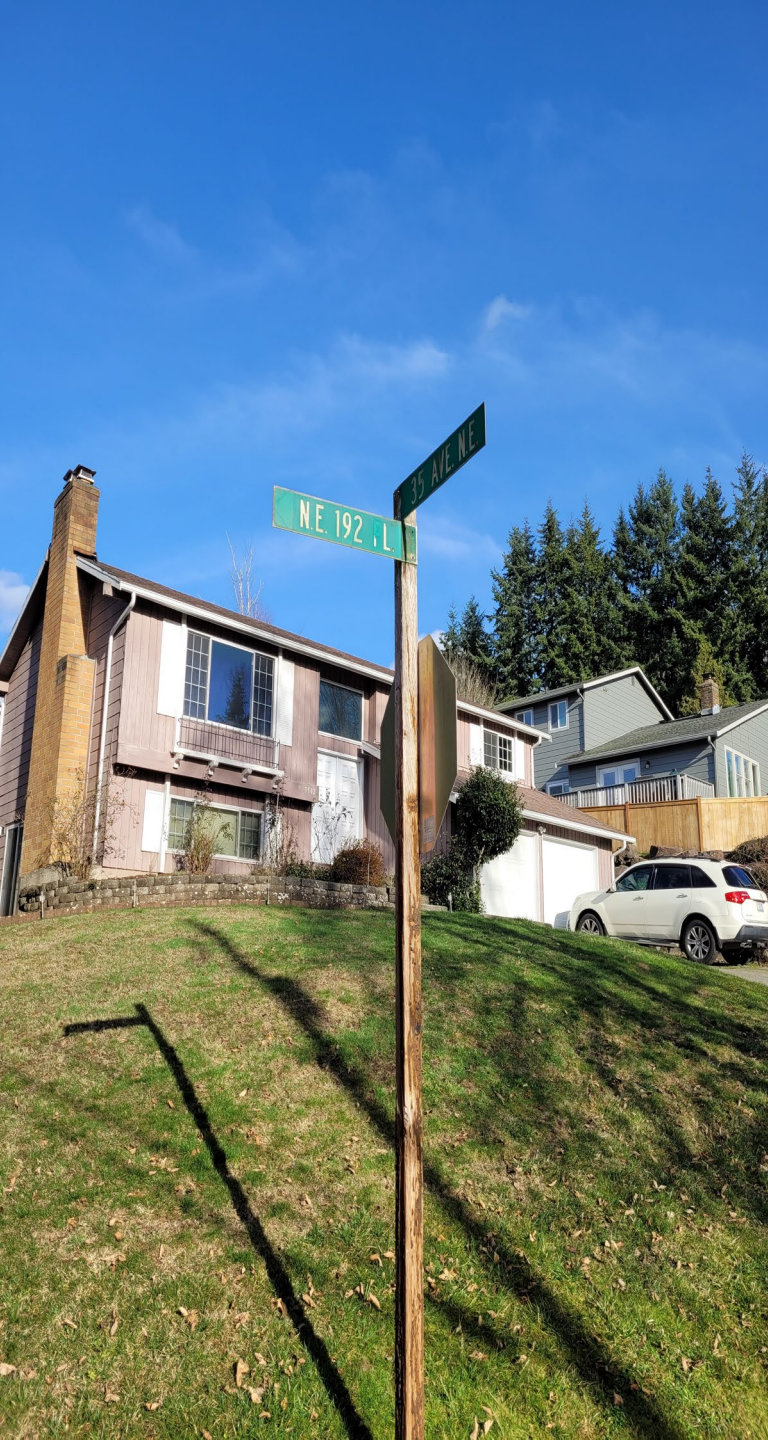
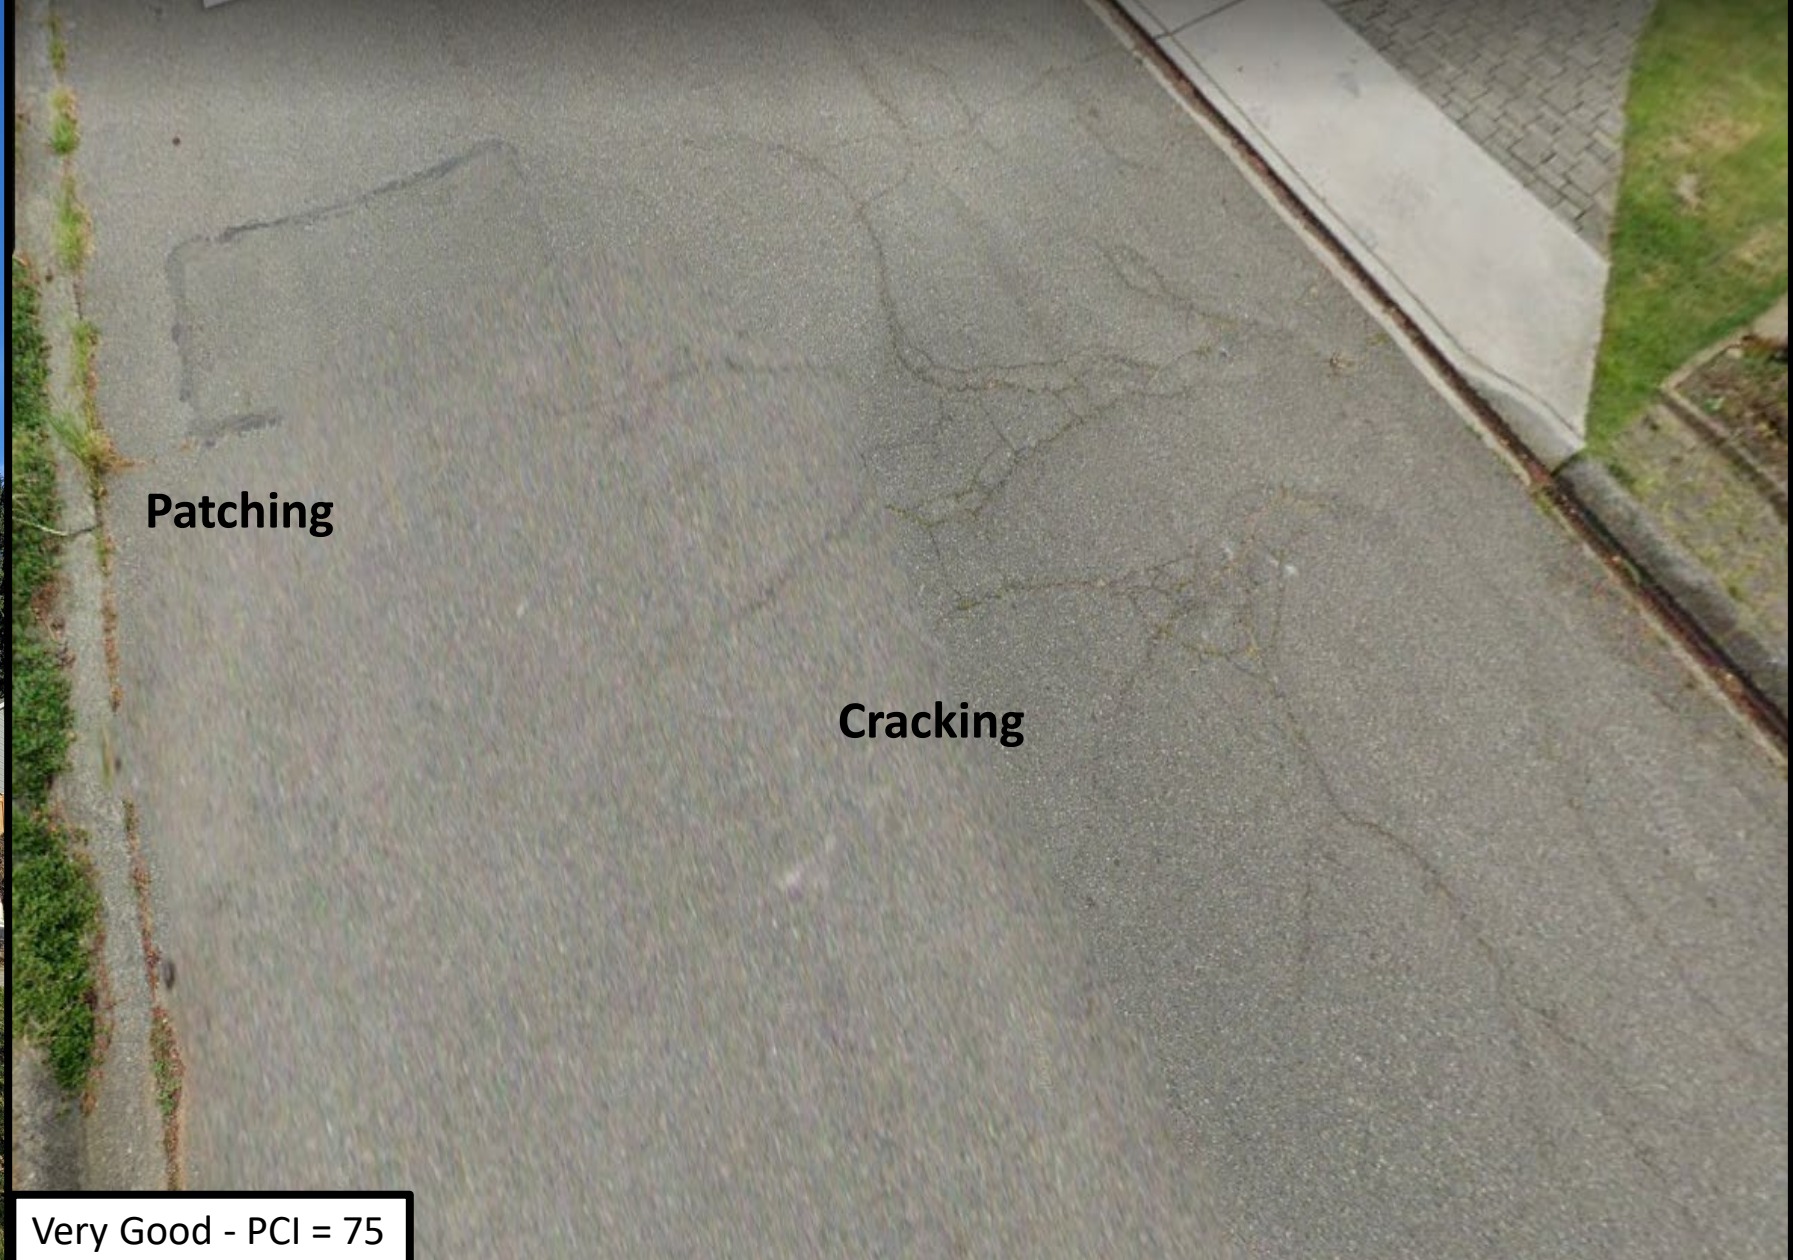
Very Good - PCI = 75

Stable, minor cracking, **generally hairline and hard to detect**. **Minor patching** and possibly some minor deformation evident. Dry or light-colored appearance. **Good riding qualities**. Rutting less than ½".

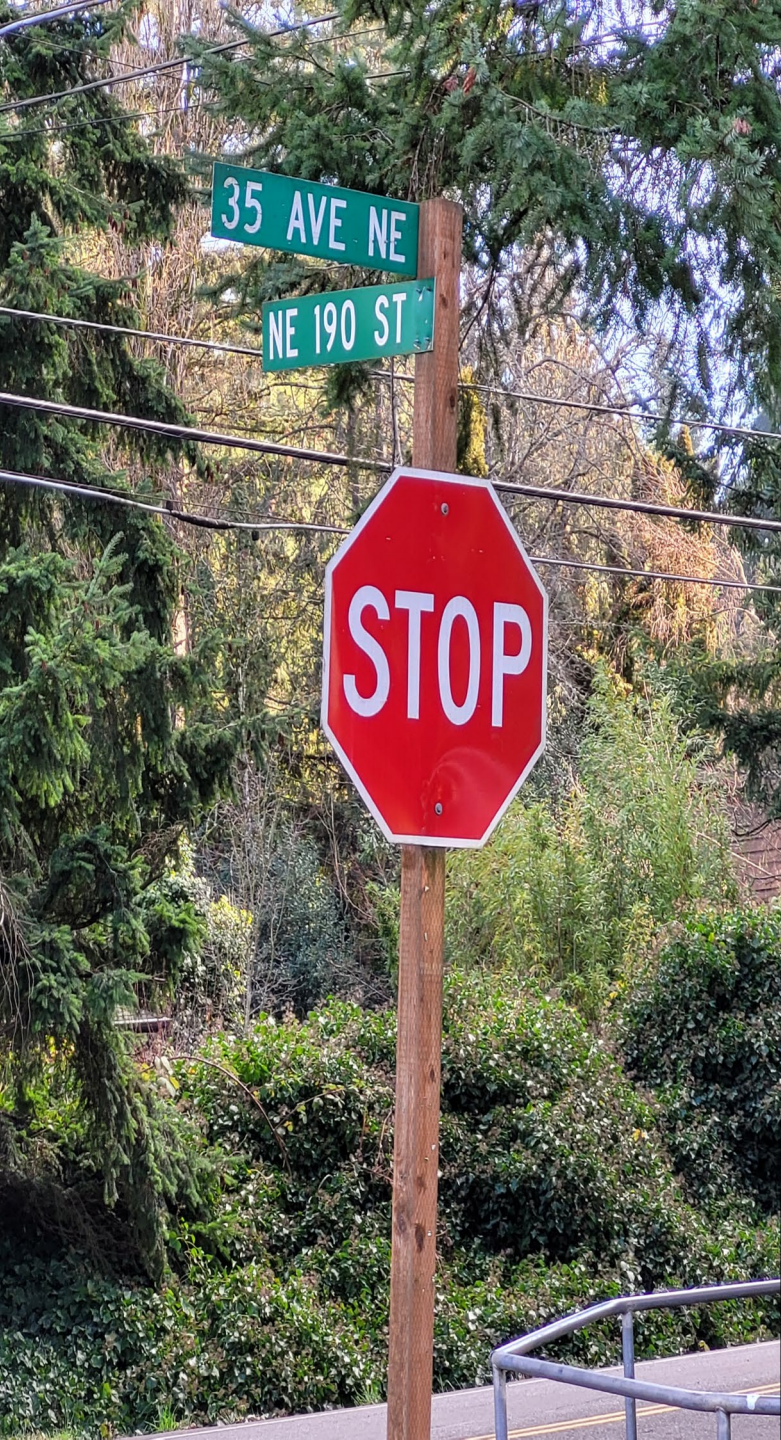
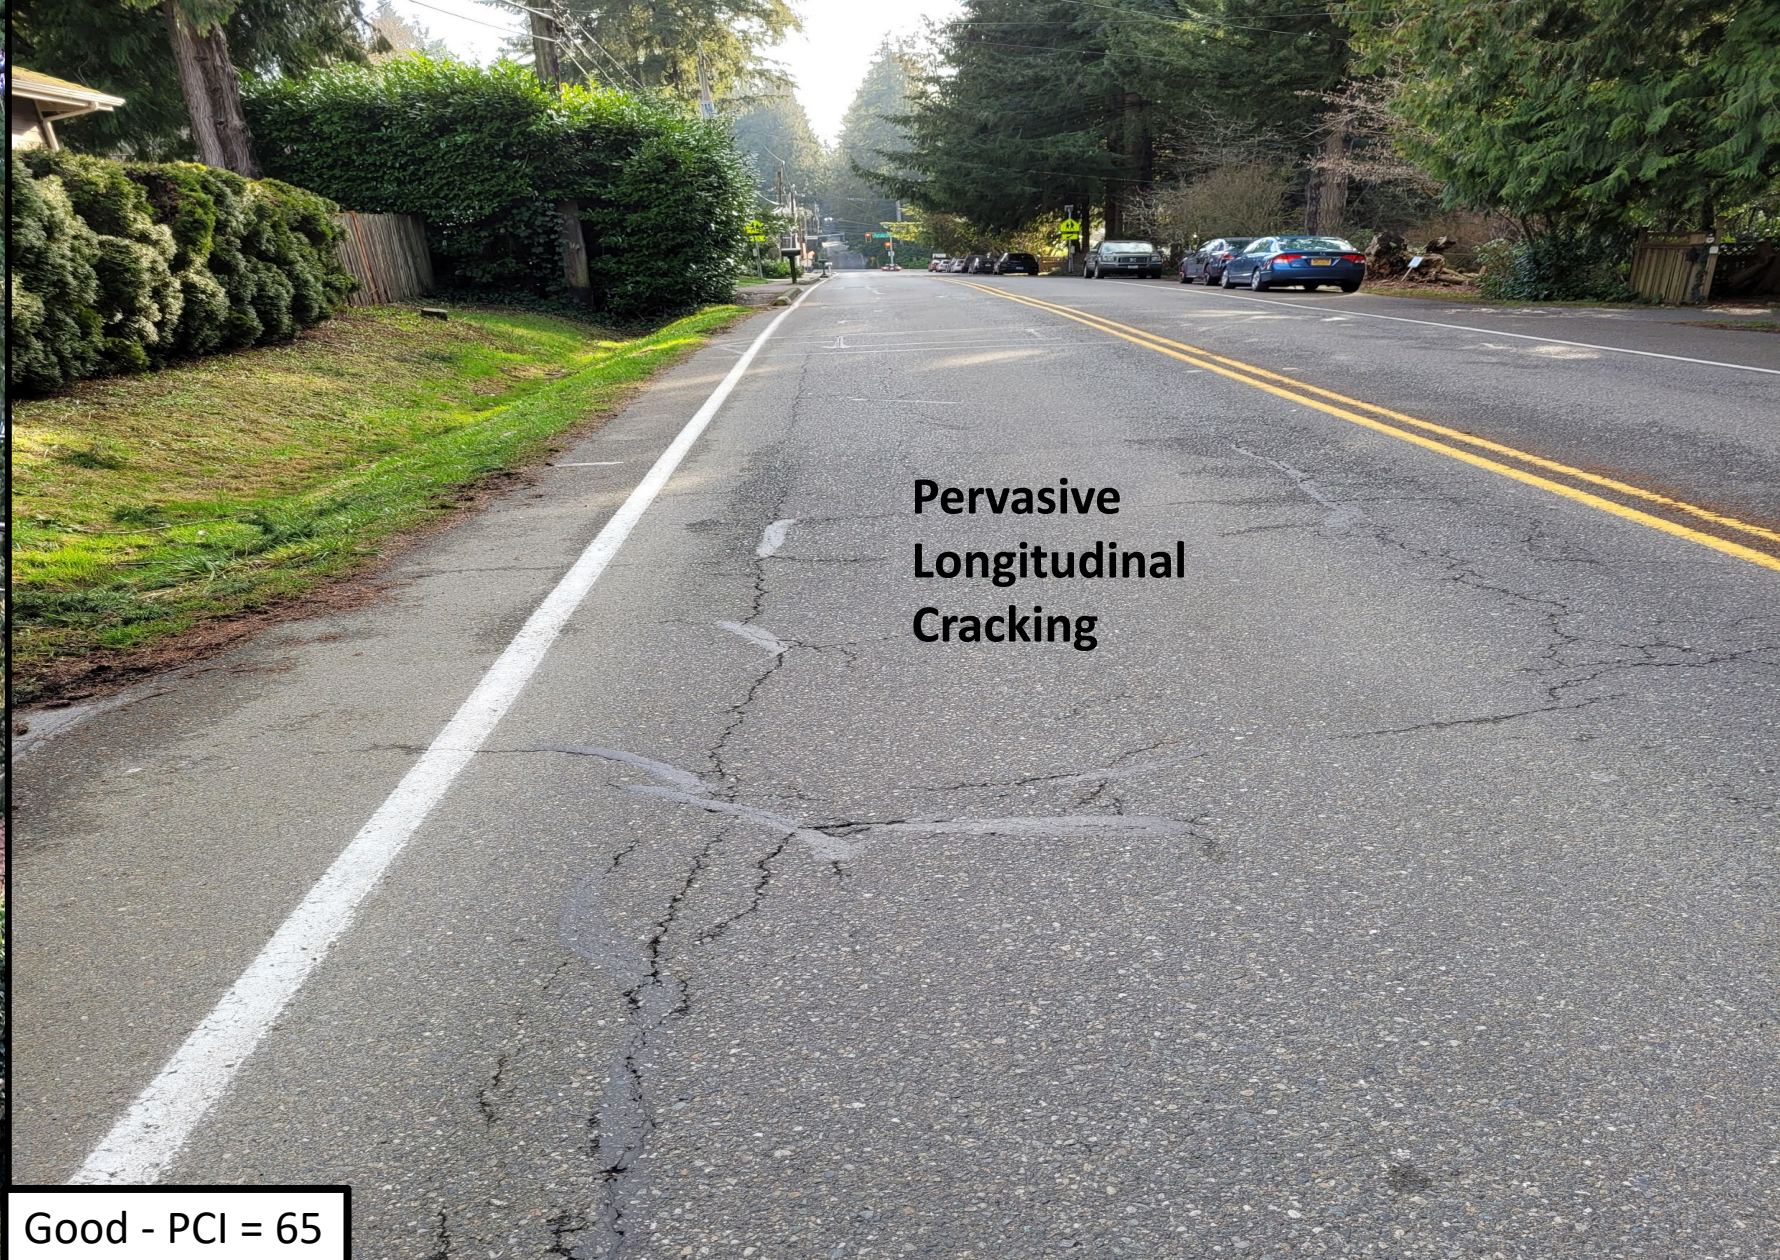
Pervasive  
Longitudinal  
Cracking

Good - PCI = 65

Generally stable, **minor areas of structural weakness evident**. Cracking is easier to detect, patches **evident**, patched but not excessively. Deformation more pronounced and easily noticed. **Ride qualities are good** to acceptable.

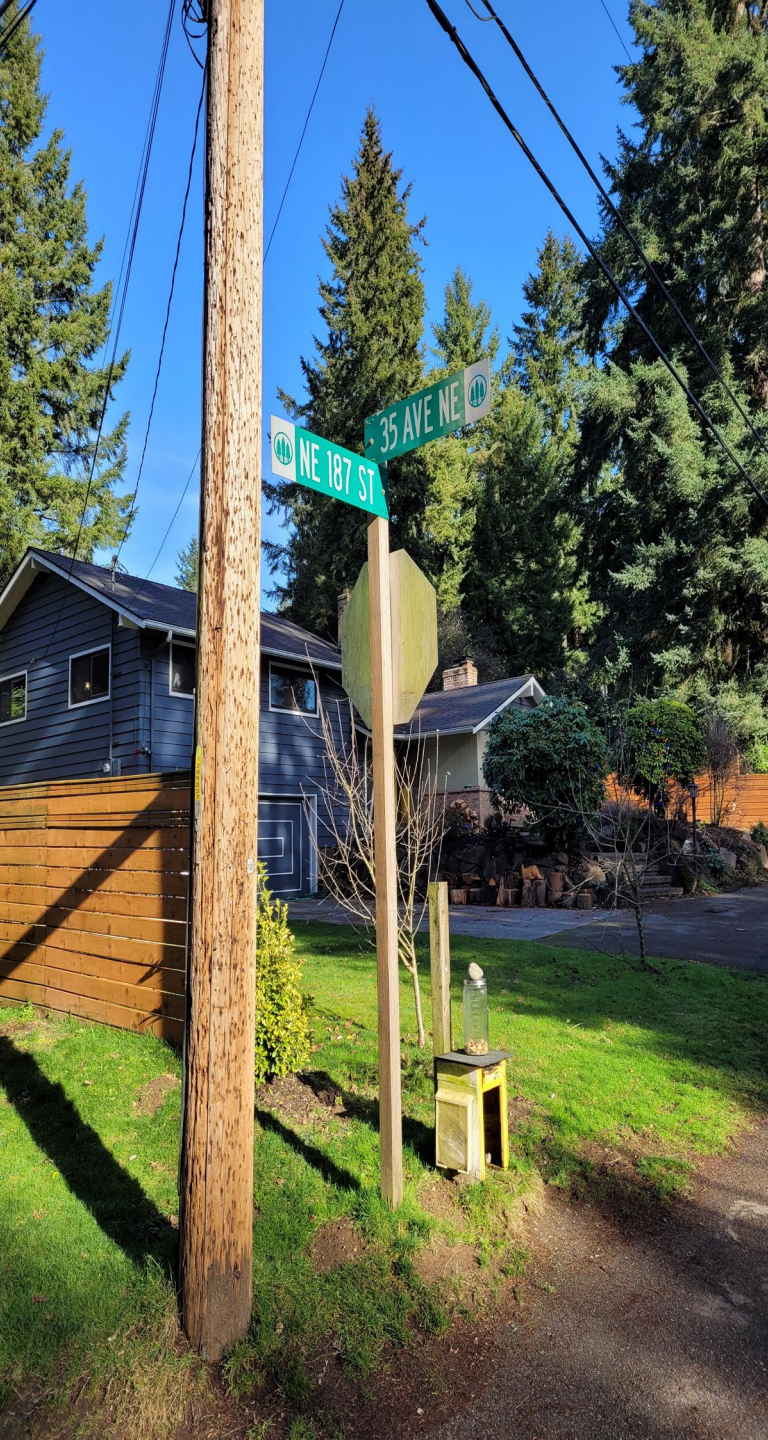
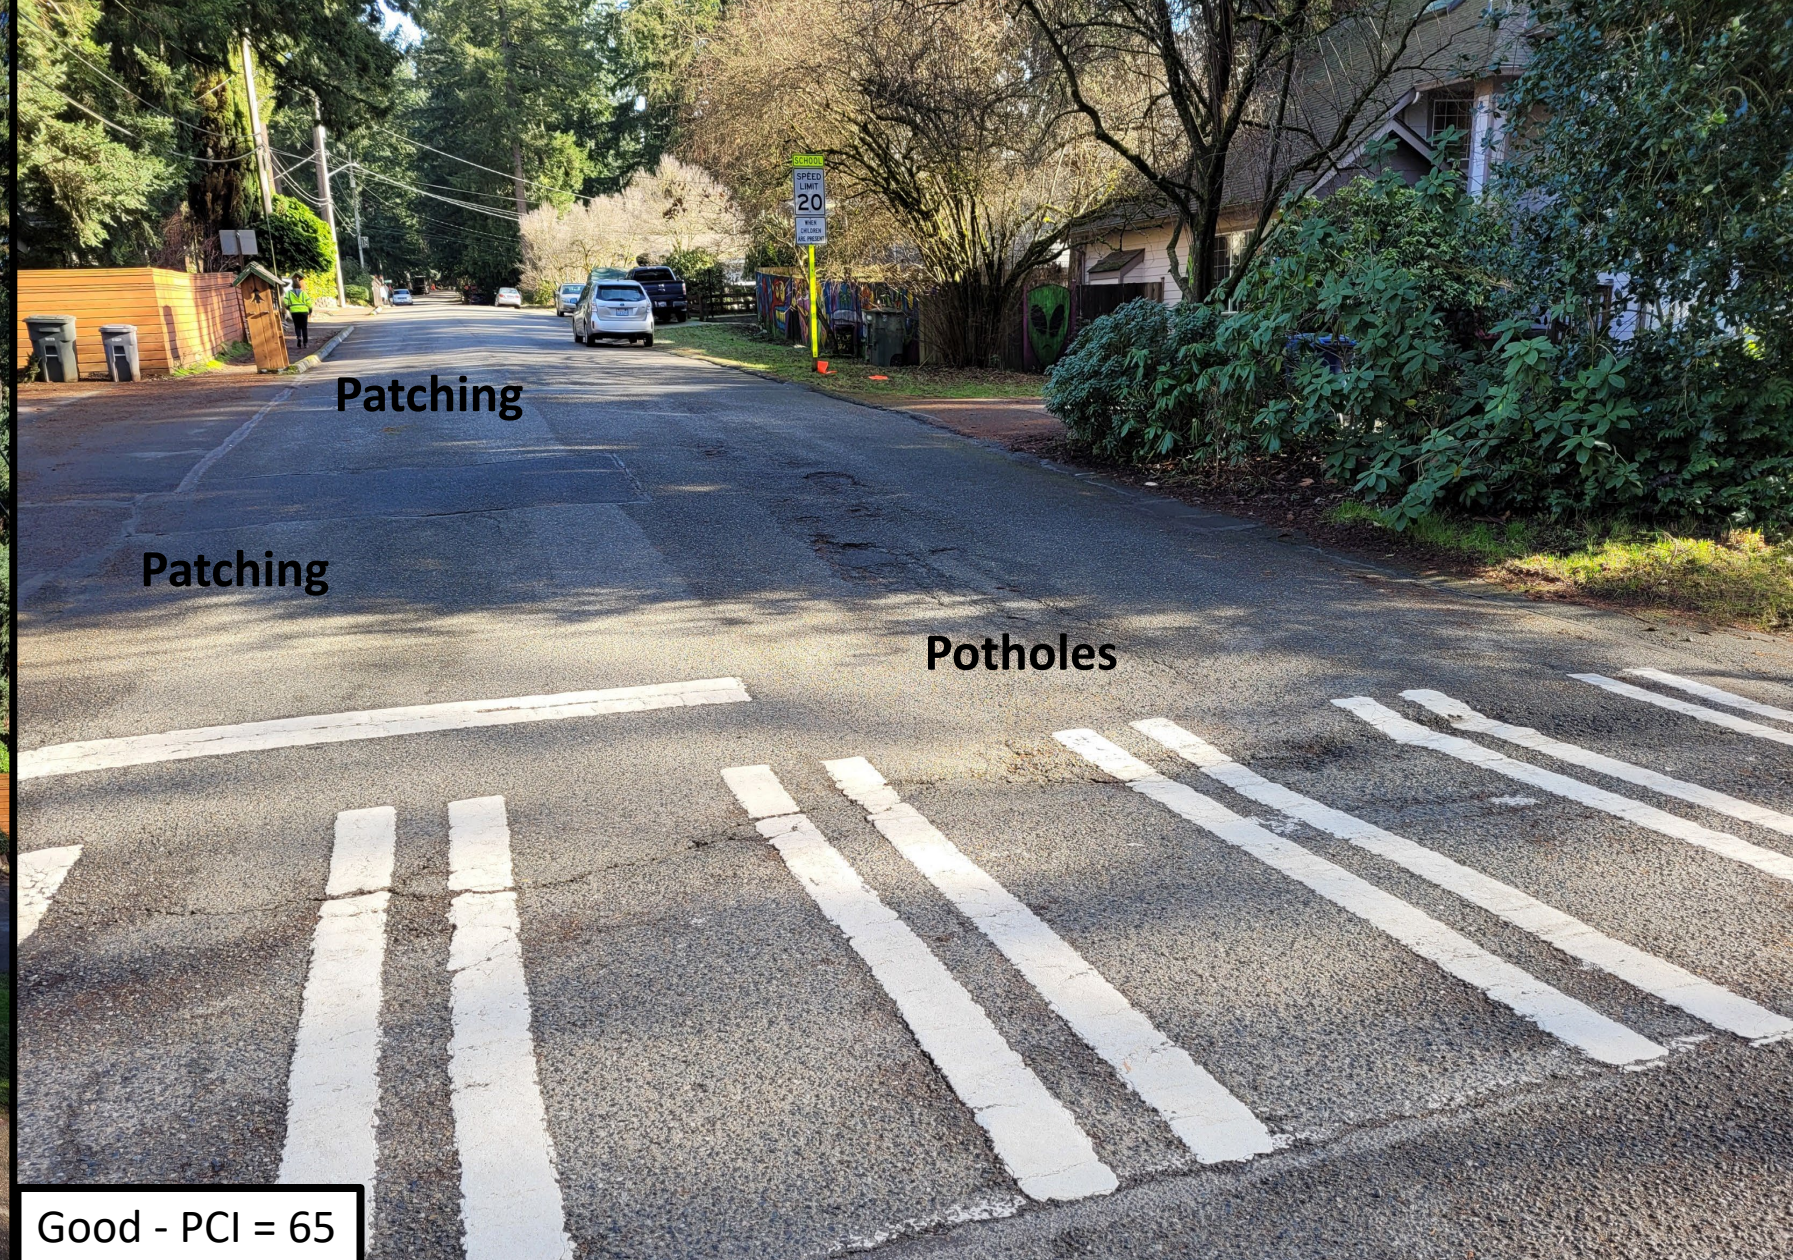
Good - PCI = 65

Generally stable, **minor areas of structural weakness evident**. **Cracking is easier to detect, patches evident**, patched but not excessively. Deformation more pronounced and easily noticed. **Ride qualities are good** to acceptable.
