FINE ART CONSERVATION

CONDITION REPORT, TREATMENT PROPOSALS AND ESTIMATES-REVISED 2024

DATE: June 11, 2024
CLIENT: City of Los Altos Hills Attn: Jon Maginot
PROJECT #: TBD
OBJECT: Outdoor Sculpture Collection-2 Sculptures
LOCATION: Los Altos Hills

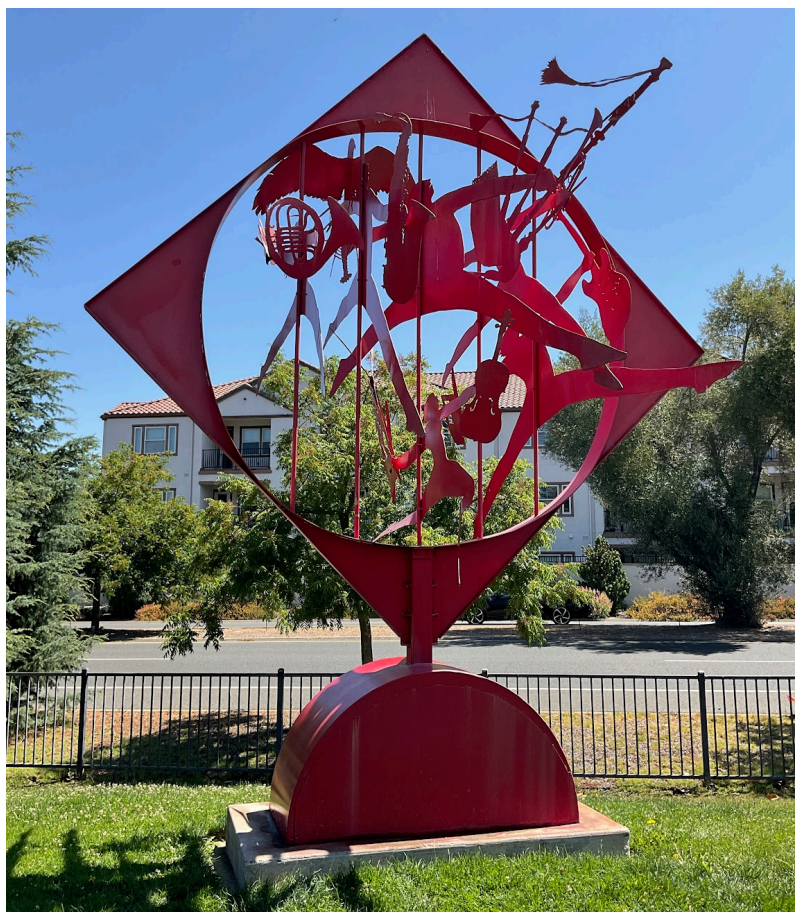
- The sculpture is structurally stable.
- There is possible corrosion under the paint, supported by the presence of blistering paint and some visible corrosion along bottom edge and along undersides of horizontal elements.
- There are several bent and misaligned elements: both legs are bent on the bottom figure; the proper left figure has a warped front leg; there is slight warping in the legs of the bagpipe and trumpet figures; the bagpipes are bent, the trumpet and bagpipes are intertwined.
- The paint is chalked and blanched.
- There is paint loss on vertical bars exposing a tan primer and a possible intermediate maroon colored primer.
- There are bird droppings, biogrowth, organic debris across the surface.
- There are mineral deposits across the front of the base.

- Photographic and written documentation will be completed before, during and after treatment.
- Paint samples will be taken and color matched to identify an appropriate paint system for repainting.
- The site will be prepared and include a scaffold for access and a fence to prevent public access to wet paint surfaces.
- The deteriorated red paint will be sanded back to provide a key for repainting, both by hand and with palm sanders.

- Corrosion will be converted and reduced.
- The bent and misaligned elements will be realigned as far as possible.
- The chosen industrial paint system will be spray applied including primer, two coats of paint, and possibly a clear top coat.
