PROPERTY CONDITION ASSESSMENT

1 North San Antonio Road
Los Altos, Santa Clara County, California 94022

RSB Project No. 2403055

Report Date: May 3, 2024

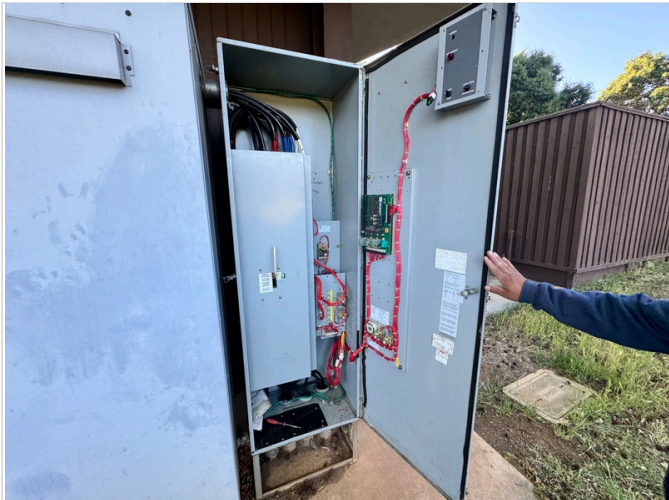
37. Electric breaker panel

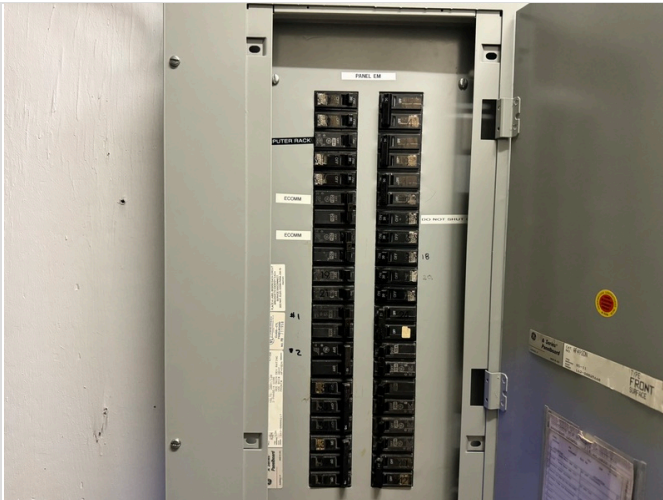
38. Electric breaker panel

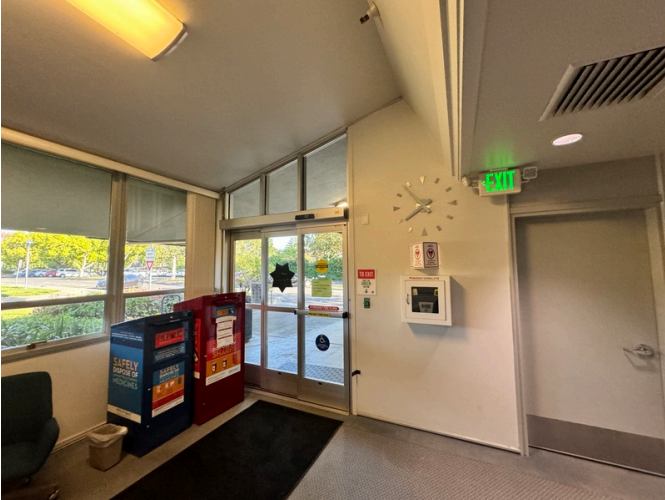
43. Illuminated exit sign

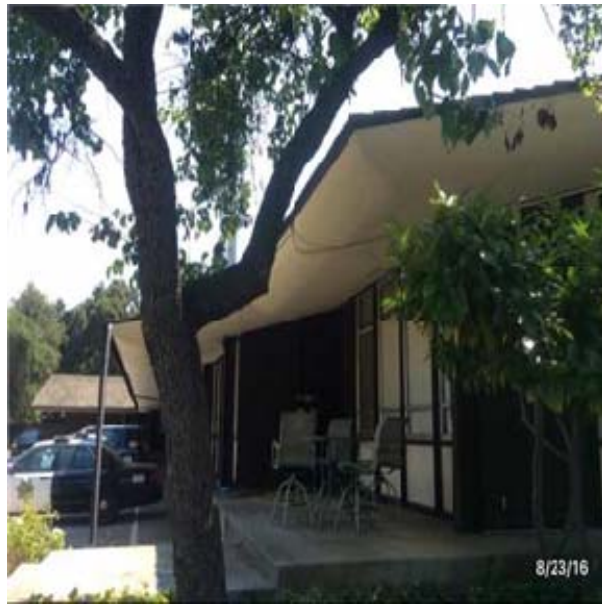
B2021 Windows:- View of Aluminum Window Units - Casement, Double Hung, Vent or Sliding

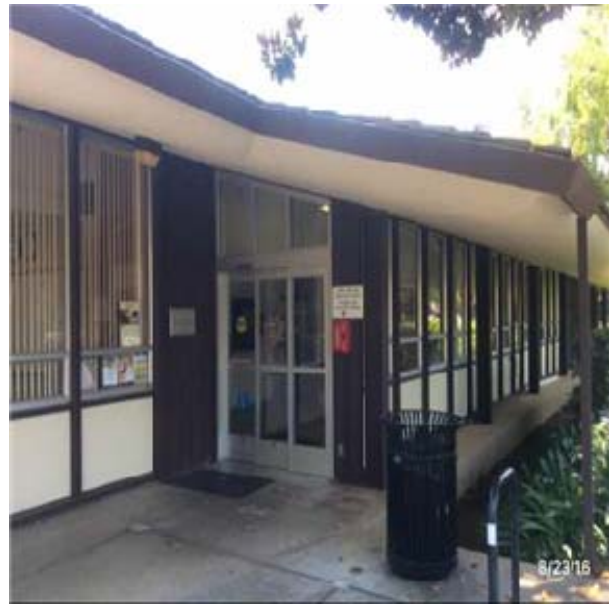
B2031 Glazed Doors & Entrances:- View of Storefronts - Glazed Aluminum Framed with Sliding Door Panels

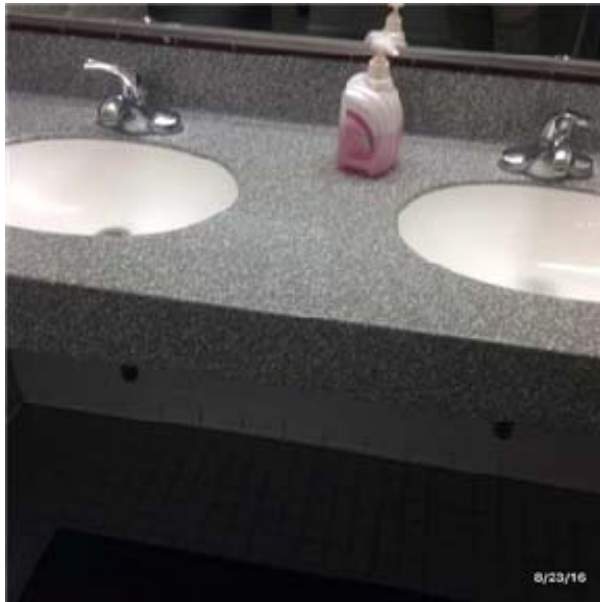
D2013 Lavatories:- View of Vanity Top Lavatories

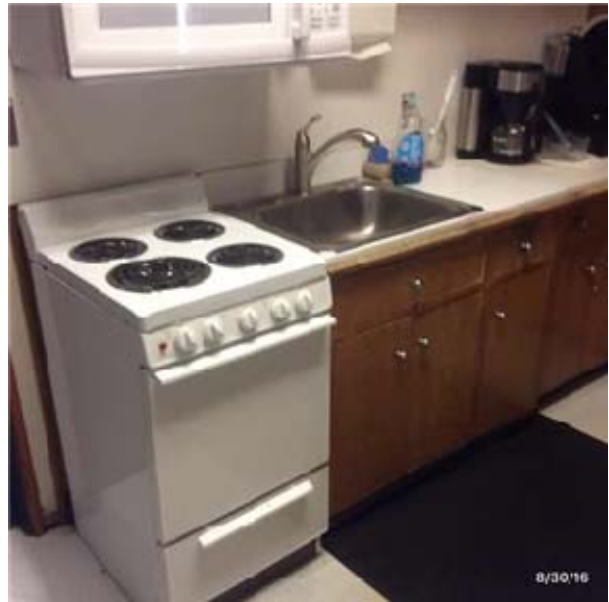
D2014 Sinks:- View of Single Bowl Kitchen Sink

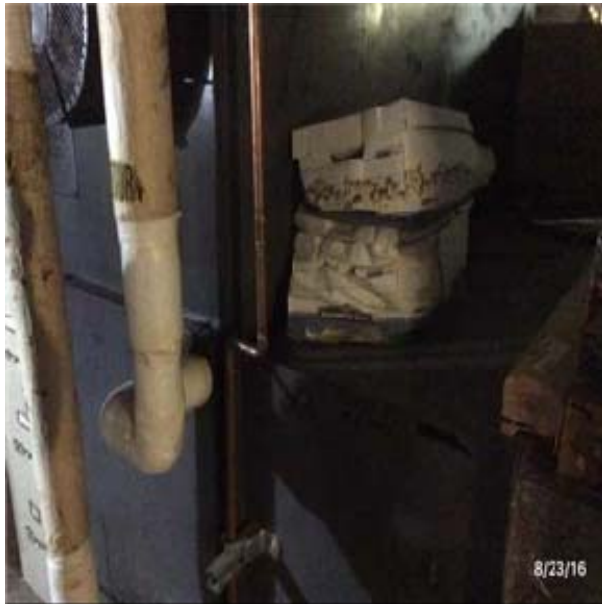
D3032 Direct Expansion Systems:- View of Split-System (Outdoor and Indoor Unit)

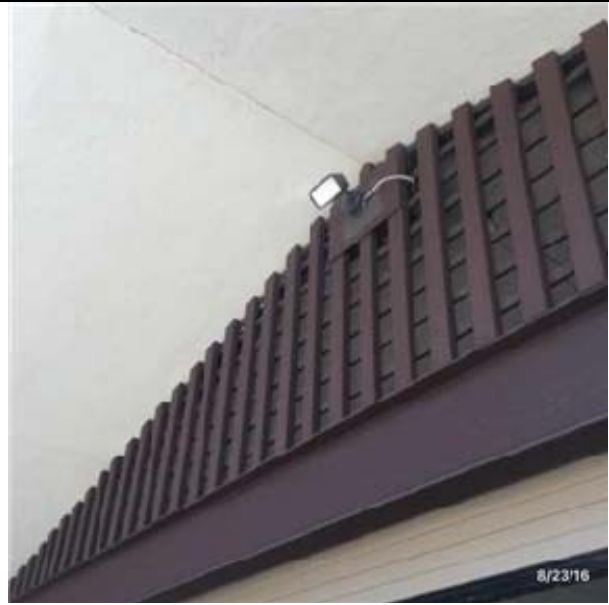
D5022 Lighting Equipment:- View of Exterior Wall Pack Light Fixtures
