PROPERTY CONDITION ASSESSMENT

765 Fremont Avenue
Los Altos, Santa Clara County, California 94022

RSB Project No. 2403055

Report Date: May 3, 2024

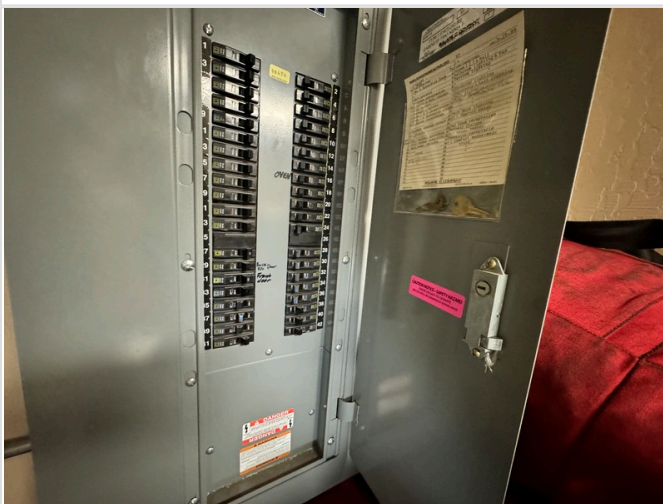
30. Electric breaker panel

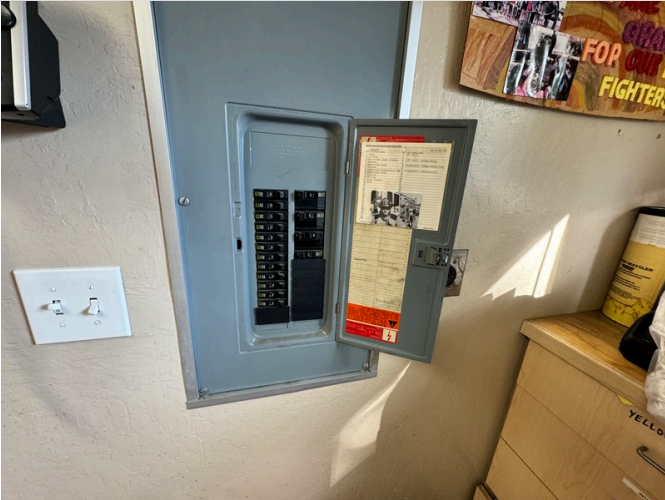
31. Electric breaker panel

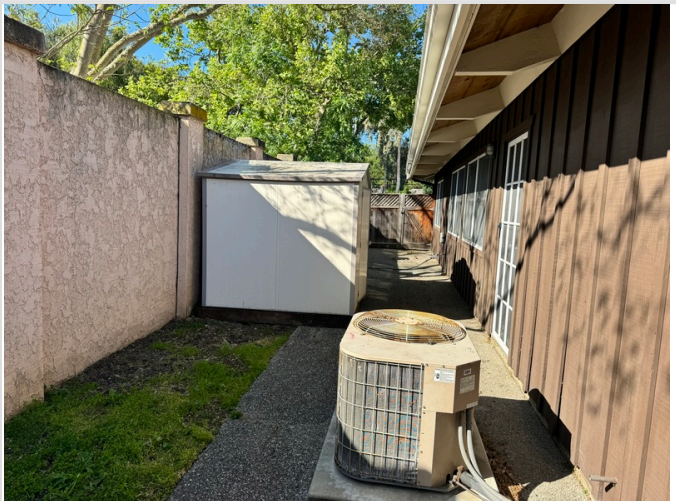
34. Grade-mounted HVAC unit

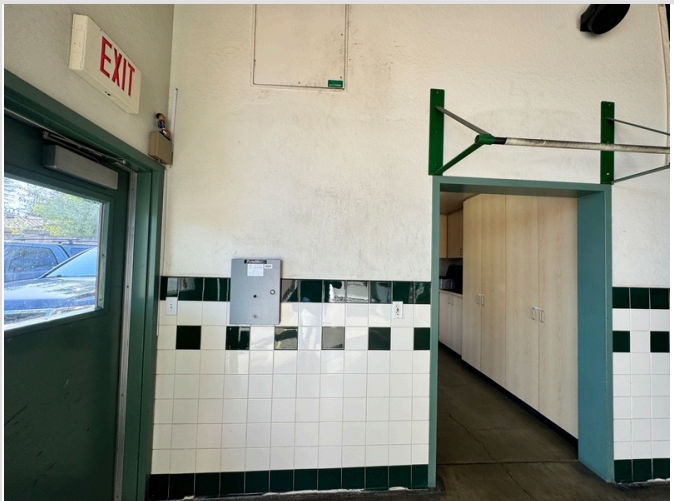
40. Illuminated exit sign

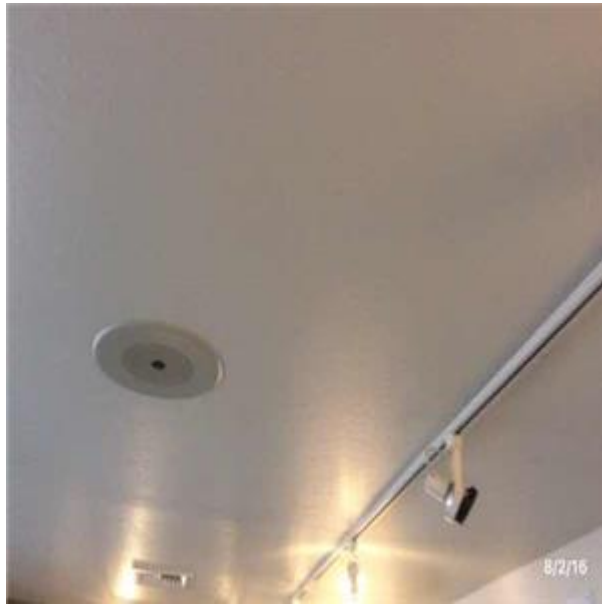
D5022 Lighting Equipment:- View of Track Lighting Fixtures

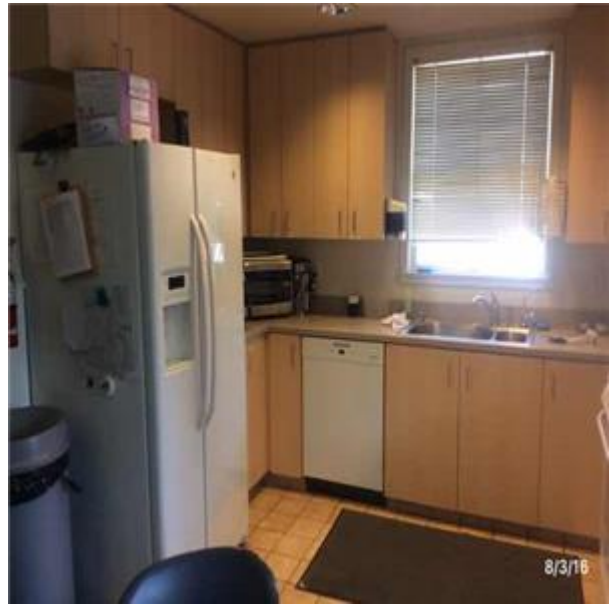
E2012 Fixed Casework:- View of Floor Mounted Base
Cabinet(s) - Standard
