PROPERTY CONDITION ASSESSMENT

10 Almond Avenue
Los Altos, Santa Clara County, California 94022

RSB Project No. 2403055

Executive Summary	
Project Name:	Los Altos Fire Station
Property Address:	10 Almond Avenue, Los Altos, Santa Clara County, California 94022
Property ID (APN):	170-43-005
Property Owner (per tax records):	City of Los Altos
Property Type:	General Public Use (Los Altos Fire Station)
Site Acreage:	Approximately 0.90 - acres
Number of Buildings:	One (1)
Total Building Square Footage:	Approximately 9,442 (Calculated) - SF
Year Built:	1968 (Historic Aerials)
Number of Floors:	One (1)
Number of Units:	One (1)
Substructure (Foundation):	Slabs-on-grade
Superstructure (Building Frame):	Concrete and steel
Facades (Exterior Walls):	Stucco, brick veneer and wood siding
Roof:	Pitched, asphalt shingle roof and low-slope, modified, bituminous asphalt membrane roof
HVAC:	Grade-mounted HVAC units, PTAC units and gas furnace
Elevators:	Not applicable
Fire and Life Safety:	Fire extinguishers
Seismic Zone:	4
Flood Zone:	Flood zone X Unshaded

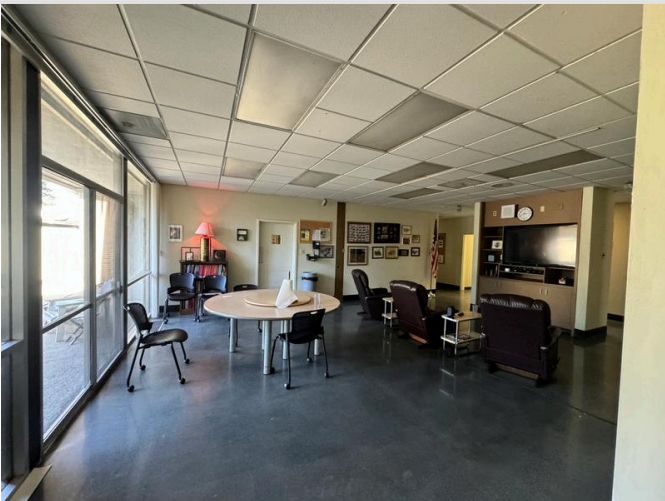
27. Lounge area interior

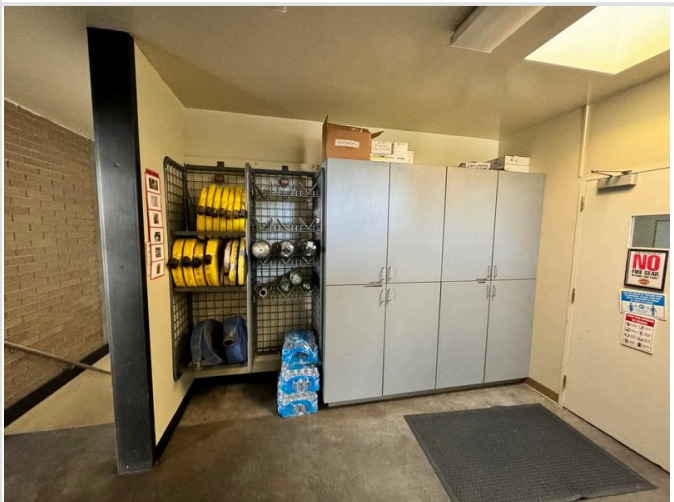
42. Storage room interior

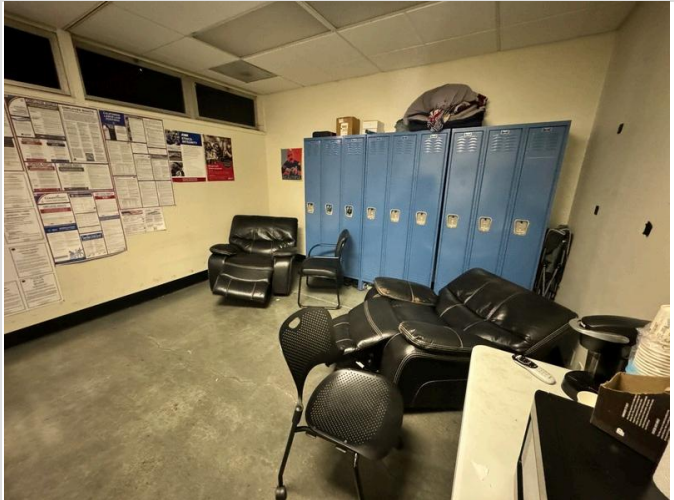
44. Locker room interior

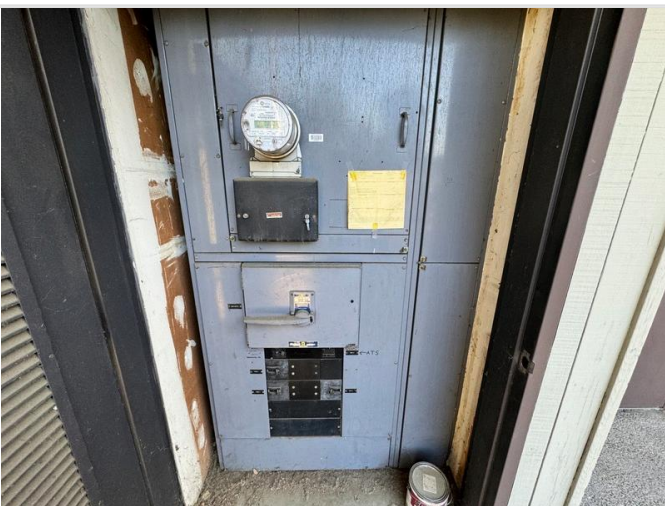
47. Main electric distribution panel

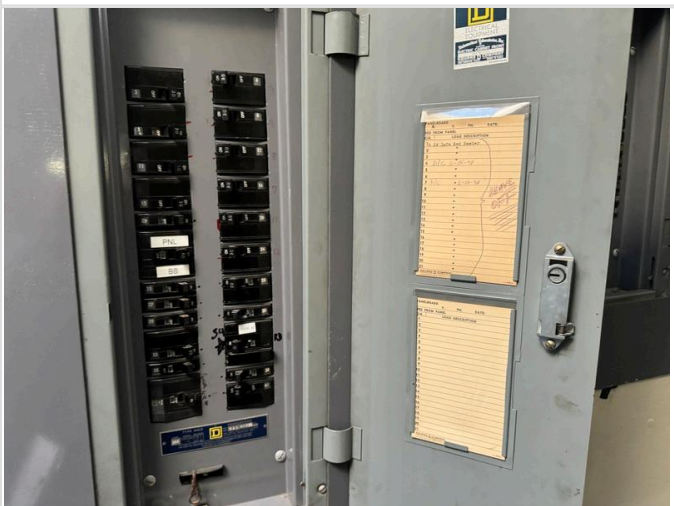
48. Electric breaker panel

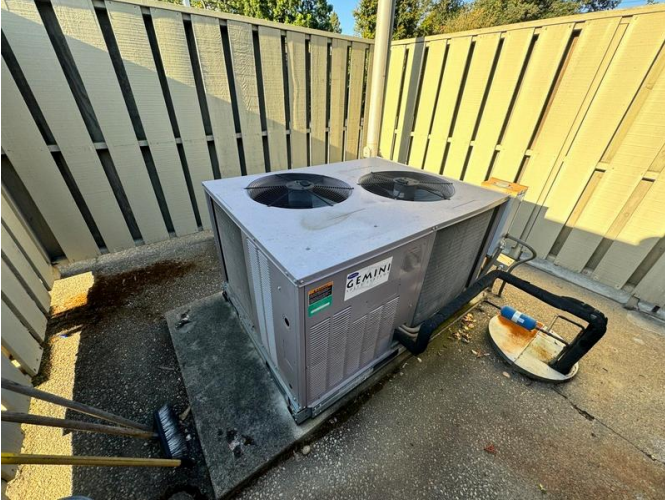
49. Grade-mounted HVAC unit

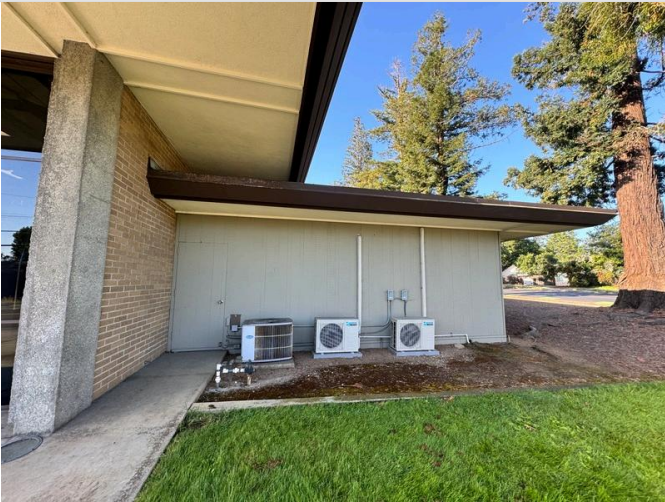
51. Ground mounted HVAC unit

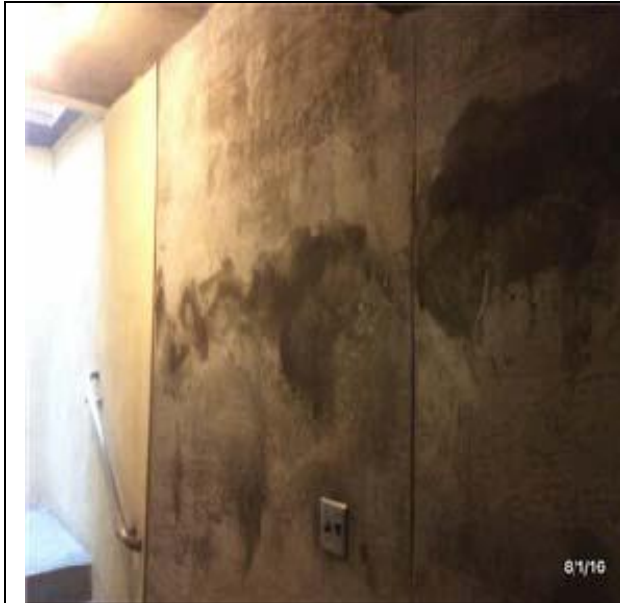
A2021 Basement Wall Construction:- View of Basement Construction

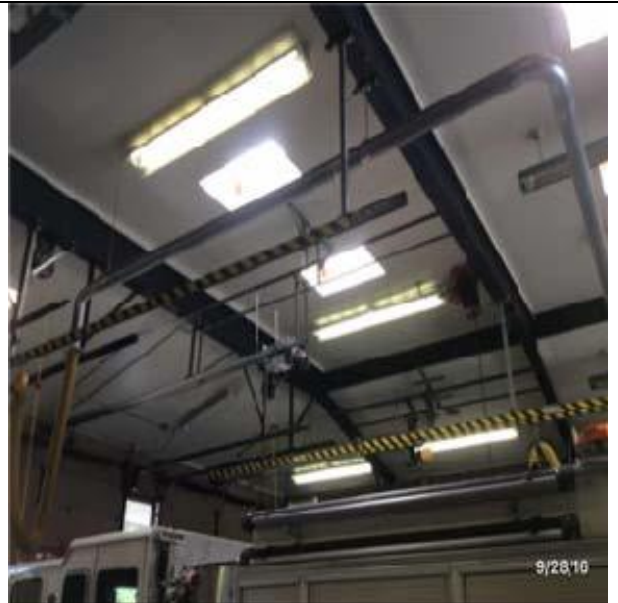
B1022 Pitched Roof Construction:- View of Steel Beams and Rafters
