December 19, 2022

RE: Evaluation of Root Exploration at 749 University Ave, Los Altos, California Project Site

FINAL ARBORIST REPORT, TREE INVENTORY, CONSTRUCTION IMPACT ASSESSMENT AND TREE PROTECTION PLAN

RE: 749 University Avenue, City of Los Altos, California [APN 175-18-042]

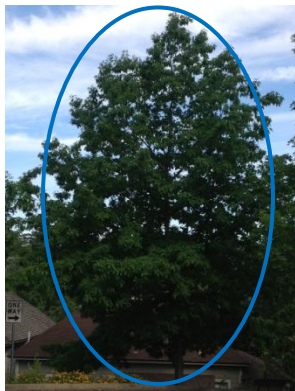
Photo of another tree – not at this site.

Over weight, reaching limb with main stem diameter small compared with amount of foliage present

Overweight limbs are a common structural fault in suppressed trees. There are two remedial actions for overweight limbs (1) prune the limb to reduce the extension of the canopy, or (2) cable the limb to reduce movement. Cables do not hold weight they only stabilize the limb and require annual inspection.

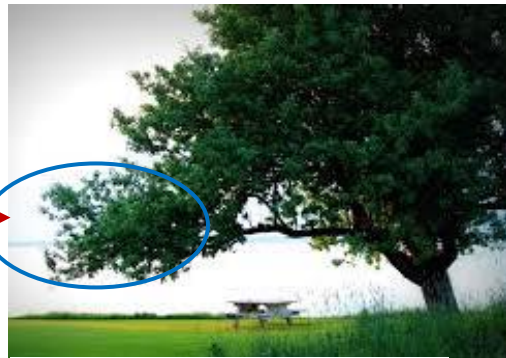
Photo of another tree – not at this site

Lion's – Tailing is the pruning practice of removal of “an excessive number of inner and/or lower lateral branches from parent branches. Lion's tailing is not an acceptable pruning practice” ANSI A300 (part 1) 4.23. It increases the risk of failure.
