FINE ART CONSERVATION

CONDITION REPORT, TREATMENT PROPOSALS AND ESTIMATES

DATE: June 15, 2022
CLIENT: City of Los Altos Hills
PROJECT #: 2022/216
OBJECT: Outdoor Sculpture Collection-5 Sculptures
LOCATION: Los Altos Hills

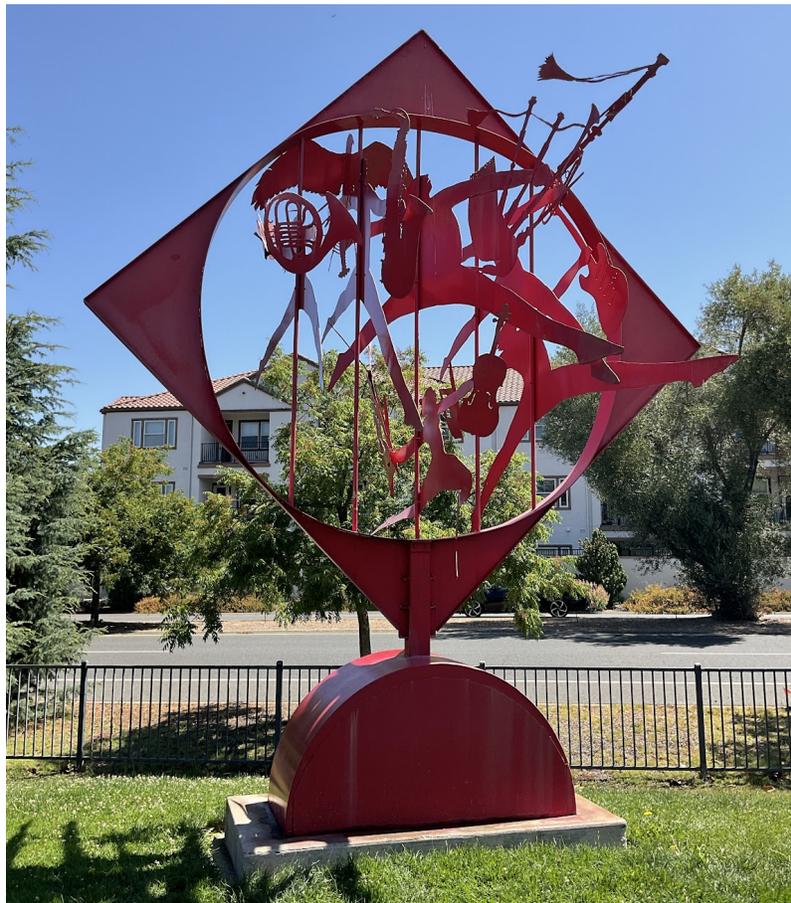
- The sculpture is structurally stable.
- There is possible corrosion under the paint, supported by the presence of blistering paint and some visible corrosion along bottom edge and along undersides of horizontal elements.
- There are several bent and misaligned elements: both legs are bent on the bottom figure; the proper left figure has a warped front leg; there is slight warping in the legs of the bagpipe and trumpet figures; the bagpipes are bent, the trumpet and bagpipes are intertwined.
- The paint is chalked and blanched.
- There is paint loss on vertical bars exposing a tan primer and a possible intermediate maroon colored primer.
- There are bird droppings, biogrowth, organic debris across the surface.
- There are mineral deposits across the front of the base.

- Photographic and written documentation will be completed before, during and after treatment.
- Paint samples will be taken and color matched to identify an appropriate paint system for repainting.
- The site will be prepared and include a scaffold for access and a fence to prevent public access to wet paint surfaces.

- The deteriorated red paint will be sanded back to provide a key for repainting, both by hand and with palm sanders.
- Corrosion will be converted and reduced.
- The bent and misaligned elements will be realigned as far as possible.
- A painting tent will be installed to cover the artwork during the painting process.
- The chosen industrial paint system will be spray applied including primer, two coats of paint, and a clear top coat.
