Tree Inventory, Assessment, and Protection Report

14 Fourth Street
Los Altos, CA 94022

May 19, 2022
Revised August 4, 2022

Monarch Consulting Arborists

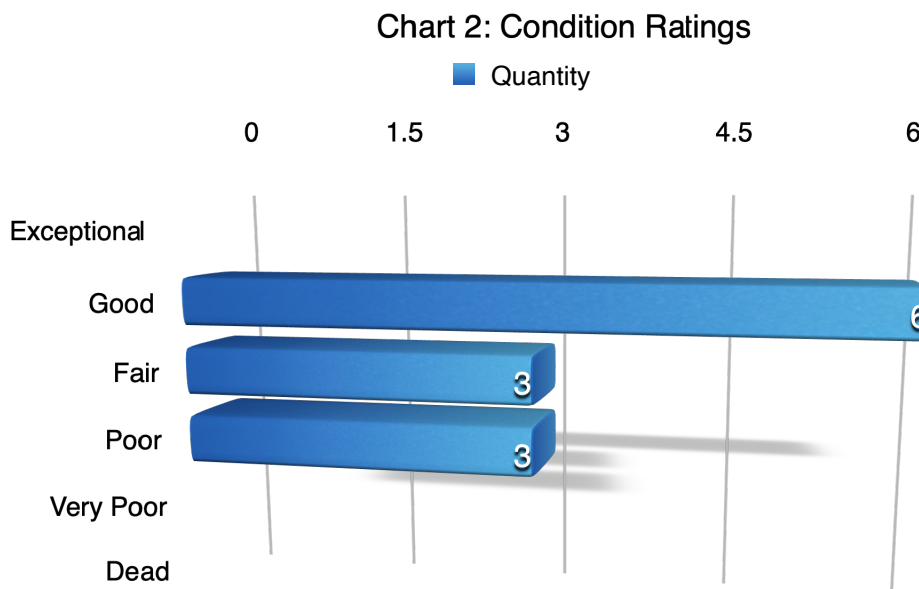
Six trees are in good condition, three fair, and three are in poor shape including coast redwood #9, silk oak #10, and purple plum #12 all originating on adjacent properties (Chart 2).

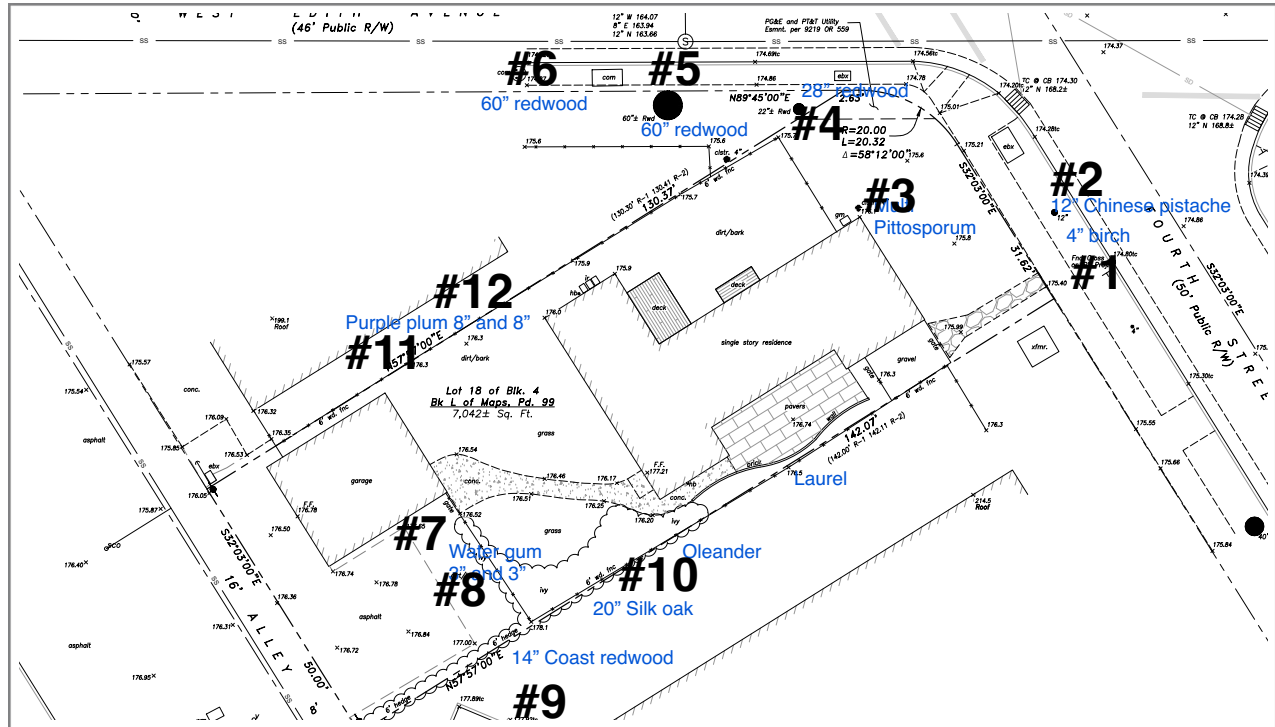
A1: Tree Locations

Tree locations not survey accurate.
