ATTACHMENT B

Kiely Arborist Services LLC
Certified Arborist WE#0476A TRAQ Qualified
P.O. Box 6187
San Mateo, CA 94403
650- 532-4418

August 17th, 2021, Revised May 9th, 2022

Site: 540 Patrick Way, Los Altos CA

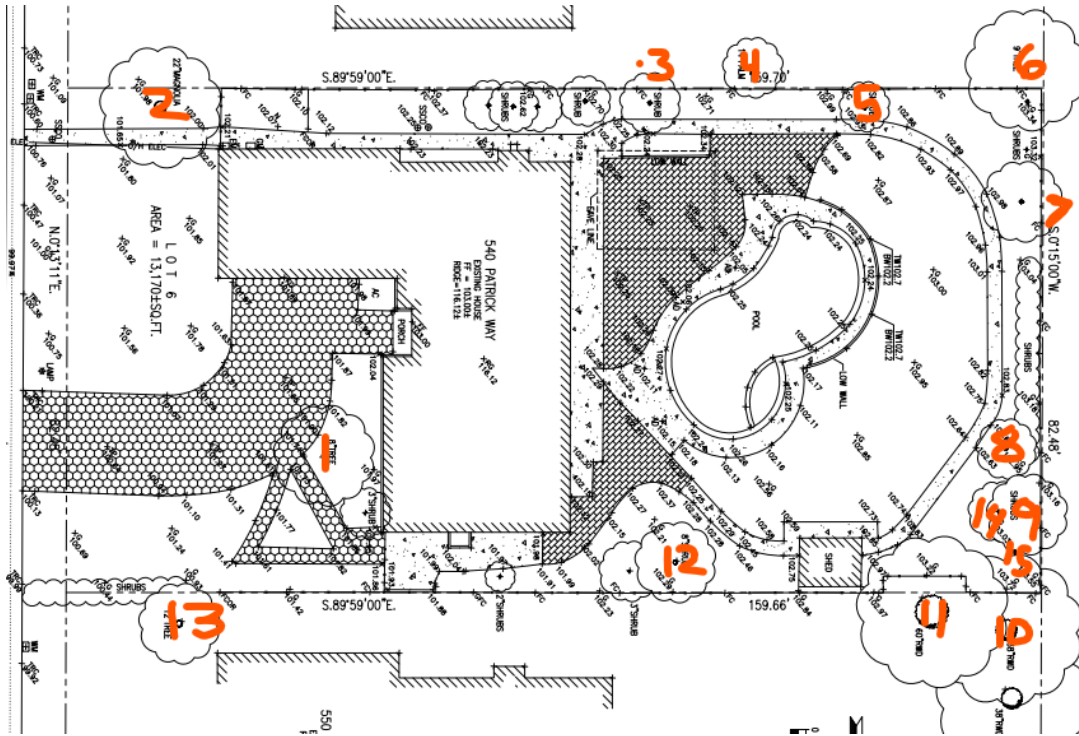
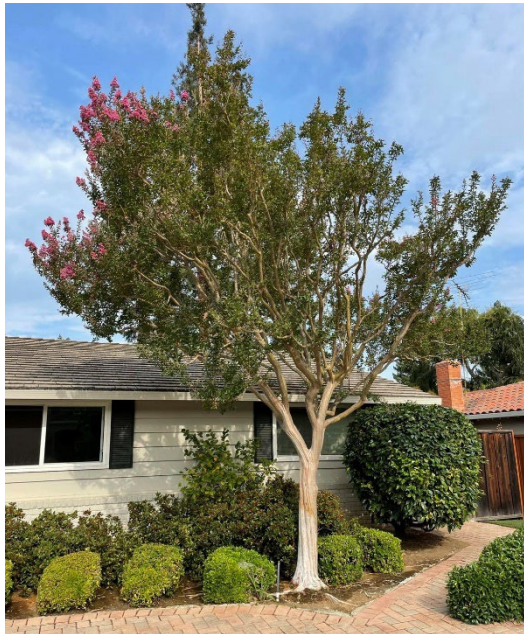
Showing tree locations

The existing landscape is in fair condition. The site is flat, and irrigation is currently being provided for the trees and shrubs on the site. Four out of the fifteen trees surveyed are in poor condition.

No impacts are expected for the retained trees. It is recommended to install tree protection fencing at the driplines where possible to reduce risk of compacting soil within the tree root zones. Irrigation every 2 weeks during the dry season is recommended to be provided within the tree protection zones for the trees. 20 gallons water is recommended within the tree protection zones. The tree protection zone for the neighboring Redwood trees is recommended to be irrigated using 50 gallons of water every 2 weeks.
