April 29, 2025

Re: Structural Condition Assessment  
313 University Avenue  
Los Altos, CA 94022  
SEI Project No. 5794.00

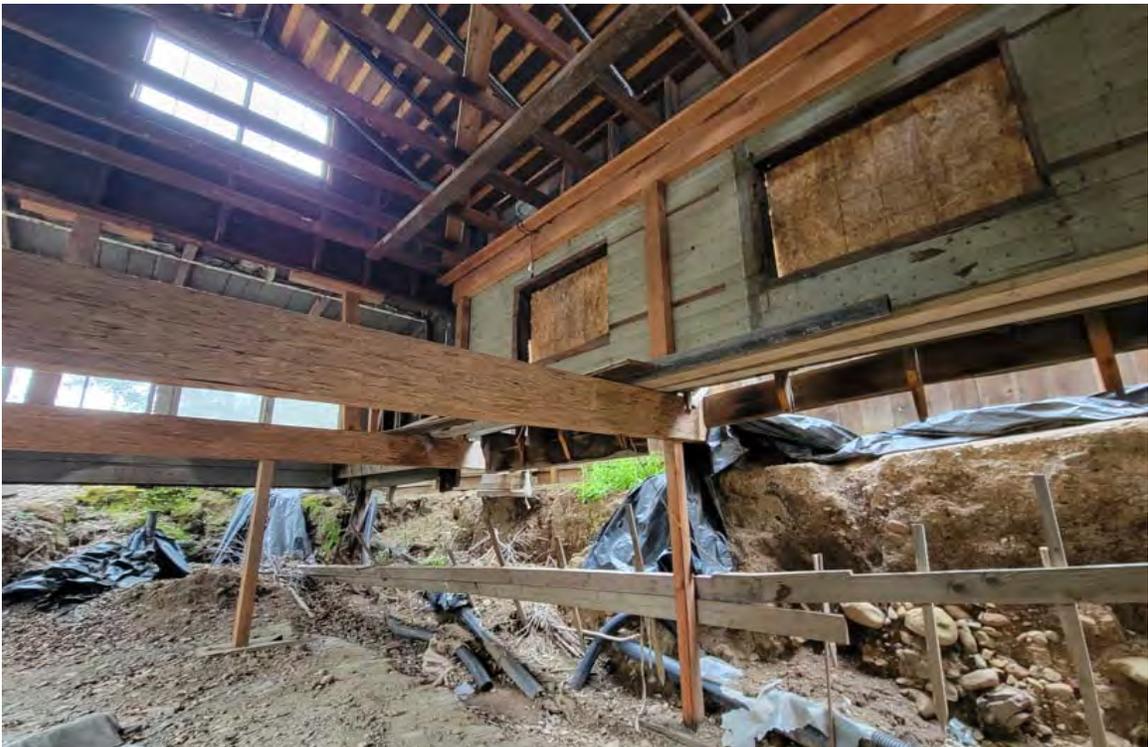
A close up evaluation of the existing framing reveals significant wood decay from both termite infestation as well as on going dry rot (fungal decay) occurring in much of the original perimeter stud framing and plank siding.

The building appears to be in significant disrepair with extensive decay, water damage and framing deficiencies. The current shoring is unstable and in eminent danger of collapse at the soil interface. We would expect that the cost to properly repair this structure would likely exceed the cost of replacement. In our opinion, the structure in its current state, poses an immediate life safety risk should someone enter the interior or stand too close to the perimeter of the excavation. We recommend that warning signs be posted immediately and that the structure be completely demolished as soon as is feasible.
