## Home Inspection Report

**8 Central Court, Los Gatos**

**Ordered by:** Peter Myers

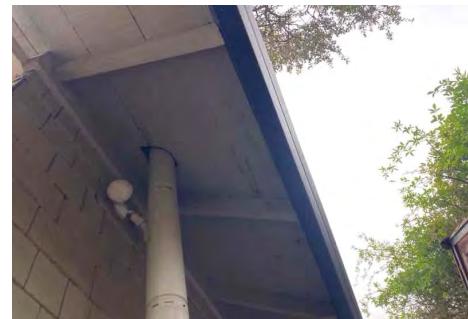
Photo 56

29. There is insufficient clearance between the furnace exhaust flue and combustible materials. This should be corrected. (See Photo 56)

! 1. There is insufficient clearance between the furnace exhaust flue and combustible materials. This should be corrected. (See Photo 56)

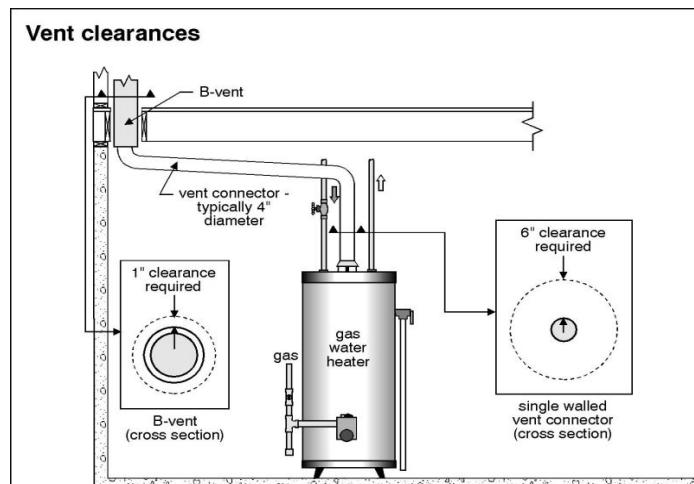
Illustration 8C

34. There is insufficient clearance between the water heater exhaust flue and combustible materials. This condition should be corrected. (See Illustration 8C) (See Photo 30)

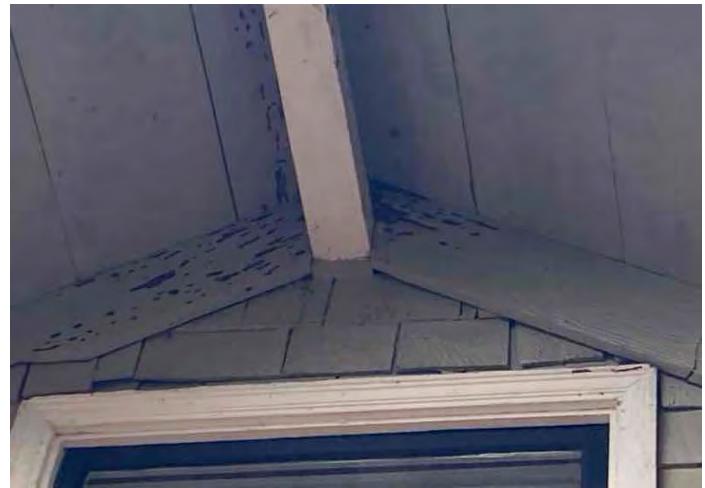
Photo 02

13. Mechanical damage was observed to the rafters at the left side and various areas. We recommend the services of a licensed general contractor and/or structural pest control company. (See Photo 2) (See Photo 29)

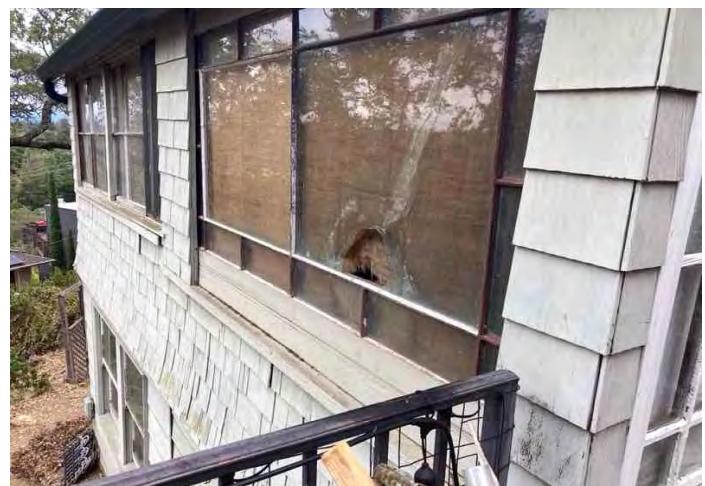
Photo 04

7. Cracked or broken exterior window glass at the back wall and various areas should be replaced. (See Photo 4) (See Photo 5) (See Photo 25)

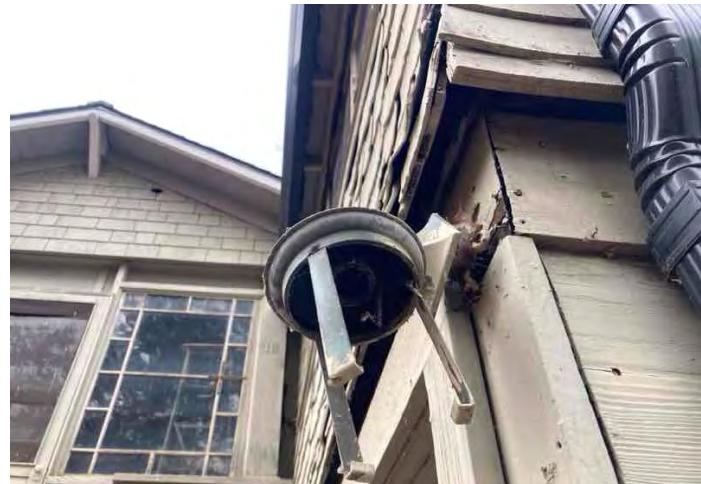
Photo 08

26. The loose light fixture in the back storage shed should be repaired or replaced. (See Photo 8)

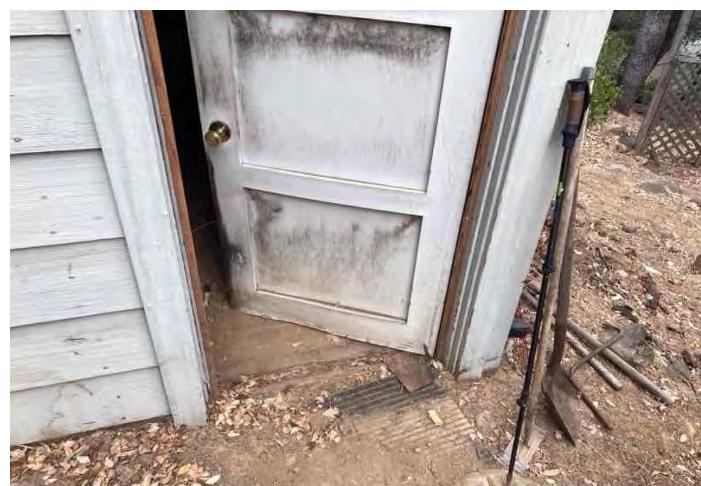
Photo 10

10. Water damage was noted at the back storage shed door. We recommend the services of a licensed general contractor and/or structural pest control company regarding repairs. (See Photo 10)

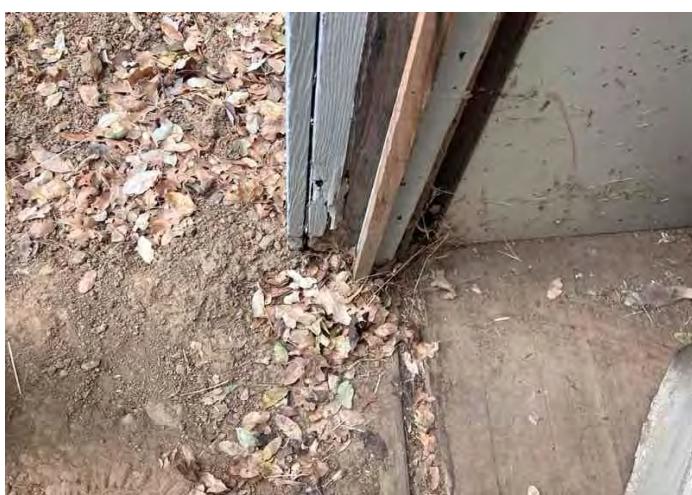
Photo 11

22. Water damage was noted at the back storage shed door jamb. We recommend the services of a licensed general contractor and/or structural pest control company. (See Photo 11)

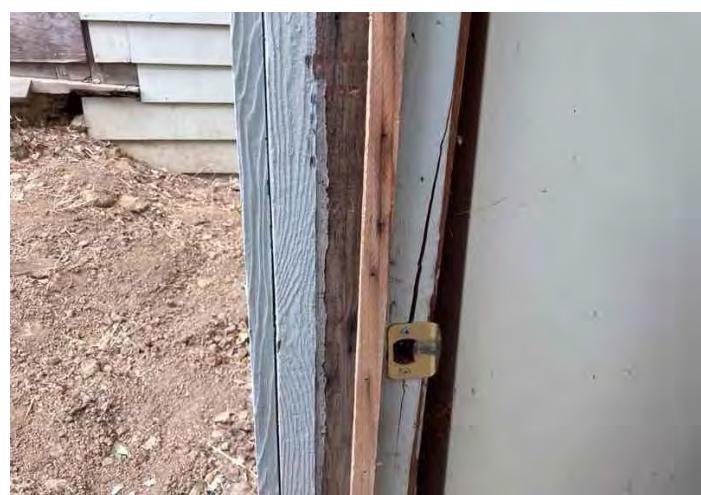
Photo 12

20. The jamb is cracked, split or damaged at the back storage shed door. We recommend it be repaired or replaced. (See Photo 12)

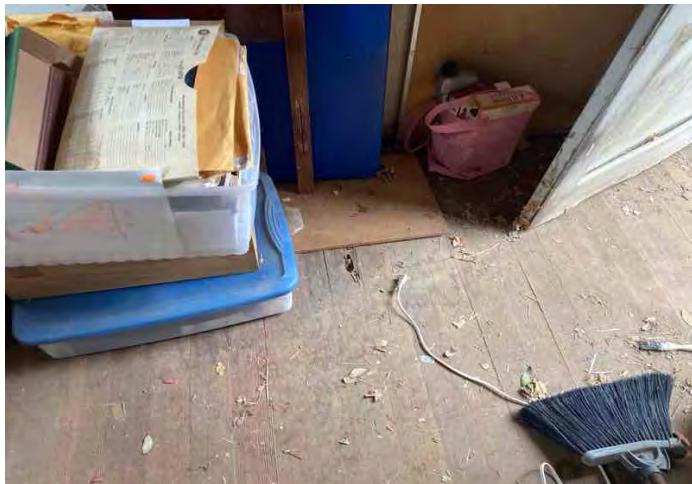
Photo 13

39. Damage to the front bathroom and bathroom storage shed hardwood flooring was observed. The extent of damage is difficult to predict without removing floor coverings. It is recommended that the source of the damage be identified and corrected by the appropriate trades. (See Photo 13) (See Photo 34)

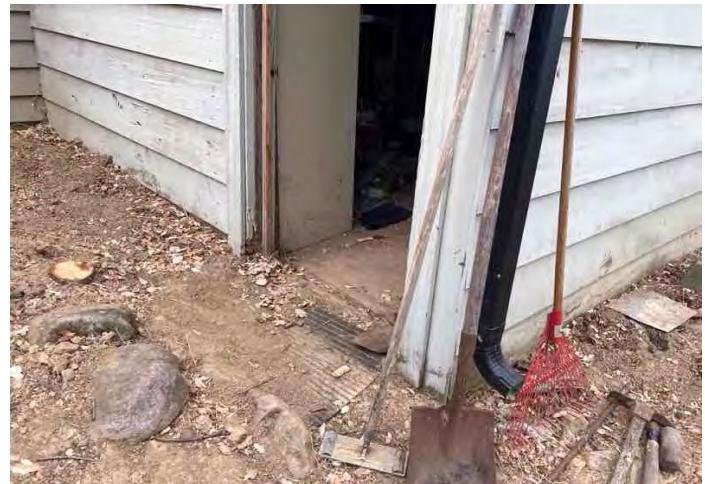
Photo 14

4. The foundation for the addition is wood mudsill. This is not considered a true foundation as this term applies to present building standards. The mudsill for conventional foundations is the first wood member, usually a 2"x 6" or 2"x 8" treated lumber, to be placed over the top of the concrete foundation stem wall, it is then secured to the foundation with anchor bolts. In this case, there is not a concrete foundation, only wood directly in contact with the soil. This exposes this structure to various forms of wood damaging organisms and activity. Additionally, there is no method that will effectively secure this structure for earthquake safety. A structural pest control operator and a licensed foundation specialist should be consulted. (See Photo 14)

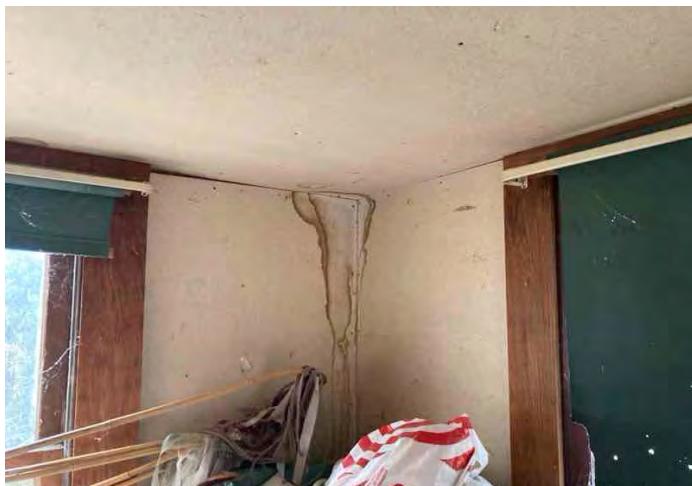
Photo 15

38. The ceiling at the back shed and side shed shows evidence of water stains. It is recommended that the source of these stains be identified and corrected and the surface be refinished. (See Photo 15)

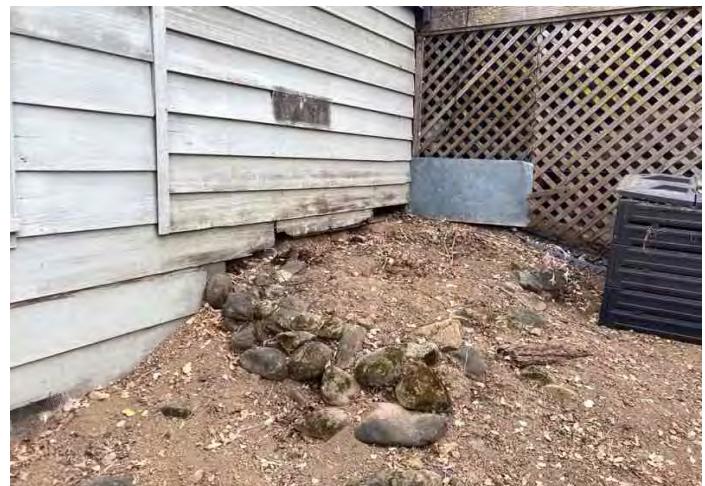
Photo 16

15. Water damage was observed to the wood siding at the front and various areas exterior walls. We recommend the services of a licensed general contractor and/or structural pest control company. (See Photo 16) (See Photo 26) (See Photo 54)

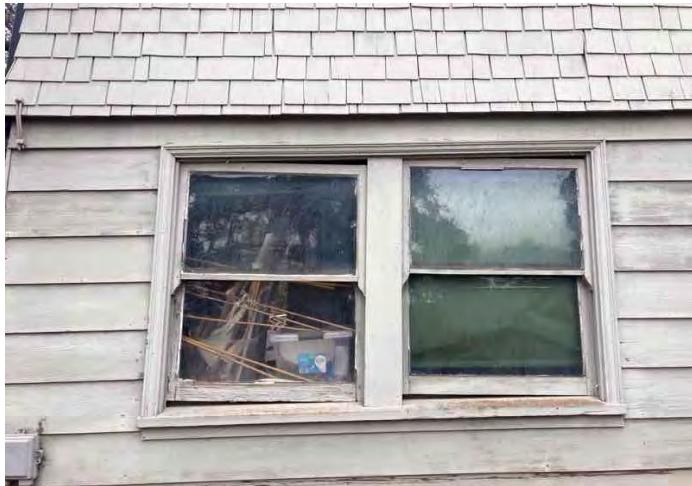
Photo 17

3. Substantial interior floor sloping, drywall cracking and/or exterior cracking was observed in the structure. This implies that structural movement of the building may have occurred. The rate of movement cannot be predicted during a one-time inspection. A structural engineer should be consulted for further evaluation of this condition. (See Photo 17) (See Photo 37)

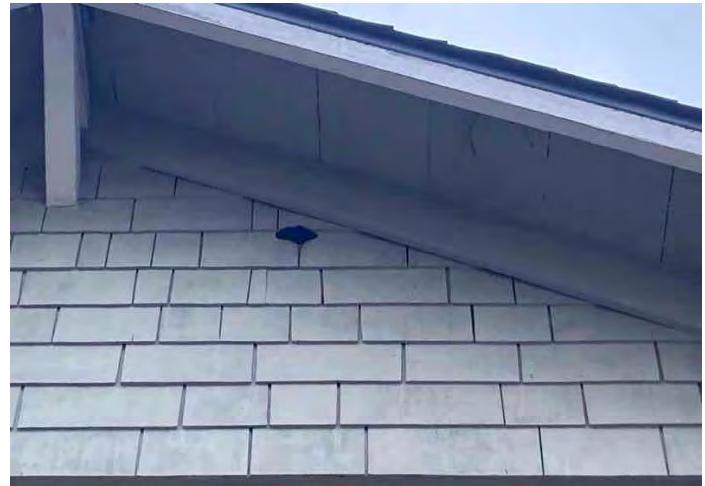
Photo 18

17. There is an opening or hole in the siding at the right side and various areas of the rear exterior wall. We recommend this area be repaired or replaced to eliminate moisture or rodent entry. (See Photo 18)

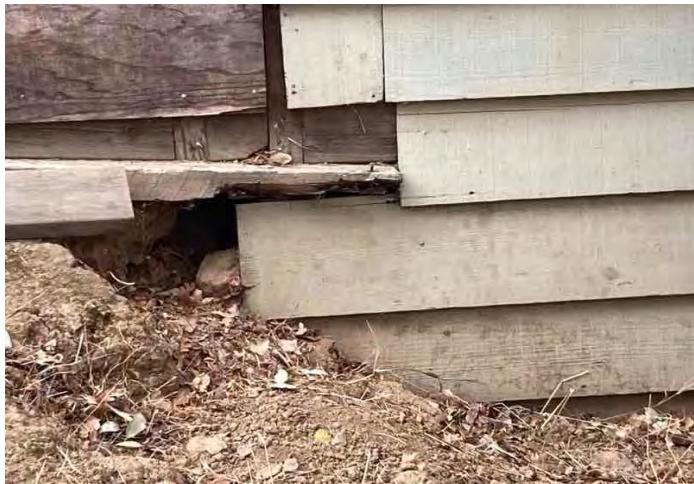
Photo 19

16. Water damage was observed to the exterior trim at the back and left rear corner. We recommend the services of a licensed general contractor and/or structural pest control company. (See Photo 19) (See Photo 21)

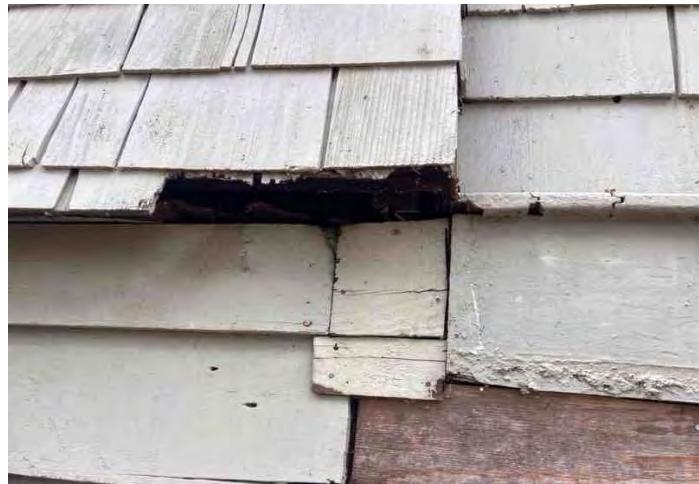
Photo 20

6. Shingle siding is missing and/or loose from the exterior wall. We recommend they be replaced to restore both cosmetic appearance and maximum protection for the underlying surface. (See Photo 20)

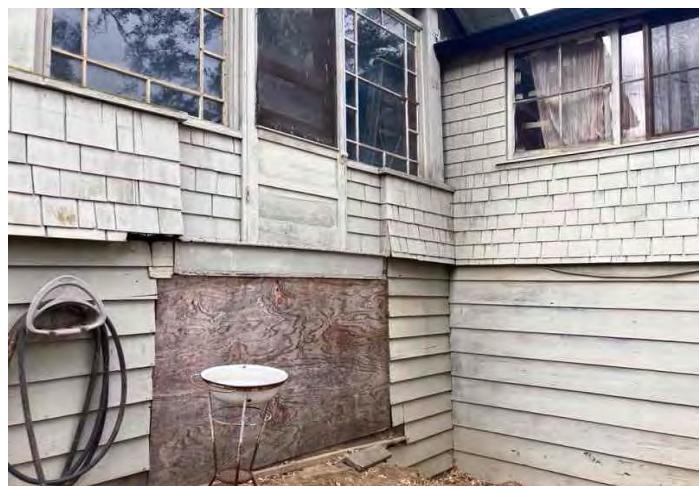
Photo 22

19. The installation of a proper porch, step, landing or deck at the exterior door should be considered for additional safety. (See Photo 22)

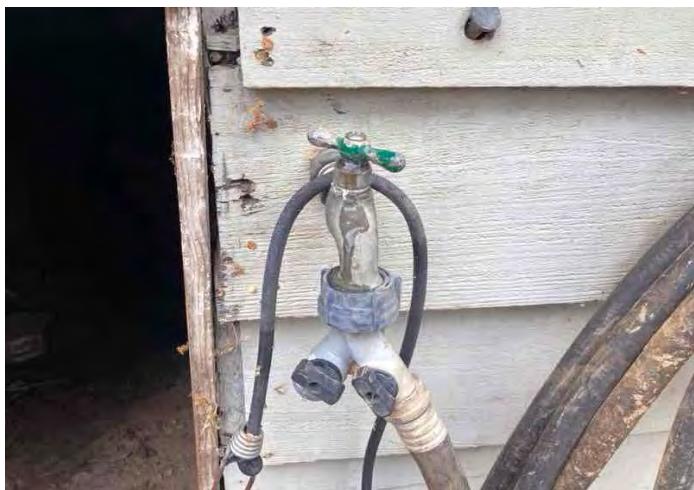
Photo 23

35. The exterior hose bib at the back is leaking. We recommend all leaks be repaired. (See Photo 23)

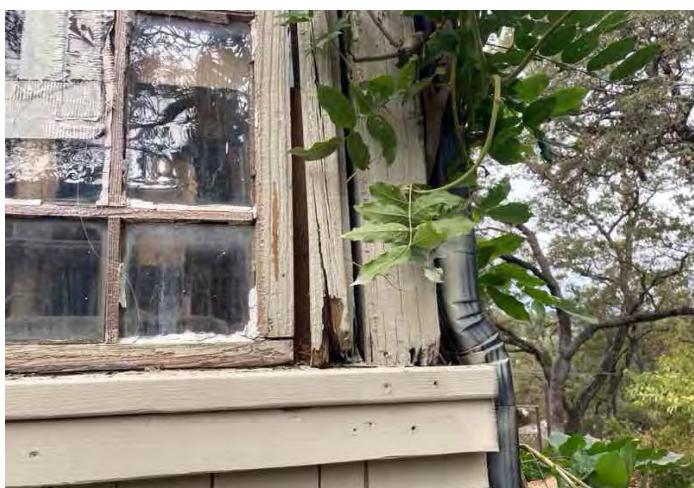
Photo 27

9. The window frames/sash at the right side wall shows evidence of water damage. We recommend the advice and services of a general contractor and/or structural pest control company regarding repairs. (See Photo 27) (See Photo 31)

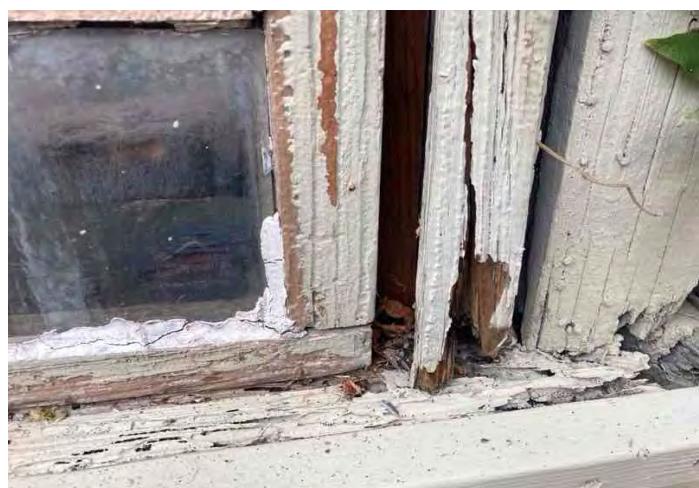
Photo 28

8. The window at the front and right side wall shows evidence of water damage to the sill/jamb. We recommend the advice and services of a general contractor and/or structural pest control company regarding repairs. (See Photo 28) (See Photo 53)

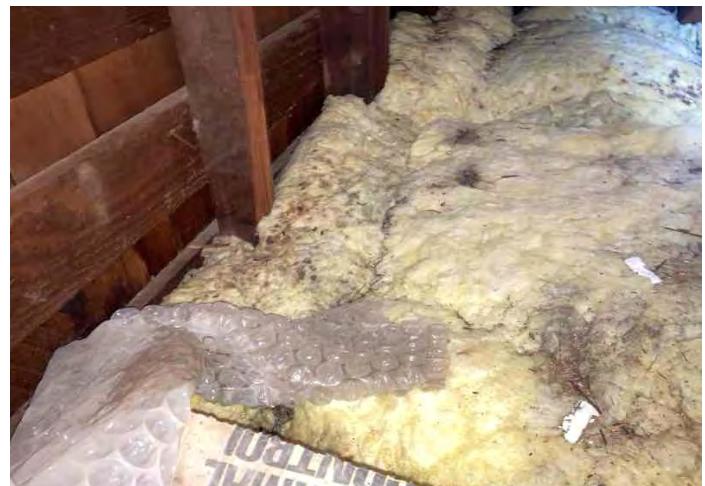
Photo 32

- ! 2. Evidence of vermin activity was observed within the structure. It is likely this evidence will extend into inaccessible areas. The owner is advised to contact the appropriate trade for further evaluation and remedial measures if necessary. (See Photo 32)

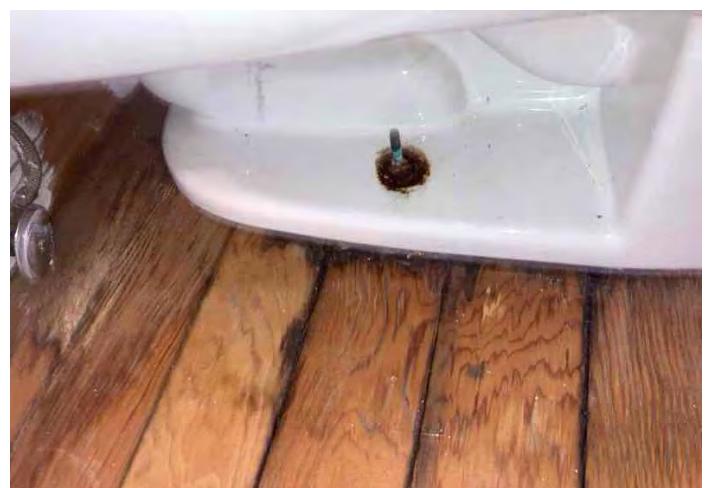
Photo 34

**! 20.** Damage to the front bathroom and bathroom storage shed hardwood flooring was observed. The extent of damage is difficult to predict without removing floor coverings. It is recommended that the source of the damage be identified and corrected by the appropriate trades. (See Photo 13) (See Photo 34)

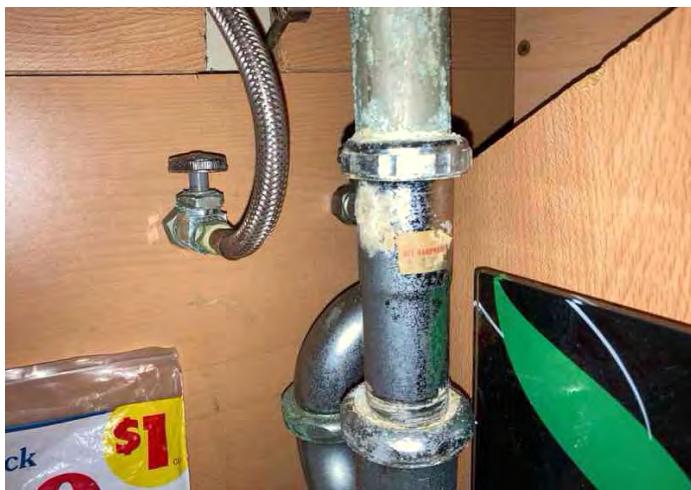
Photo 35

- ! 7. The plastic/metallic waste piping is leaking at the front bathroom toilet. We recommend all leaks be repaired. (See Photo 52)
- ! 8. There is evidence of heavy corrosion and rust, but no leakage on the exterior of the exposed and accessible metal drain piping in the front bathroom. This piping should be monitored for leakage and repaired as necessary. Upgrading this piping and connections should also be considered. (See Photo 35)

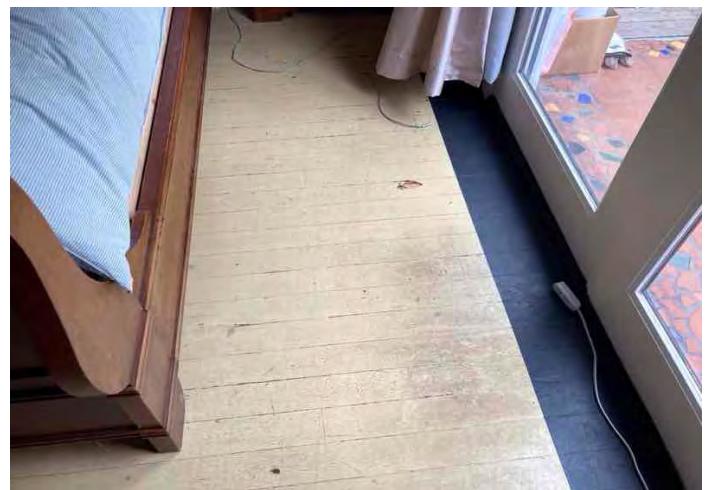
Photo 36

- ! 3. Minor water damage to the master bedroom hardwood flooring was observed. It is recommended that the source of the damage be identified and corrected, and the surface be repaired and refinished to restore its appearance. (See Photo 36)

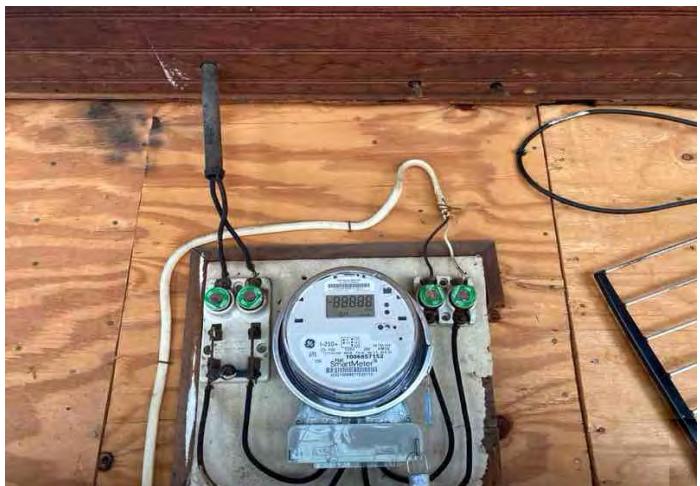
Photo 38

- ! 3. The loose light fixture in the back storage shed should be repaired or replaced. (See Photo 8)
- ! 4. The branch/auxiliary panel cover plate (sometimes called the "Dead Front") is missing. It should be replaced. (See Photo 38)

- ! 5. We found exposed wiring at the sun room. Even if insulated, we recommend all wiring be encased in conduit or otherwise protected in accordance with present standards. (See Photo 38)

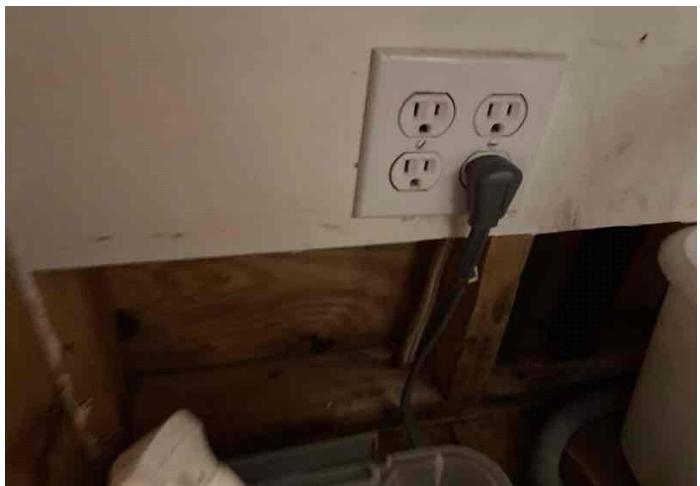
Photo 40

- ! 13. Exposed wiring inside the kitchen cabinet should be relocated, covered or protected by rigid conduit. (See Photo 40)

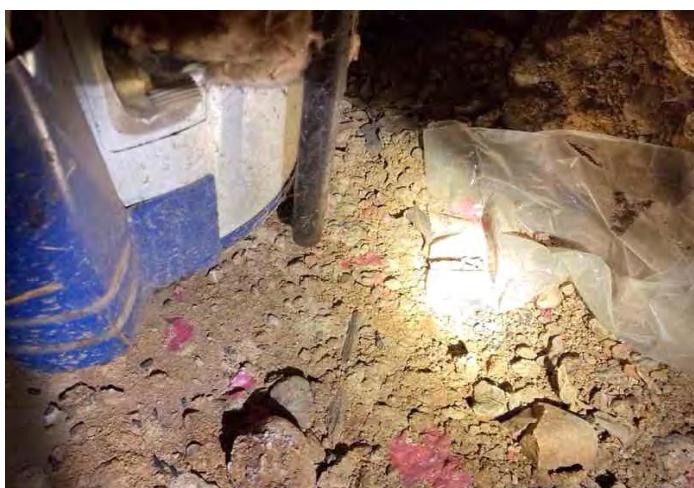
Photo 45

- ! 1. The temperature and pressure relief discharge pipe for the water heater is improper. We recommend the installation of a proper discharge pipe to an approved location. (See Photo 45)

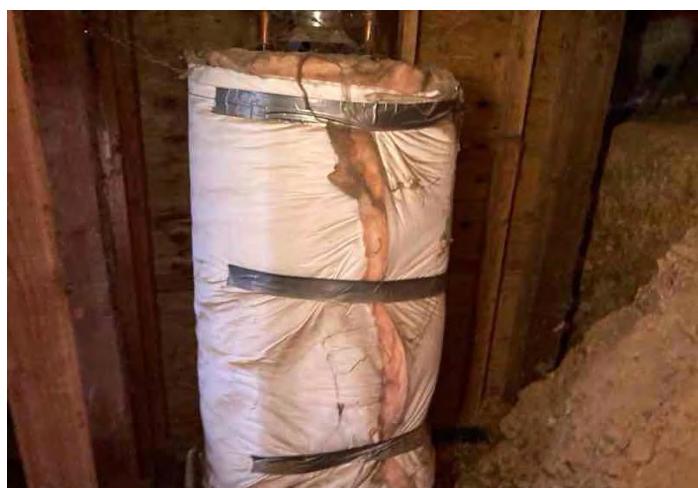
Photo 46

- 5. Straps should be secured to adjacent wall or stud and from opposing directions
  - 6. Straps should be secured to the wall or studs using 1/4" diameter by 3" long lag bolts with washers. (See Illustration 8E) (See Photo 46)

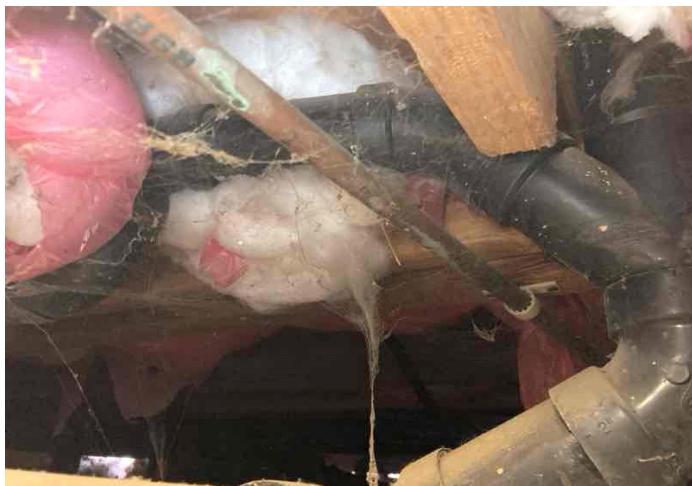
Photo 49

- ! 6. The drain system adjacent to the laundry area and master bathroom shower was improperly installed. We recommend the drains be reconfigured according to industry standards. (See Photo 49) (See Photo 51)

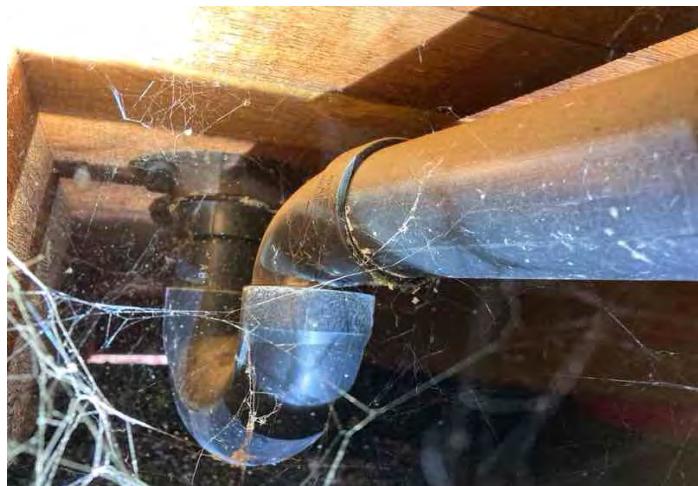
Photo 50

- ! 9. There is a cracked and leaking Plastic drain pipe at the front bathroom stall shower. This is a potential health hazard. We recommend the piping in question be repaired or replaced. (See Photo 50)

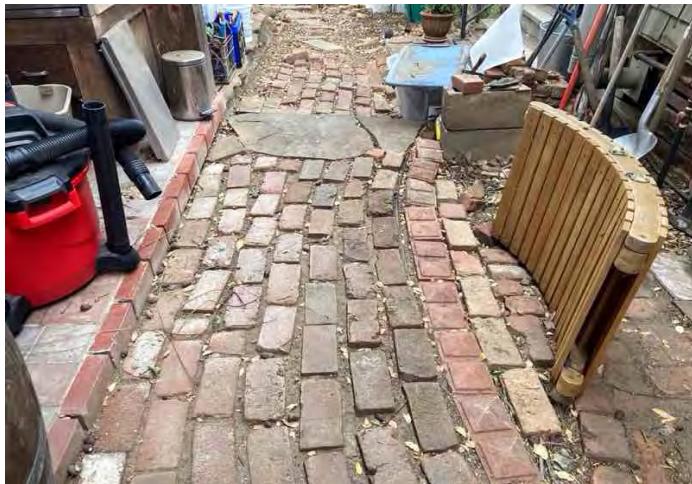
Photo 55

- ! 6. The cracked and heaved walkway section(s) at the front present a trip hazard. This condition should be corrected for improved safety. (See Photo 55)
