WOOD DESTROYING PESTS AND ORGANISM INSPECTION REPORT

Building No.	Street	City	ZIP	Date of Inspection	Number of Pages
8	Central Court	Los Gatos	95030	9/18/2024	Page 1 of 16

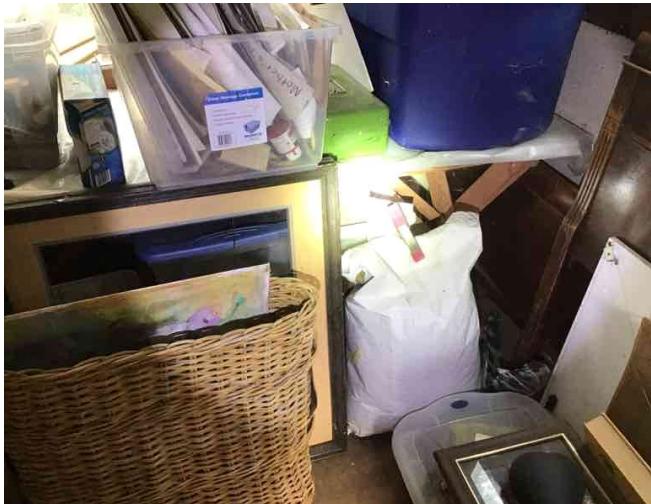
Photo 19

3B. FINDING: We were unable to inspect the interior of the upstairs and downstairs storage closets due to stored personal property. (See Photo 19) (See Photo 26) (See Photo 27)

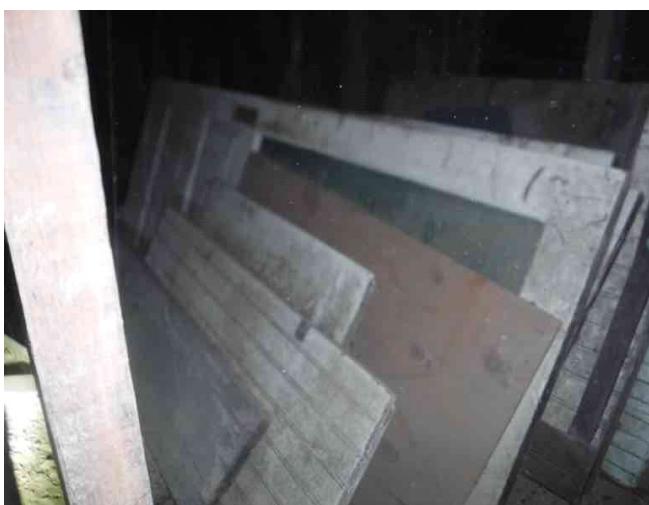
Photo 35

3C. FINDING: Portions of the subarea were inaccessible for inspection due to storage. (See Photo 36) (See Photo 35)
