**Tree Inventory, Assessment,  
and  
Protection Report**

**16195 George Avenue, Los Gatos  
Los Gatos, CA 95032**

**Town of Los Gatos**

**August 9, 2021**

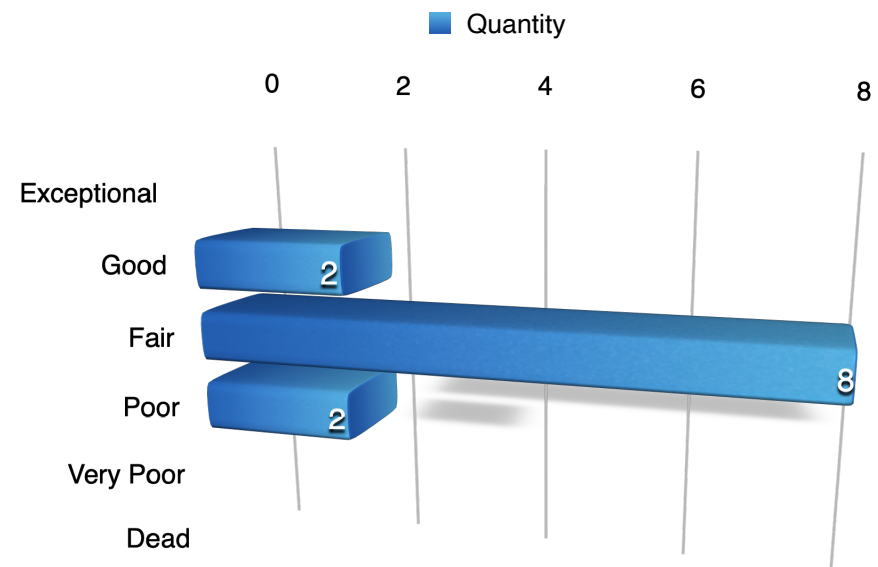
Chart 2: Condition Ratings

Walnut #875 and sweetgum #885 are both poor condition. The mulberries are in fair shape and the two adjacent coast redwoods #884 and #886 are in good condition. The mulberries are all pollarded (type of pruning system that removes all annual growth to “knuckles”).
