Arborist Report Update

**Los Gatos Meadows
Los Gatos, CA**

October 12, 2020

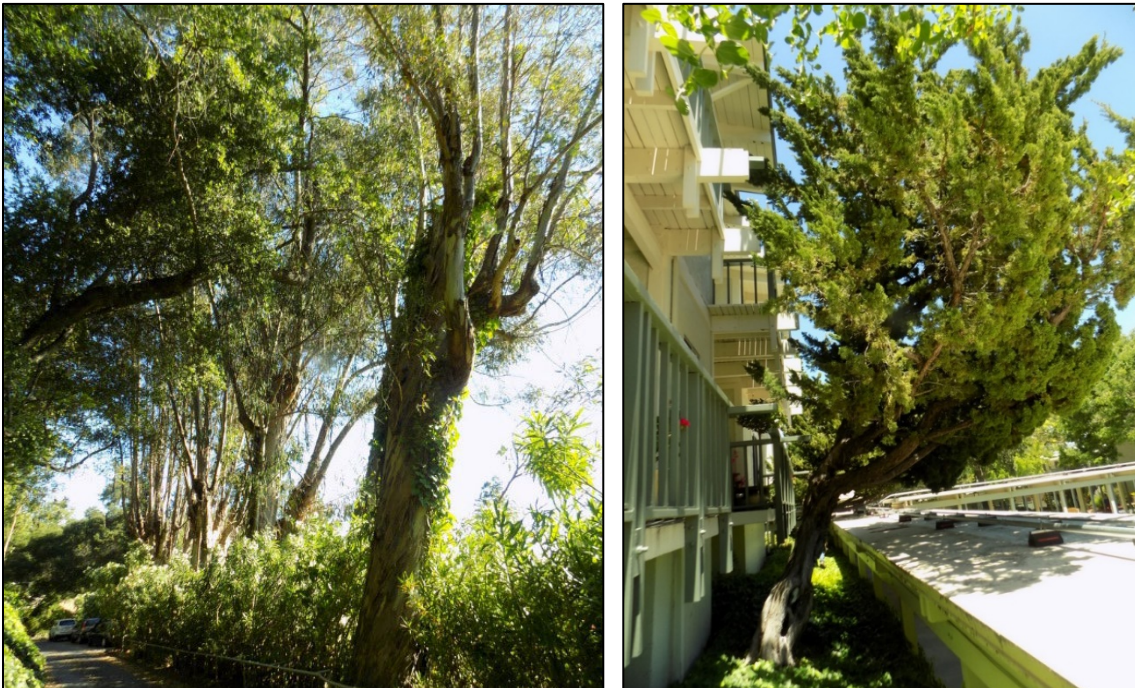
Twelve (12) blue gum eucalyptus trees were assessed (3% of population). The blue gums were in poor (7 trees) to fair (5 trees) condition with no trees in good condition. They were the largest trees assessed with an average trunk diameter of 44". Blue gum #62 was the largest tree assessed with a trunk diameter of 62". Blue gums #7-12 had been harshly topped with poorly attached regrowth (Photo 3).

Photo 3 (lower left) – Blue gums #7-12 had been topped with poorly attached regrowth.
