Arborist Report

North 40 Phase II Los Gatos, CA

August 2023

Updated September 27, 2024

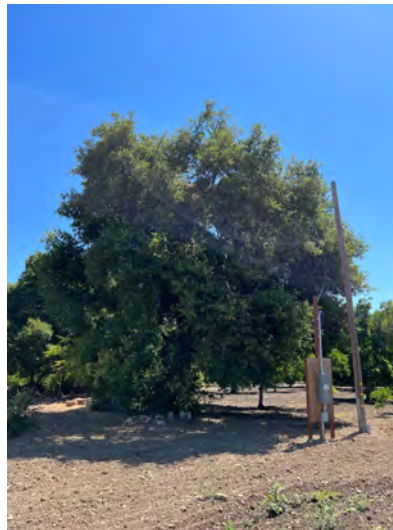
(11) Coast Live Oak #334

334	Coast live oak	32	Yes/LP	4	50	50	High	Large , round crown; broken top; previous branch failures.
335	English walnut	8	No	3	10	20	Moderate	Small crown; young tree; good form.
336	California pepper	11	Yes	3	20	25	Moderate	Bows heavy east; poor form; one sided.
337	Coast live oak	11	Yes	3	25	25	Moderate	One-sided northeast; leans
338	Jacaranda	10,9	Yes	3	30	25	Moderate	Codominant at 3'; fair form; leans
339	Coast live oak	25	Yes/LP	4	50	50	High	Good structure and form; bricks
340	Avocado	6	No	3	10	15	Moderate	Fair structure and form; leans east.
341	Black locust	12	Yes	2	10	15	Low	Topped at 5'; multiple attachments at 4'.
342	Persimmon	12	No	4	15	15	High	Good form; high vigor; umbrella

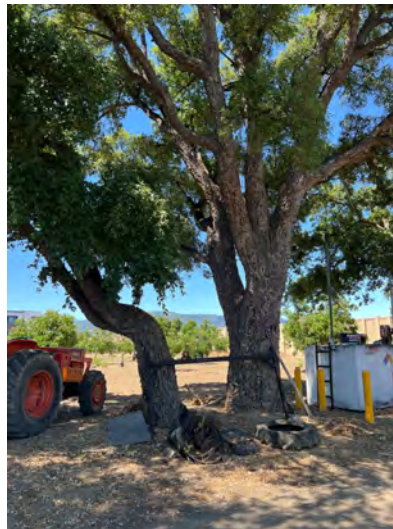
(40) Cork Oak #395

Tree No.	Species	Trunk Diameter (in.)	Protected Tree? LP=Large Protected	Condition 1=poor 5=excellent	Canopy Spread (ft.)	Height (ft.)	Suitability for Preservation	Comments
395	Cork oak	32	Yes/LP	4	60	60	High	Large crown; good structure and form; wide spreading; codominant
396	Cork oak	22	Yes	3	30	50	Moderate	One sided east; 3 stems at 8'.
397	Cork oak	38	Yes/LP	4	60	60	High	Large crown; wide spreading; codominant at 10'.
398	Cork oak	32	Yes/LP	4	60	60	High	Large crown; wide spreading; sinuous trunk.
399	English walnut	10	No	3	25	15	Moderate	Multiple attachments at 7'; round crown; fair form.
400	English walnut	9	No	3	15	15	Low	Multiple attachments at 7'; round
401	English walnut	6	No	1	4	15	Low	Lost too; poor form; nearly dead.
402	English walnut	10	No	3	20	15	Moderate	Full, round crown; good form; multiple attachments at 7'.
403	English walnut	9	No	2	15	15	Low	Small crown; small crown to height ratio; dead twigs.

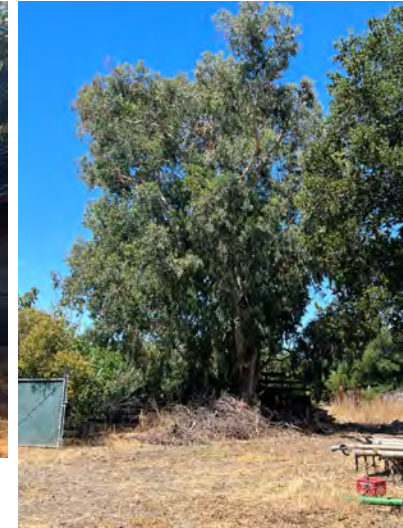
(44) Siberian elm #277

276	Chinese elm	<i>Ulmus parvifolia</i>	15,14	40	Protected	\$ 5,250	Remove - Severe	24	Within construction footprint.
277	Siberian elm	<i>Ulmus pumila</i>	29,28	50	Large Protected	\$ -	Remove - Severe	48	Storm damaged tree, split at base.
278	Coast live oak	<i>Quercus agrifolia</i>	18	40	Protected	\$ 3,650	Remove - Severe	15	Within construction footprint.

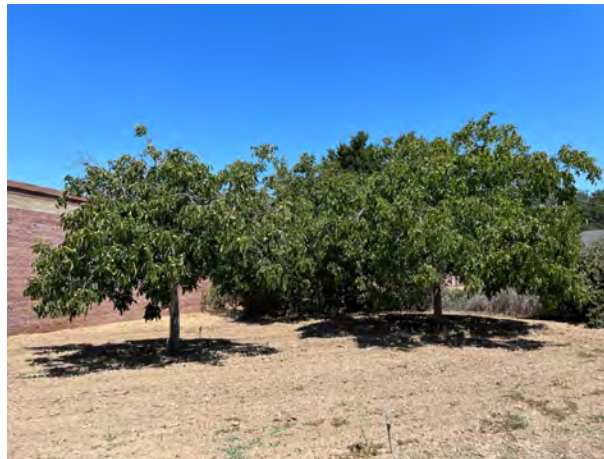
(64) Dead Mulberry #274

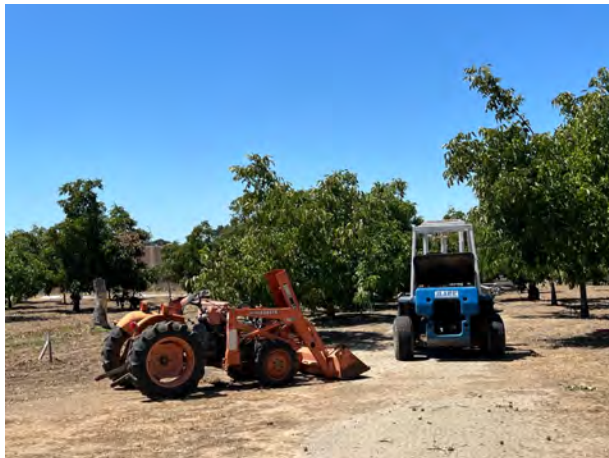
(75) Walnuts #406 - 423

Tree No.	Species	Trunk Diameter (in.)	Protected Tree? LP=Large Protected	Condition 1=poor 5=excellent	Canopy Spread (ft.)	Height (ft.)	Suitability for Preservation	Comments
412	English walnut	10	No	3	20	15	Moderate	Good structure and form; medium crown; sinuous trunk.
413	English walnut	6	No	3	20	15	Moderate	Good structure and form; medium crown; codominant at 4'.
414	English walnut	7	No	3	20	15	Moderate	Good structure and form; medium crown; multiple attachments at 5'.
415	English walnut	5	No	2	10	15	Low	Thin crown; low vigor; twig
416	English walnut	8,7	No	3	30	15	Moderate	Two stem at 3'; wide crown; fair form.
417	English walnut	6	No	2	8	15	Low	Poor form; heavy lean north; small crown.
418	English walnut	4	No	1	8	15	Low	Poor form; small crown; nearly
419	English walnut	7	No	3	10	15	Moderate	Small crown; good form; moderate vigor.
420	English walnut	8	No	3	20	15	Moderate	Small crown; good form; moderate vigor.

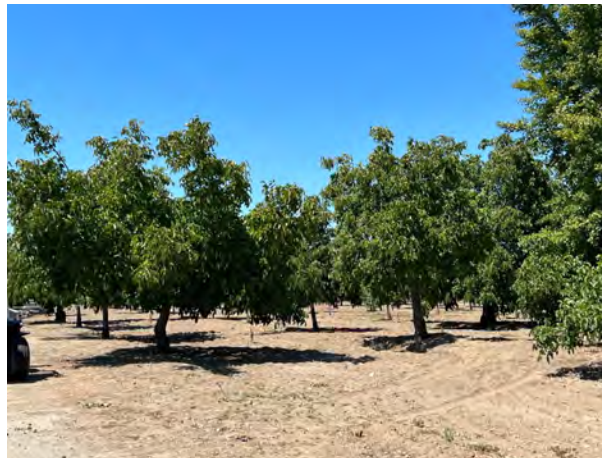
(76) Walnuts #424 - 437

Tree No.	Species	Trunk Diameter (in.)	Protected Tree? LP=Large Protected	Condition 1=poor 5=excellent	Canopy Spread (ft.)	Height (ft.)	Suitability for Preservation	Comments
429	English walnut	7	No	3	20	15	Moderate	Wide crown; moderate vigor.
430	English walnut	6	No	3	20	15	Low	Medium crown; moderate vigor; decay at base of trunk.
431	English walnut	6	No	3	18	15	Moderate	Medium crown; moderate vigor; good form.
432	English walnut	4	No	3	18	15	Moderate	Small crown; moderate vigor; good form.
433	English walnut	7	No	3	18	15	Moderate	Medium crown; moderate vigor; good form.
434	English walnut	4	No	2	10	15	Low	Poor form; major wound in north side of trunk.
435	English walnut	5	No	3	10	15	Low	Fair form; small crown; low vigor.
436	English walnut	6	No	3	10	15	Low	Good form; small crown; moderate vigor.
437	English walnut	5	No	3	10	15	Low	Fair form; small crown; low vigor.
438	English walnut	6	No	3	15	15	Moderate	Fair form; small crown; moderate vigor.

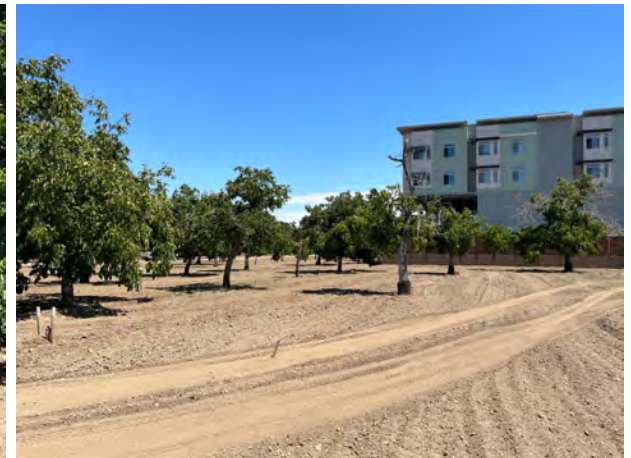
(77) Walnuts #438 - 445

439	English walnut	9	No	3	20	15	Moderate	Fair form; small crown; moderate vigor.
440	English walnut	6	No	2	10	15	Low	Poor form; small crown; previous branch failure.
441	English walnut	5	No	3	10	15	Low	Fair form; small crown; fair structure.
442	English walnut	8	No	2	20	15	Low	Wide crown; twig dieback; fair vigor.
443	English walnut	6	No	3	20	15	Moderate	Medium crown; fair form and moderate vigor.
444	English walnut	6	No	3	20	15	Moderate	Medium crown; fair form and moderate vigor.

Tree No.	Species	Trunk Diameter (in.)	Protected Tree? LP=Large Protected	Condition 1=poor 5=excellent	Canopy Spread (ft.)	Height (ft.)	Suitability for Preservation	Comments
445	English walnut	10	No	3	20	15	Moderate	Medium crown; fair form and moderate vigor; crook in trunk at
446	Ginkgo	14	Yes	3	30	25	Moderate	Wide crown; multiple attachments at 8'; poor structure and form.
447	Arizona cypress	10,9,8,7,6,4	Yes	3	35	20	Low	Wide crown; multiple attachments at 3'; poor structure.
448	Japanese maple	4,4,3,3,2,2	Yes	2	10	12	Low	Decay in base; multiple attachments at 1'; decay in base.
449	Monterey pine	38	Yes	3	40	40	Moderate	Large crown; thin middle; leans south; large lateral branch
450	Coast live oak	30	Yes/LP	5	60	50	High	Large crown; good structure and form; wide crown; excellent
451	Chinese pistache	5	Yes	1	10	15	Low	Poor form; previously topped.
452	Chinese pistache	7	Yes	2	20	20	Low	East side of driveway.; thin crown; multiple attachments at 6'.
