**Tree Inventory, Assessment,  
and  
Protection Report**

**400 Surmont Drive  
Los Gatos, CA 95032**

**Town of Los Gatos**

**September 27, 2019  
Revised February 11, 2022**

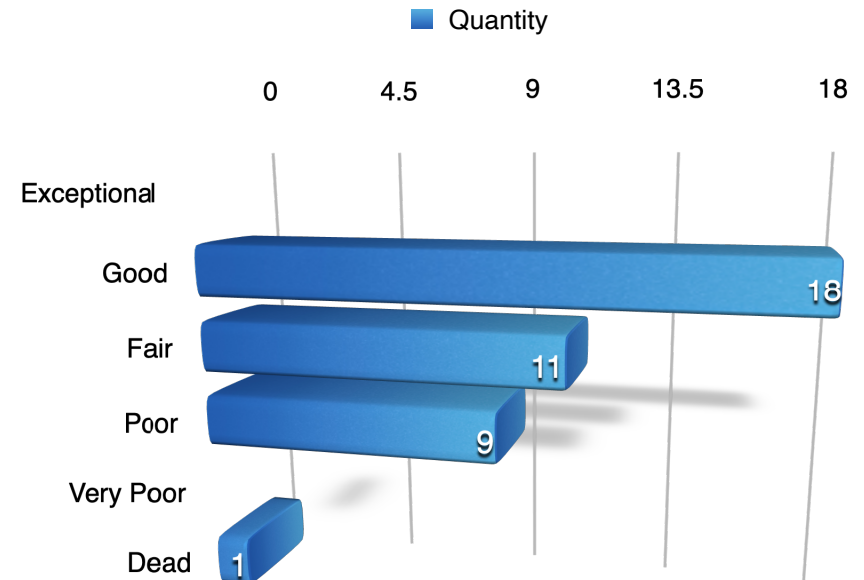
Chart 2: Condition Ratings

Eighteen trees are in good condition, eleven fair, nine in poor shape and one is dead (Chart 2). Most of the trees in poor condition are remnant orchard trees. The best specimen in the building area is coast live oak #133.

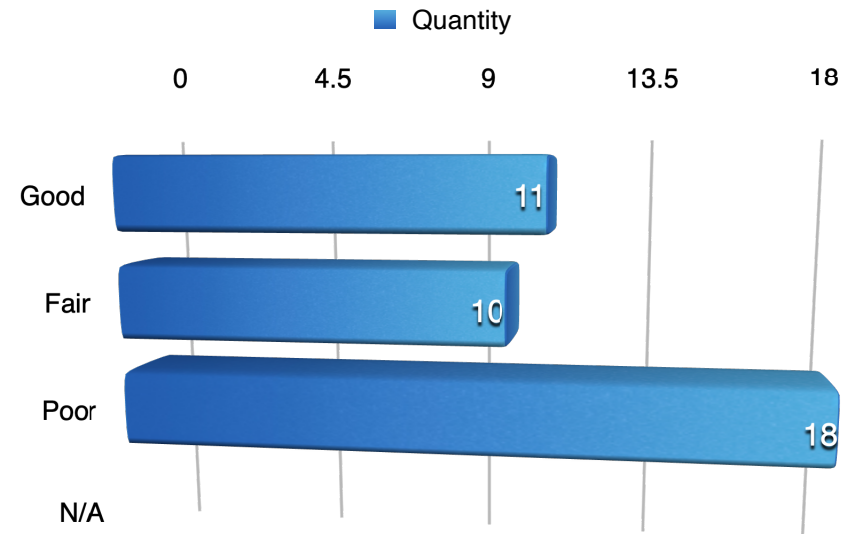
Chart 3: Suitability for Preservation

Eighteen trees are poorly suited for retention which are primarily fruit trees (Chart 3). Ten trees have fair suitability for preservation. The remaining eleven have good suitability and primarily consist of naturally occurring coast live oaks or holly oaks.

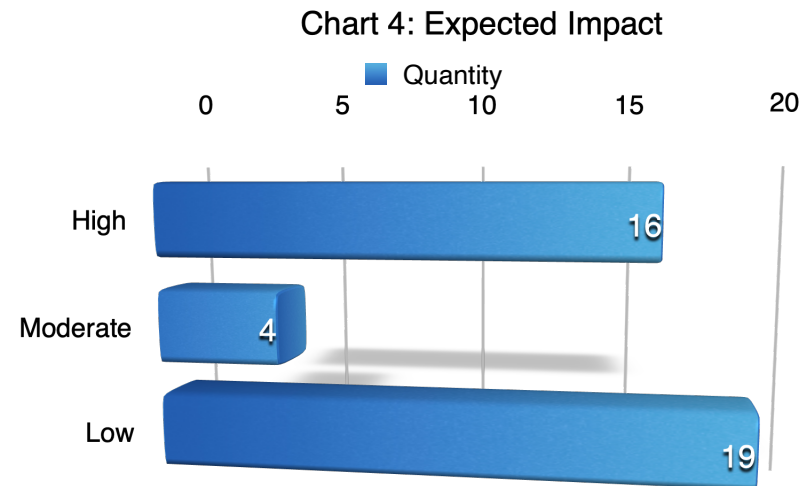
Sixteen trees will be highly impacted and are expected to be removed, four moderately affected, and nineteen are not near the improvements (Appendix A and B). Seven of the sixteen trees expected to be highly impacted are Protected (#111, #127, #128, #129, #130, #700, and #896) while the remaining are Exempt fruit trees.

The table below indicates the recommended replacement values (Table 3). Seven trees will require replacements (#111, #127, #128, #129, #130, #700, and #896) resulting is twenty-one (21) 24 inch box specimens. Alternatively it may be possible to create an approved landscape plan or provide an in-lieu payment.
