**Tree Inventory, Assessment,  
and  
Protection Report**

**17121 Crescent Drive, Los Gatos  
Los Gatos, CA 95032**

**Town of Los Gatos**

**October 14, 2021**

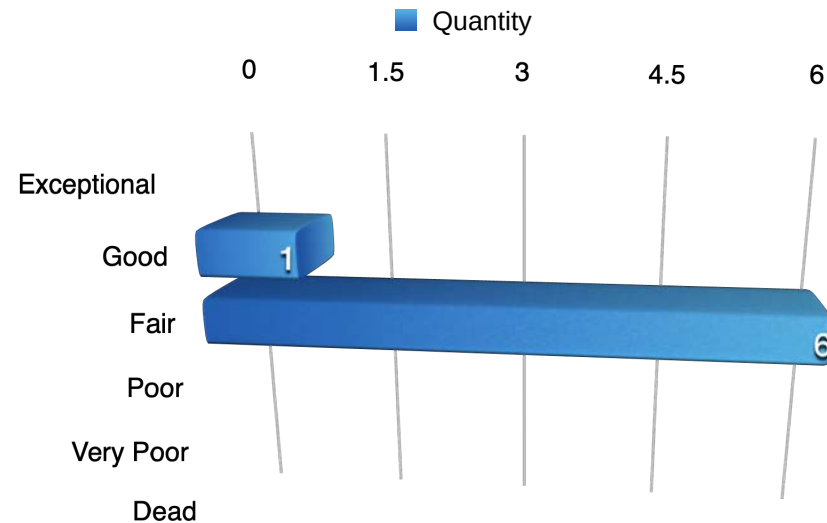
Chart 1: Condition Ratings

There is one tree in good condition which is the Brazilian pepper and the remaining trees are in fair shape. The redwoods are drought stressed with sparse crowns and multiple tops and the coast live oaks have codominant stems. The pines have grown naturally and are somewhat stressed.

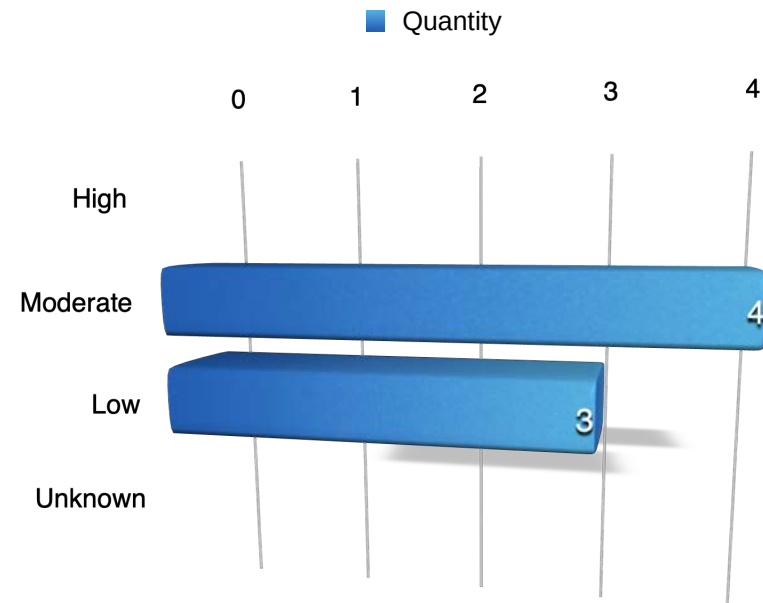
Chart 2: Expected Impact

No trees are expected to be highly impacted or removed. Four trees will be moderately impacted by the proposed plans which are the two coast redwoods in front and the two coast live oaks along the road with drainage and soil filling nearby. The driveway will remain in a similar location with half of the roundabout abandoned. The new driveway is located in the same footprint of the existing. If there is significant grading, compaction, or sub base excavation it will likely destroy roots of the redwoods under the existing asphalt. The soil filling near the coast live oaks #717 and #720 will need to be at least 18 feet from the trees.
