**Tree Inventory, Assessment,
and
Protection Report**

**16940 Roberts Road
Los Gatos, CA 95032**

Town of Los Gatos

October 10, 2019

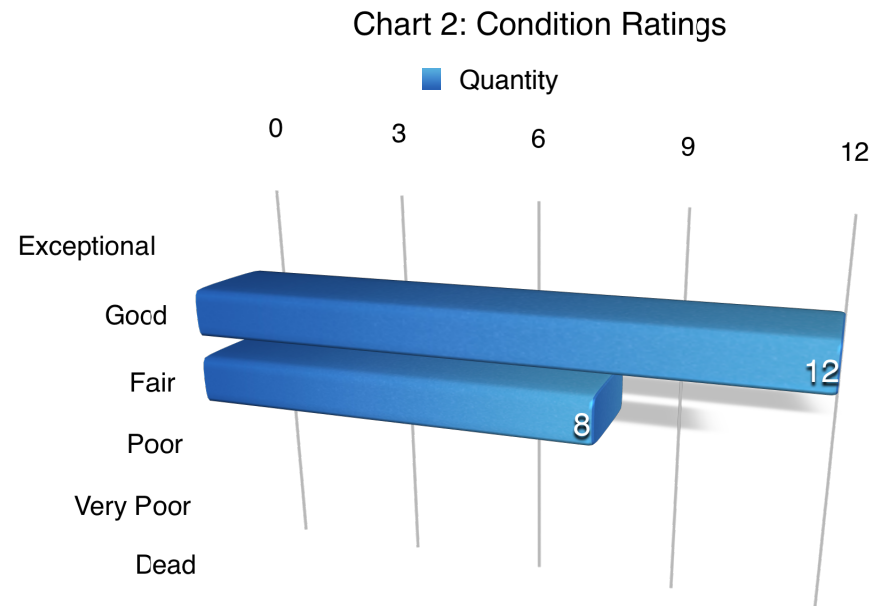
Twelve trees are in good condition and eight fair (Chart 2). Five of the trees in good shape originate on the adjacent site.

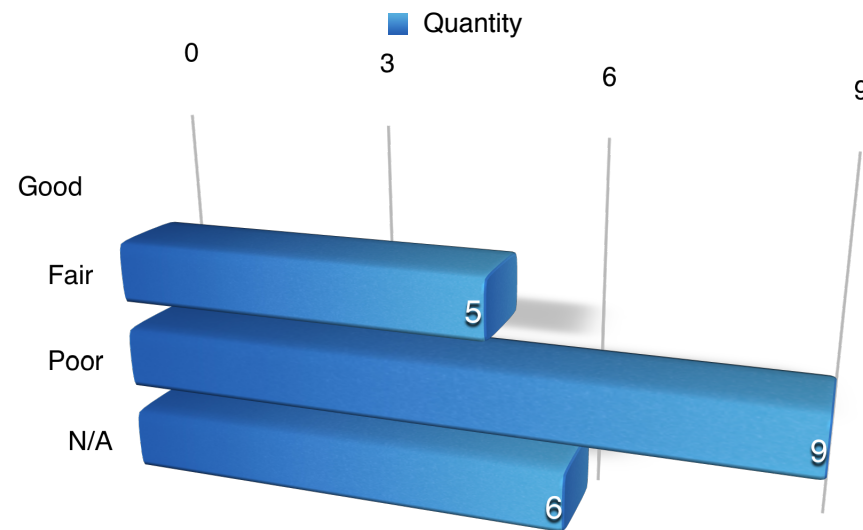
Chart 3: Suitability for Preservation

Five trees have fair suitability, nine poor, and six originate on the adjacent site and their suitability is not relevant (Chart 3).

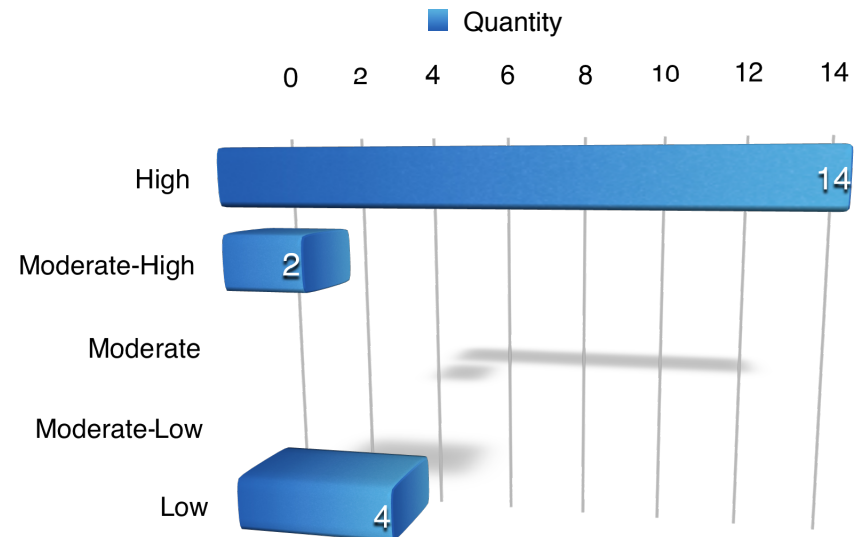
Chart 4: Expected Impact

All fourteen trees originating on the site will be highly impacted and caused to be removed. Two trees going on the adjacent site #378 and #379 will be moderate to highly impacted by the construction driveway ingress/egress. The remaining trees originating on the adjacent property will not be affected (Chart 4).
