August 15, 2019

Monarch Consulting Arborists LLC
P.O. Box 1010
Felton, CA 95018
831.331.8982

I was asked to locate and inspect the indicated additional trees down slope on 15365 Santella Court (Appendix A). The trees were to be assessed as part of the visibility analysis to help determine their condition. One tree had previously been labeled #244 "blue oak" which is in fact a 36 inch trunk diameter coast live oak (*Quercus agrifolia*).

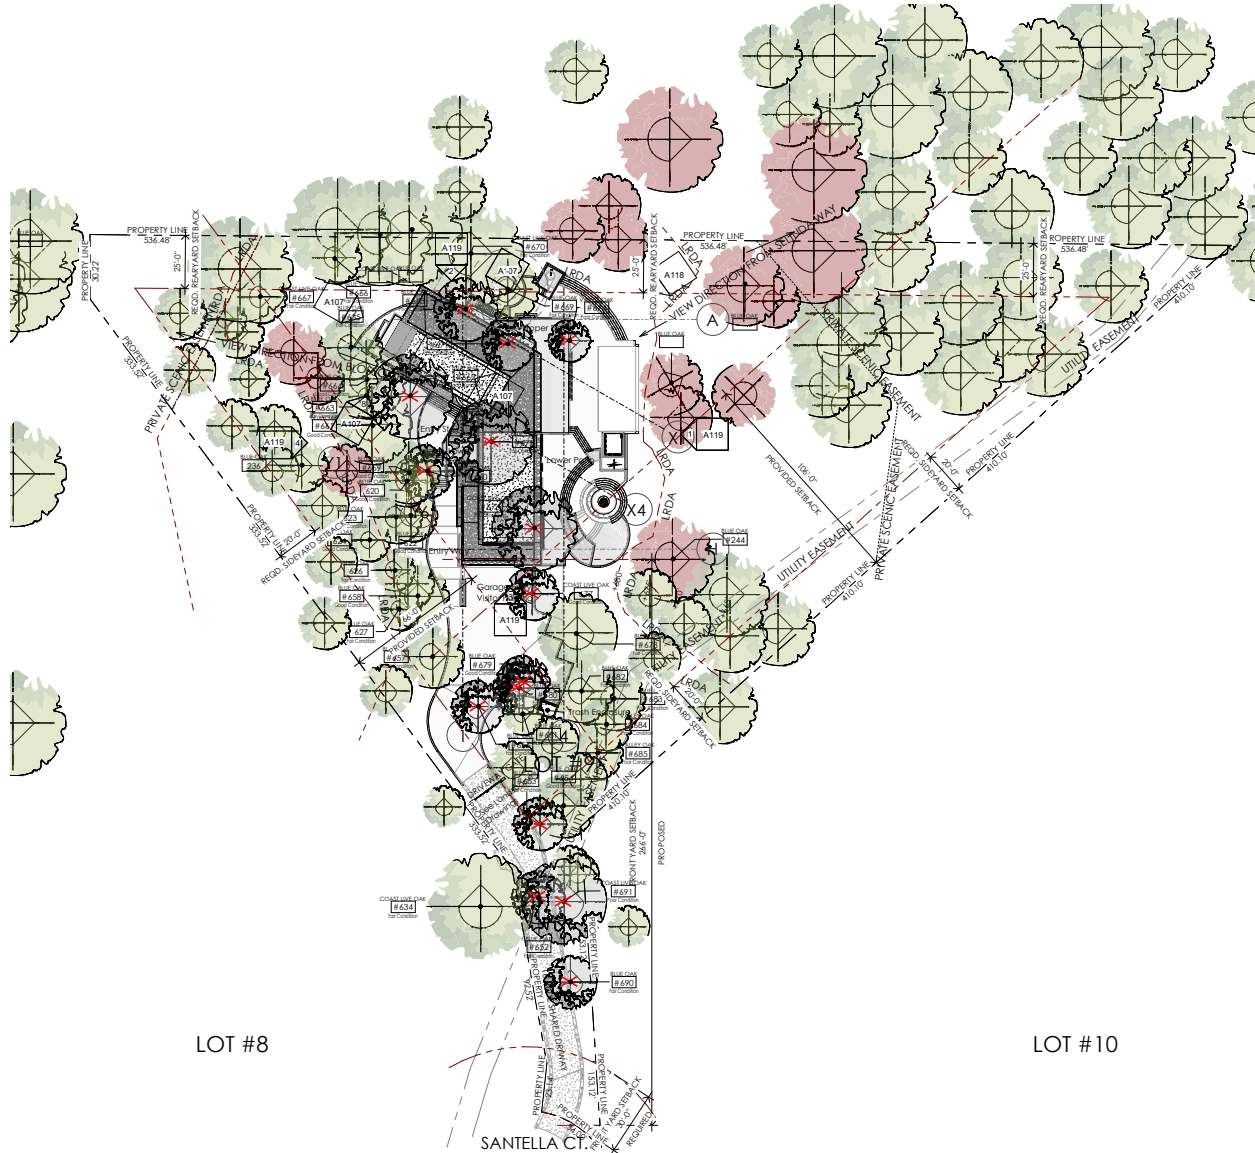
Appendix A: Aerial image provided for assessment

Snapshot not to scale from A120 dated October 19, 2018 provided by Srusti Architecture. The trees in pink are indicated in this report.
