**Tree Inventory, Assessment,  
and  
Protection Report**

**120 Oak Meadow Drive  
Los Gatos, CA 95032**

**Town of Los Gatos**

**December 16, 2022**

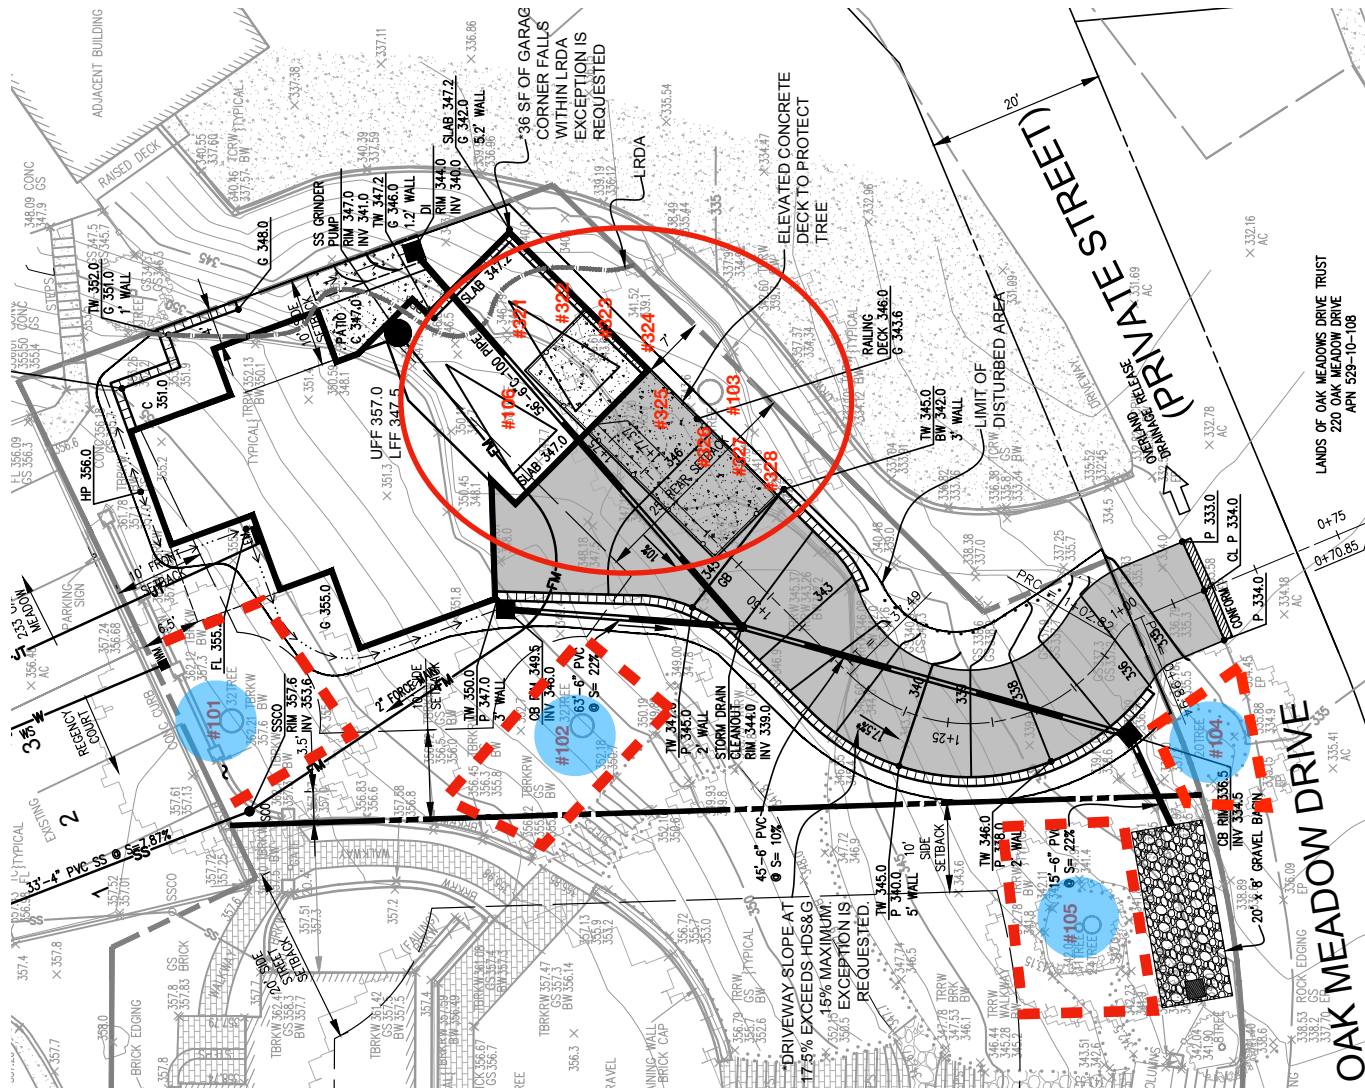
# Appendix A: Tree Inventory Map and Proposed Site Plan

Red dashed line indicates potential tree protection zones.

Red circle are all removals.
