REVISED GEOTECHNICAL AND ALTERNATIVES REPORT
SHANNON ROAD EMBANKMENT STABILIZATION PROJECT

CE&G DOCUMENT: 200300.001

7 DECEMBER 2020

Town of Los Gatos
41 Miles Avenue
Los Gatos, California 95030

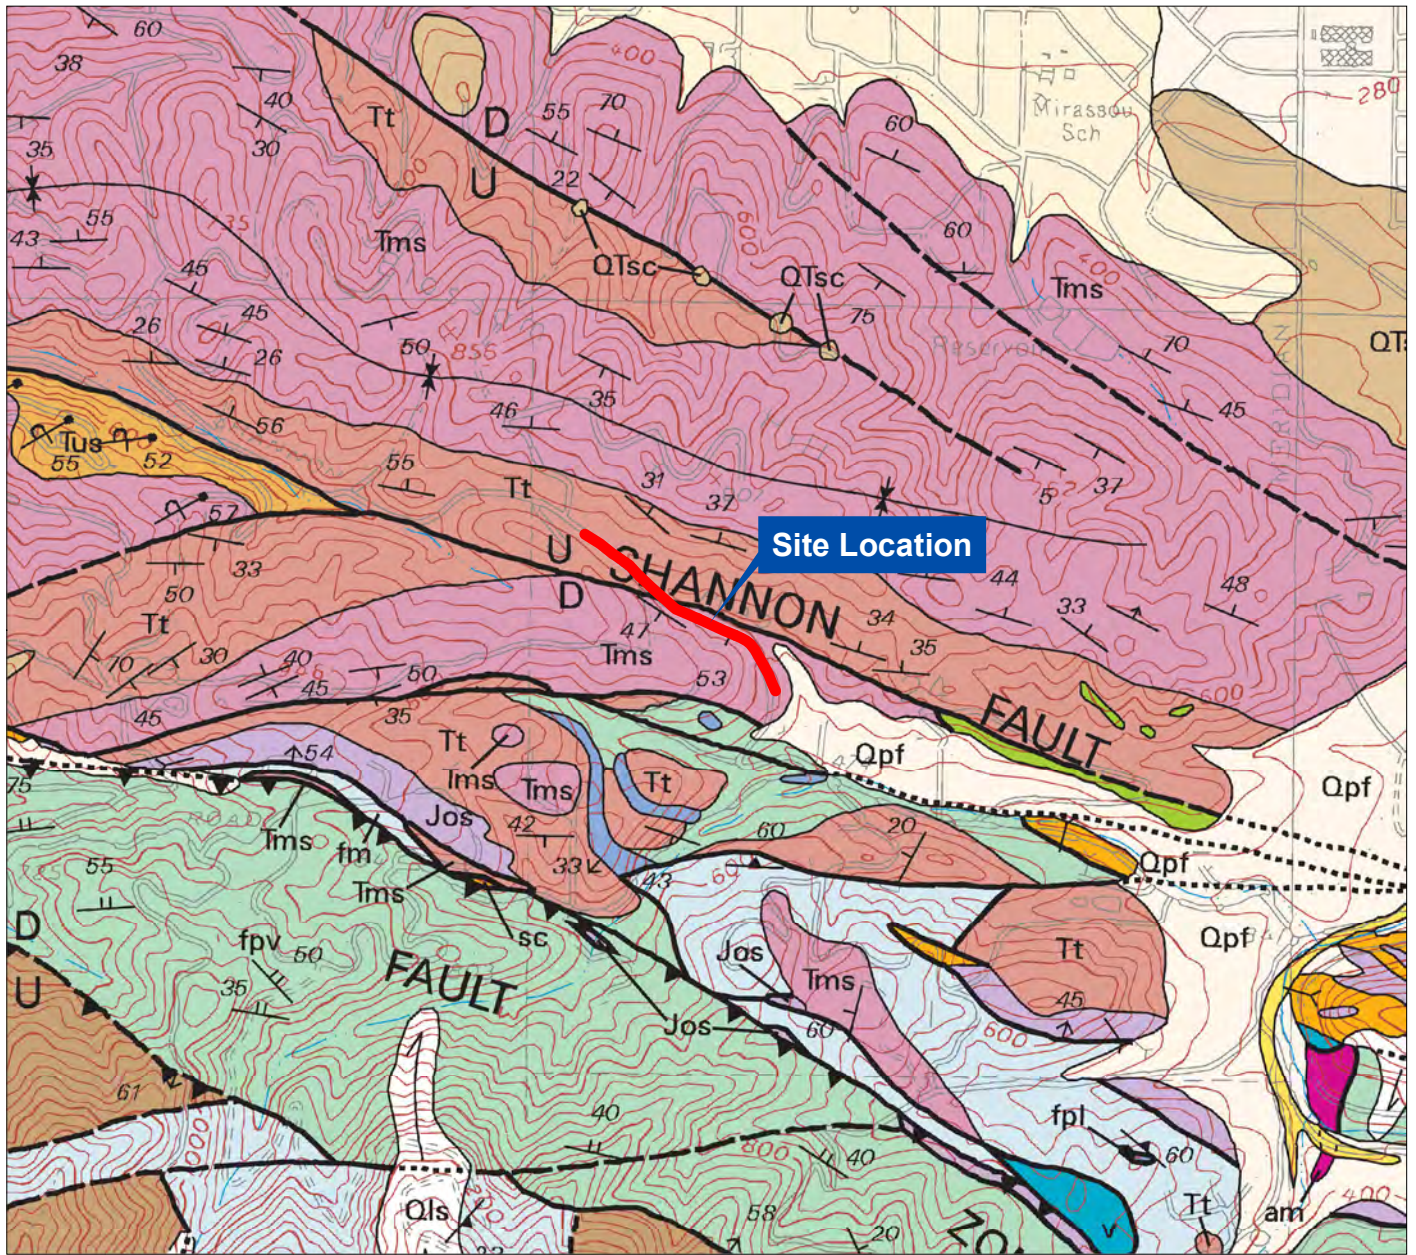
FIGURE 3

Regional geologic mapping by McLaughlin and others (2001), shows bedrock in the site vicinity as the Monterey shale (middle and lower Miocene) and Temblor sandstone (middle Miocene to Oligocene?), which have been juxtaposed near the center of the project site by the Monte-Vista Shannon Fault (Figure 3). The Monterey shale generally consists of siliceous mudstone, diatomite, and porcellanite, whereas the Temblor sandstone primarily consists of pebbly, lithic arkosic sandstone, and fossiliferous conglomerate (McLaughlin and others, 2001). The Monterey shale in the vicinity of the site, along Shannon Road, is shown as dipping 47° to 53° to the southwest (McLaughlin and others, 2001). This mapping agrees with earlier mapping by Wentworth (1999).

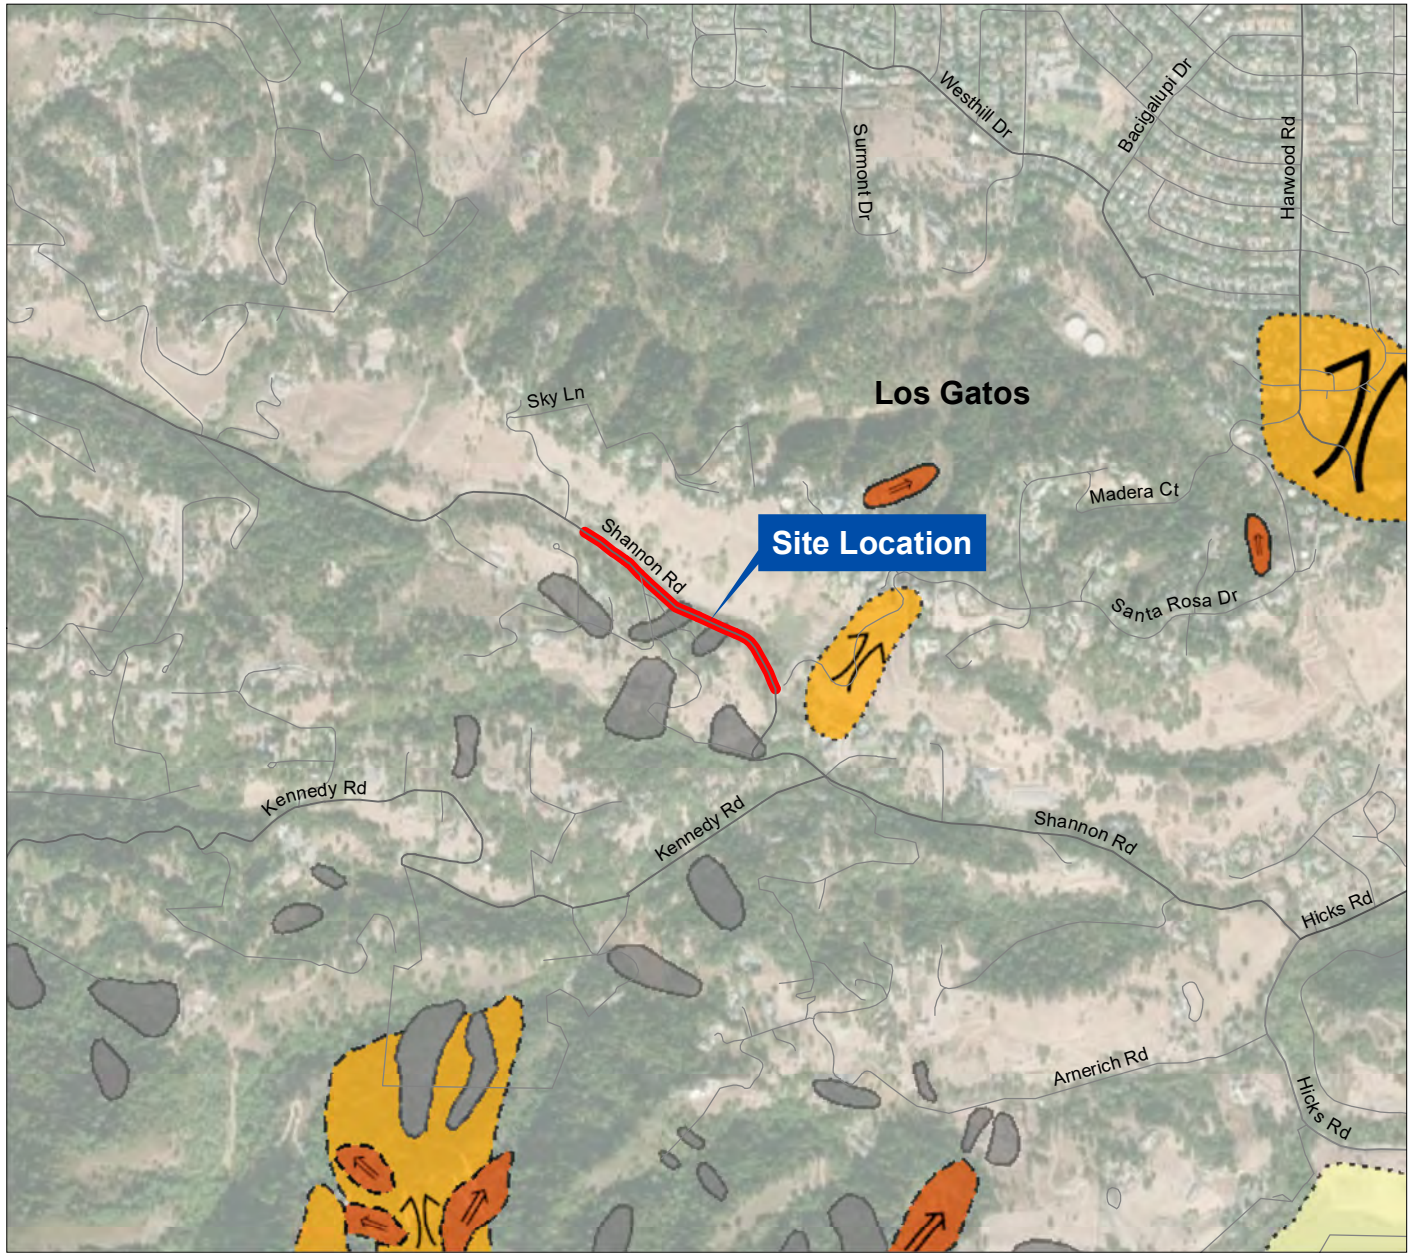
FIGURE 4

According to the California Geological Survey's (CGS) Landslide Inventory Map, two landslides of uncertain age are shown as crossing Shannon Road in the area of the project site, see Figure 4 (CGS, 2002).
