TREE REPORT
For
La Rinconada Golf & Country Club
MAINTENANCE YARD UPGRADE PROJECT
14595 Clearview Dr. Los Gatos 95032

Lisa Edwards & Straun Edwards
Trees 360 Degrees
Certified Arborist #WE-5055A / #WE-5612A
Ph. (408) 455-5911/408-898-0625

January 29th, 2026
(Revised February 28th, 2026)

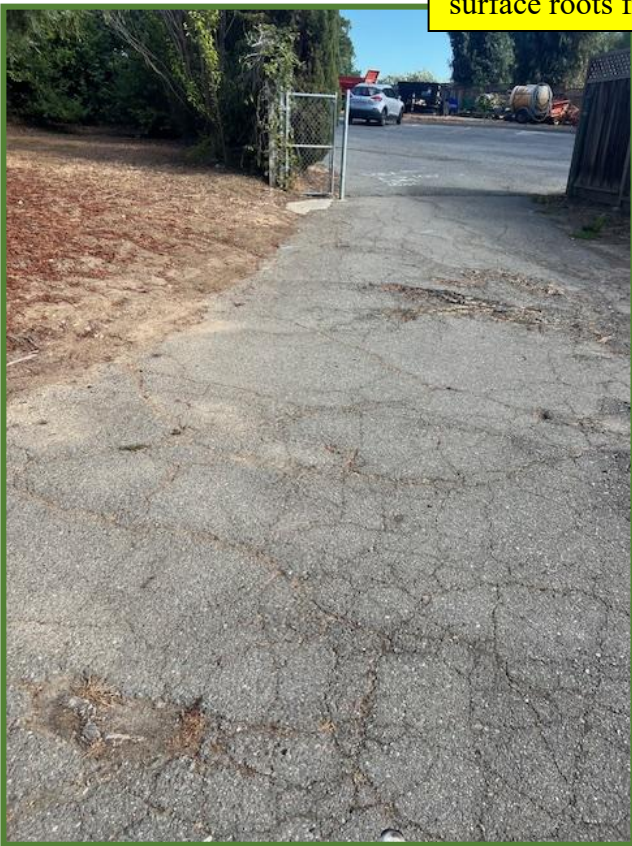
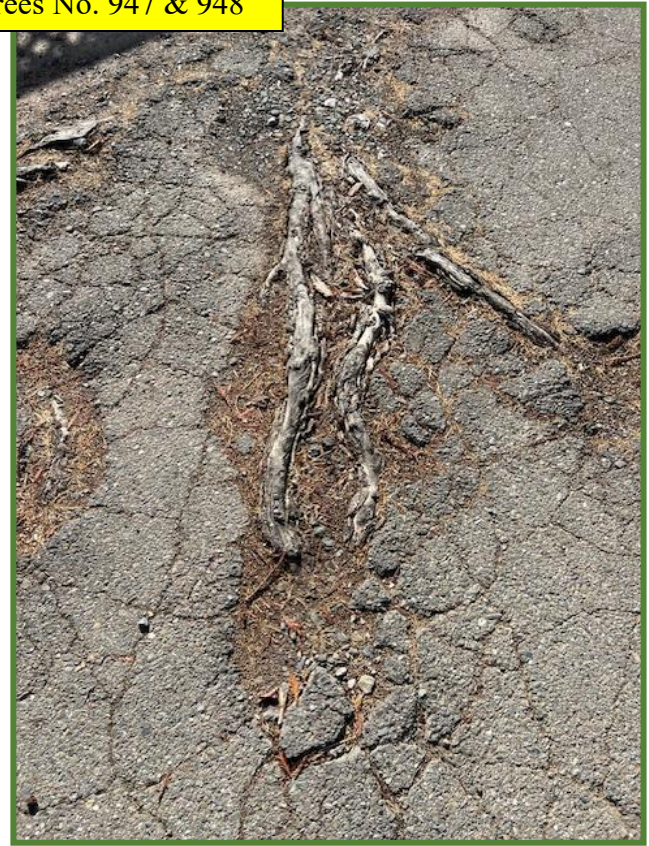
Hardscape damage due to extensive surface roots from Trees No. 947 & 948

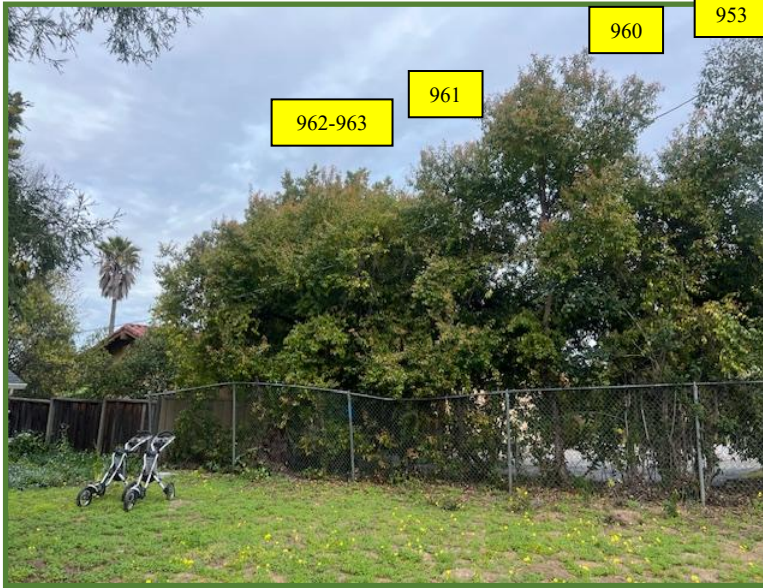
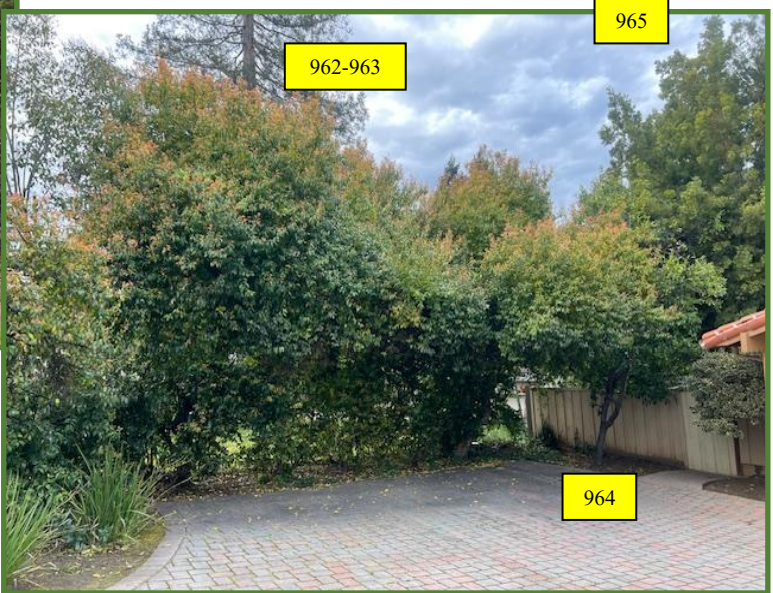
View from west side of hedged Xylosmas on 17423 Zena Ave. front yard.

View from east side of hedged Xylosmas on 17423 Zena Ave. front yard.

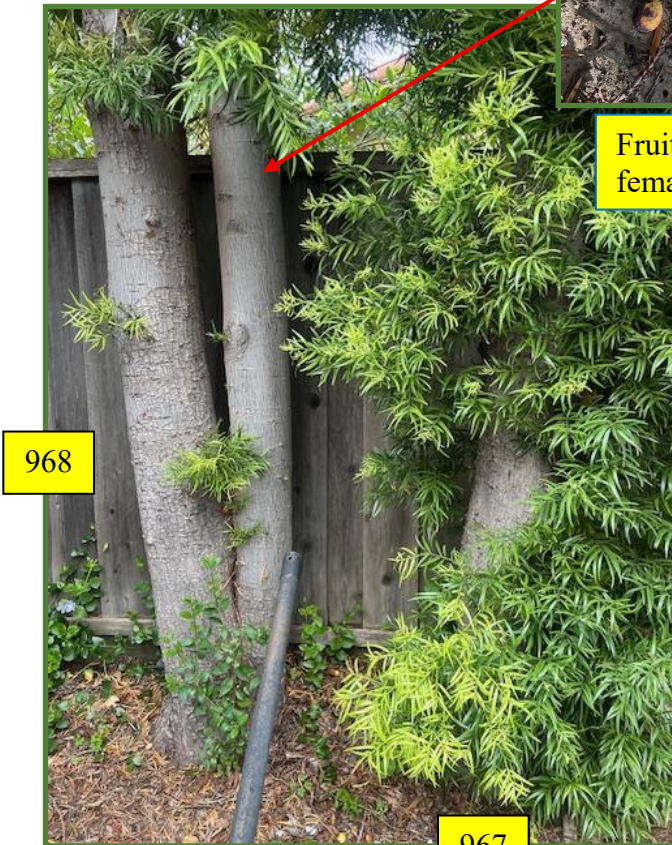
Fruit drop from female Tree No. 968

Highly recommend removal of these two large trees adjacent to the fence – growing in confined space with no room for future growth.
OR
Top to reduce canopies back to a manageable hedge height between 10-15ft (see blue line in photo)

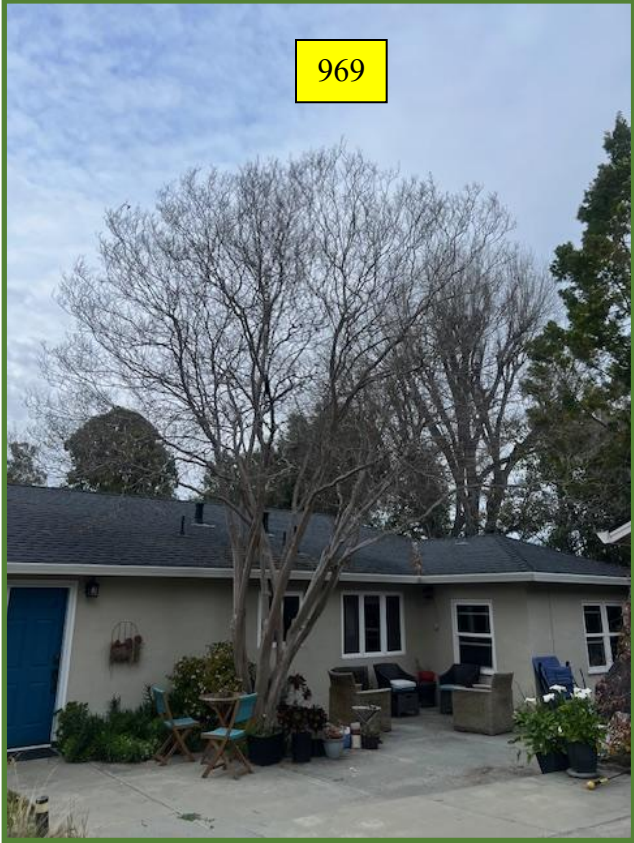
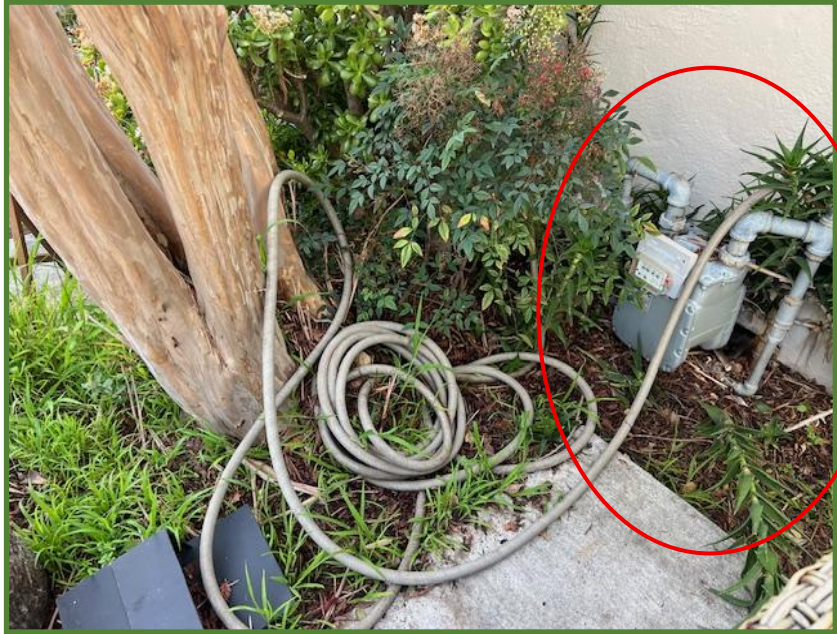
969

A relatively small, healthy tree with structure that is not ideal at ground level. See image with multiple trunks and tight unions with included bark. Growing in small concrete cutout next to house foundation, gas lines and hose bib.
