**Tree Inventory, Assessment,
and
Protection Report**

**45 Reservoir Road
Los Gatos, CA 95032**

Town of Los Gatos

December 4, 2022

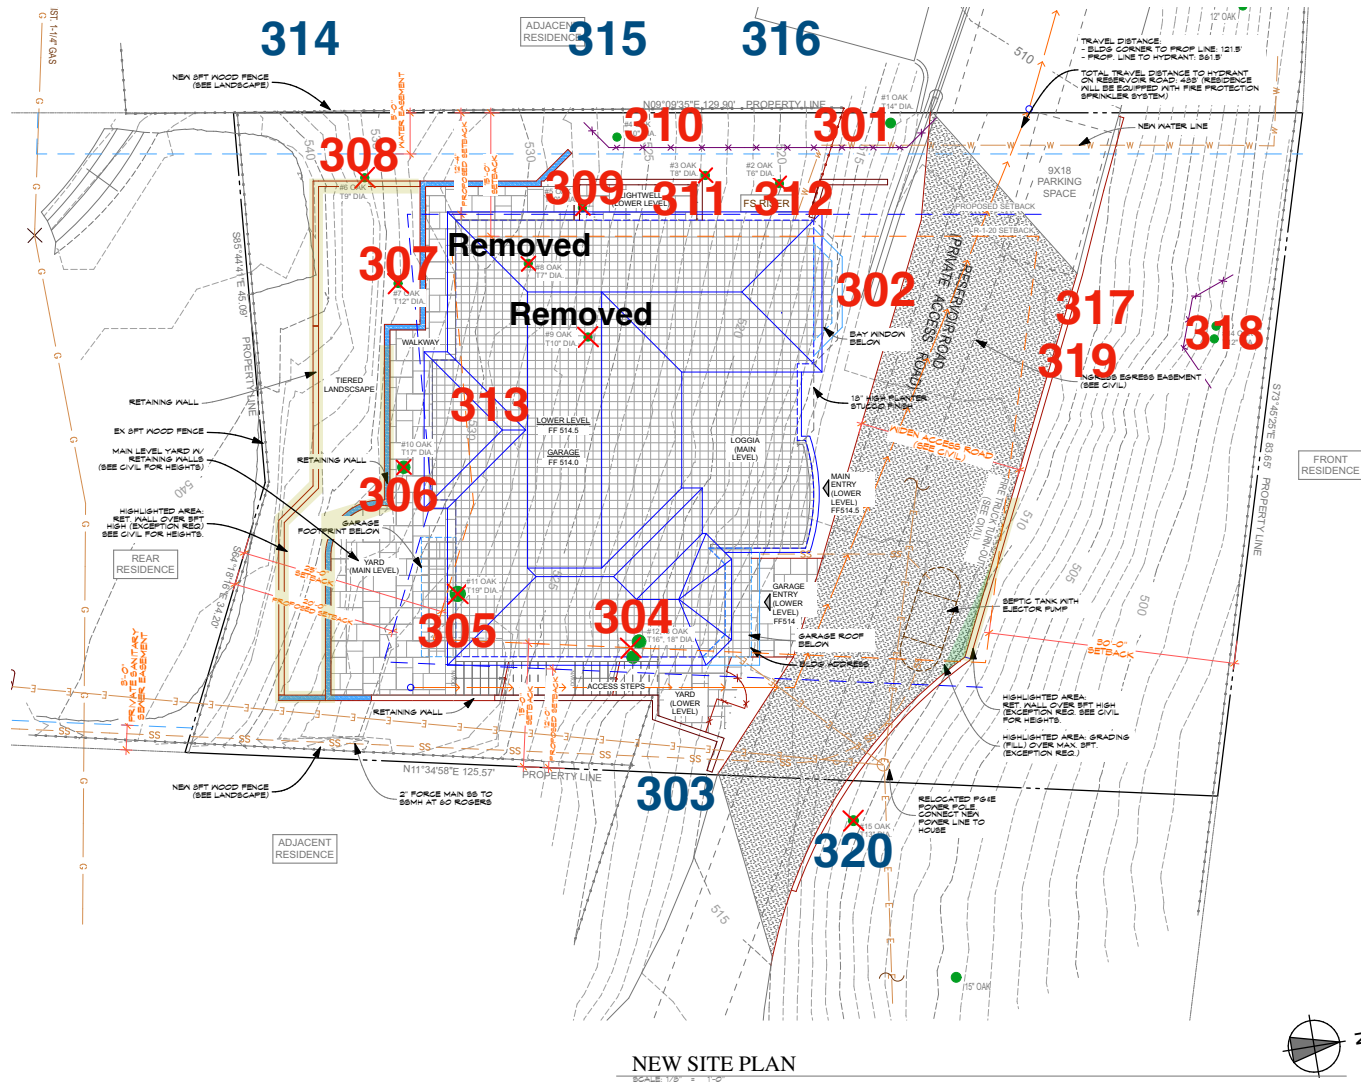
Appendix A: Tree Inventory Map and Proposed Site Plan

Looking at the civil plans all the trees on site would be required to be removed. The architectural plans indicate #301, #310, and #318 are to be preserved but again are in conflict with the grading and drainage plans. There are five trees that could be moderately impacted located on the adjacent properties which are #314, #315, #316, #303, and #320. Trees #314, #315, #316 will need to be located to obtain exact distances from the excavation to the trees. #303, and #320 are near the road improvements and will need to be preserved. Fifteen trees are to be highly impacted and five moderate to highly (Chart 4).
