**Tree Inventory, Assessment,  
and  
Protection Report**

**140 Prospect Avenue, Los Gatos  
Los Gatos, CA 95032**

**Town of Los Gatos**

**October 13, 2021**

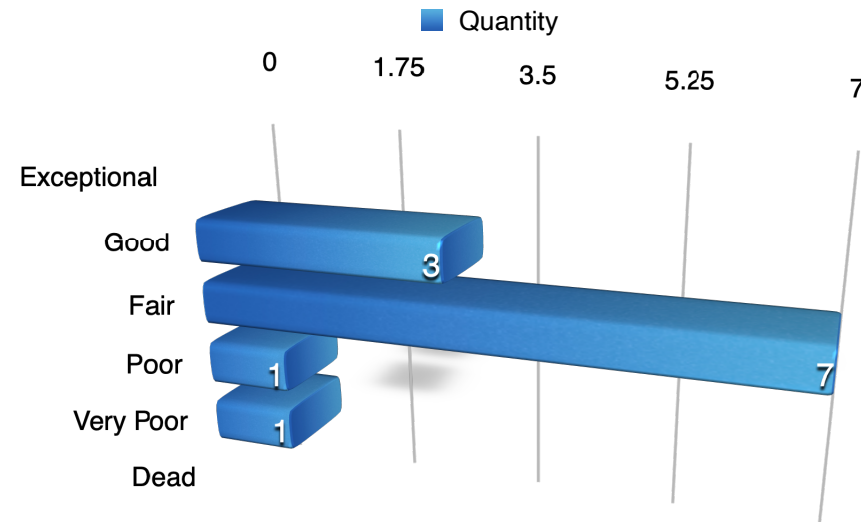
Chart 2: Condition Ratings

Three trees are in good condition and they are the newly planted coast live oaks in front with the exception of #749. Seven trees are in fair shape, one poor (#749), and one very poor (#254). Large Protected blue oak #254 is void of foliage and in irreversible decline. Black oak #275 and blue oak #252B have large columns of decay and the black oak leans.

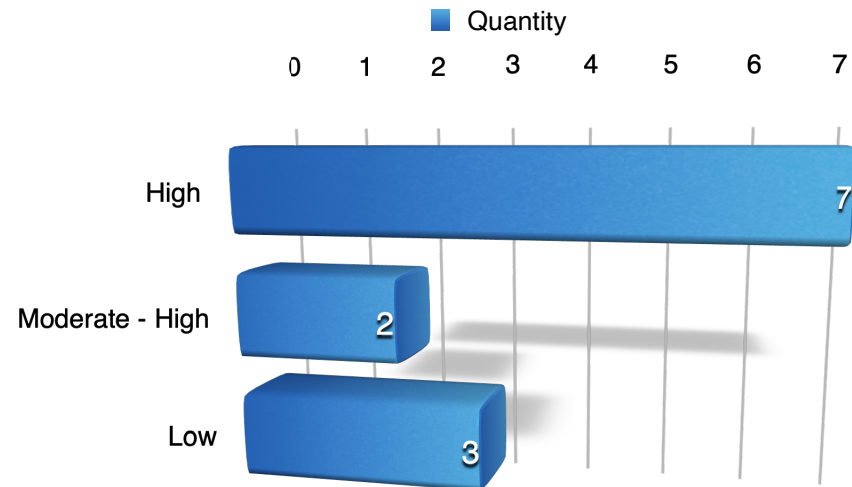
Chart 3: Expected Impact

Seven trees could highly impacted by the proposed plans including two Large Protected blue oaks #261 and #254. Tree #254 is in irreversible decline and may in fact be dead. Oaks #261 and #275 would be affected by the expanded garage while #257 and #254 are either adjacent to grading or within the footprint. I considered #275 and #252A to be moderate-highly impacted. The four coast live oaks in front #746, #747, #748, and #749 would all require removal or transplanting while #749 is a failed planting with a shifted root ball and leaning trunk. It may be possible to work around #261 and #254 or use alternative construction techniques to minimize impacts but as displayed these trees would be destroyed. The trees in front were all somewhat recently planted large specimens and

technically that could be lifted out of the ground and moved to another location if feasible and desired.
