"Hands On Tree Care"

2/11/2019

Re: Arborist Report for Proposed Development Project at 16 Chestnut Ave. in Los Gatos

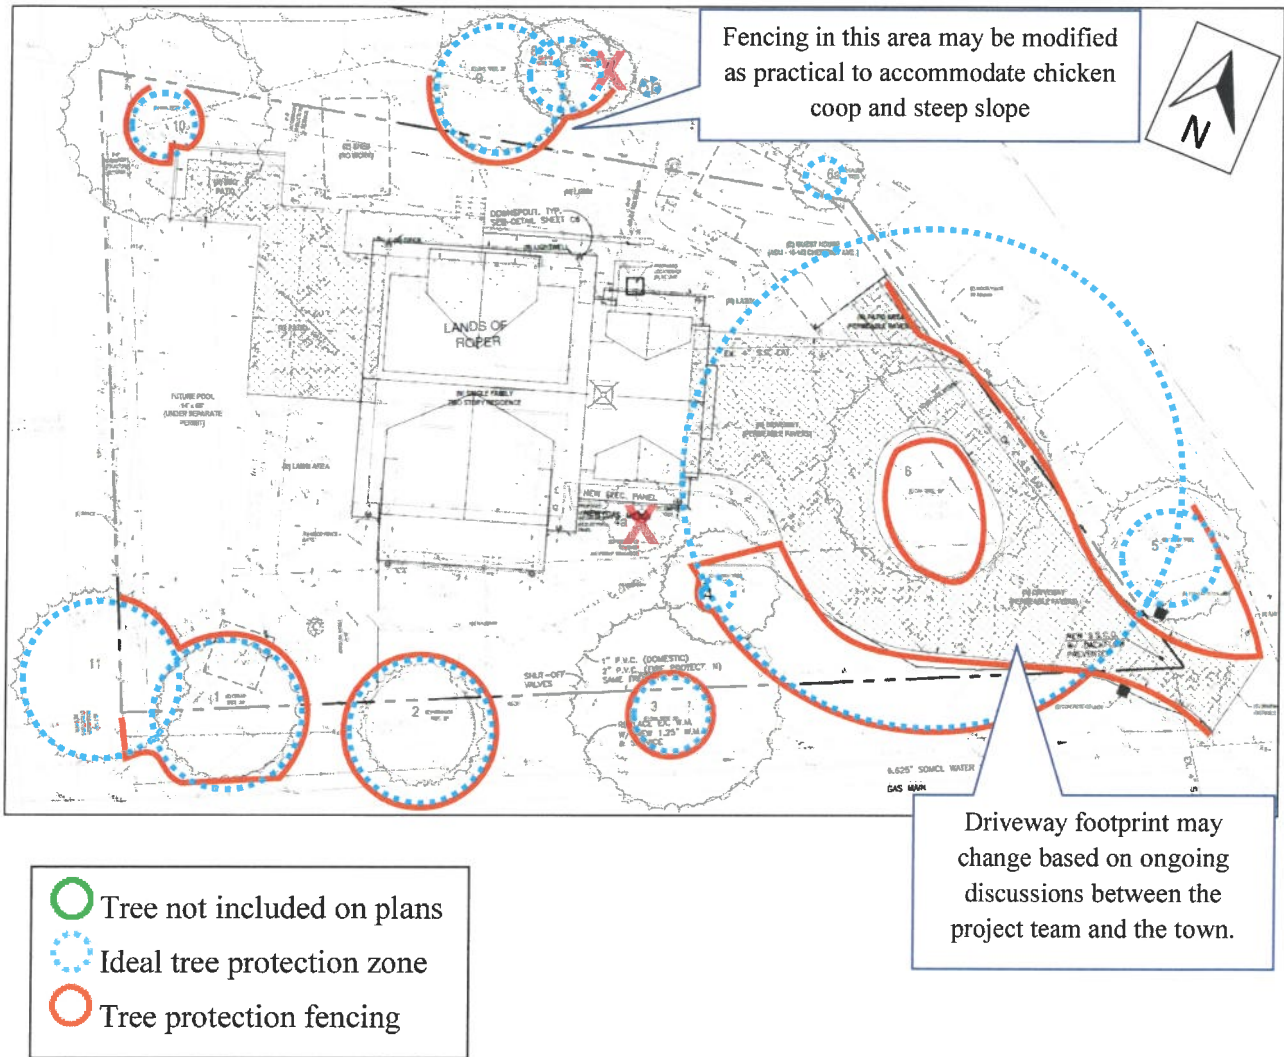
Tree Map (my features in color; scale roughly estimated)³

Two trees are recommended for removal: Chinese juniper #4A and coast live oak #7. Tree #4A lies at the corner of the existing house and would be substantially damaged during demolition. Tree #7 is dead. Each tree's canopy is approximately 15 feet in width, so the total replacement requirement is six 15-gallon trees.

Coast live oak #6 appears likely to decline irrespective of construction activities, but retention is desired by the property owner. This tree would benefit greatly from the removal of girdling roots and application of a growth regulator in the short term, and substantial site remediation after construction.
