**MACKINAC ISLAND FERRY COMPANY  
MAIN DOCK EVALUATION**

**CITY OF MACKINAC ISLAND  
MACKINAC ISLAND, MICHIGAN**

**January 2024**

I hereby certify that the structural inspection, conditions study and feasibility report for the above referenced location were prepared by me or under my direct supervision and that I am a duly Licensed Professional Engineer under the laws of the State of Michigan.

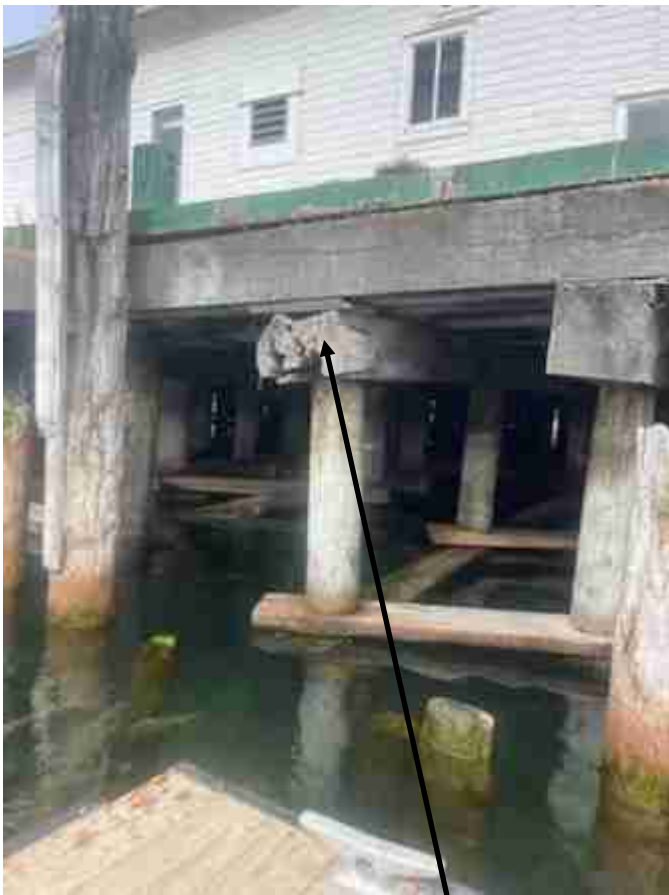
- 5) The main girder or cap beam that sits on the piles to help support the framing and deck above are deteriorated as shown in several photos. The supporting capability of these members is significantly compromised and is a safety concern.

**25) Dock (south) (west end)**  
Main girder deterioration

4. **Damaged bumper piles:** Several bumper piles have been damaged. The top of these piles should be removed and replaced with new.
5. **Main girder or cap beam:** Several cap beams have deteriorated beyond repair. These beams should be removed and replaced with new cap beams.

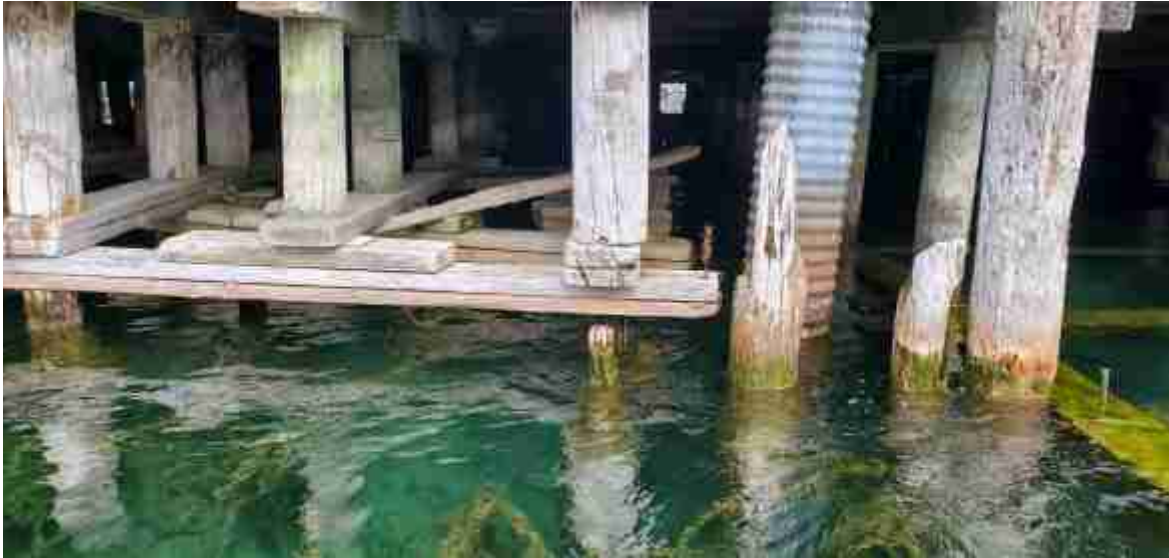
**106) North (east end)**

Excessive benching/missing or deteriorated piles

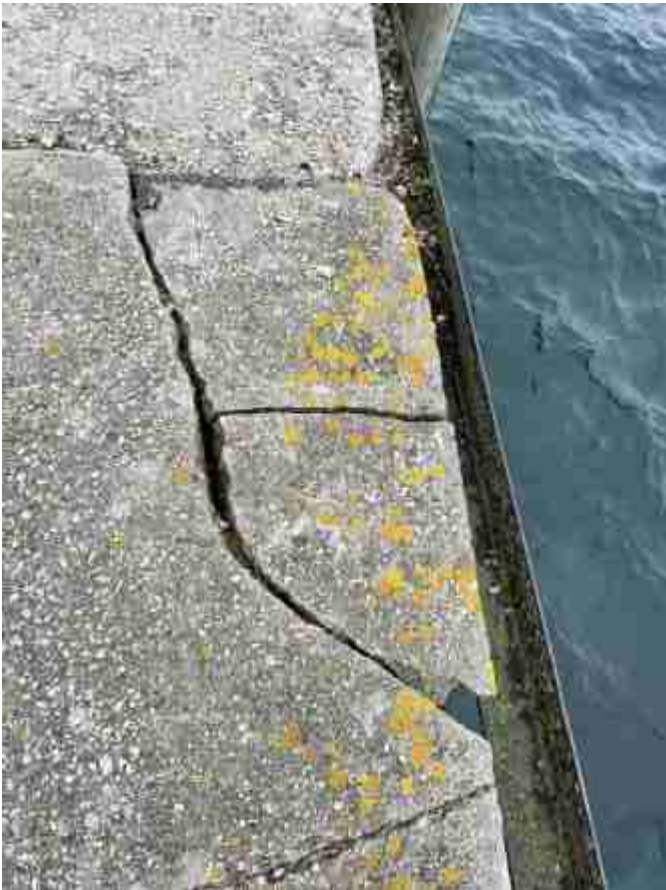
**123) Angle separation**

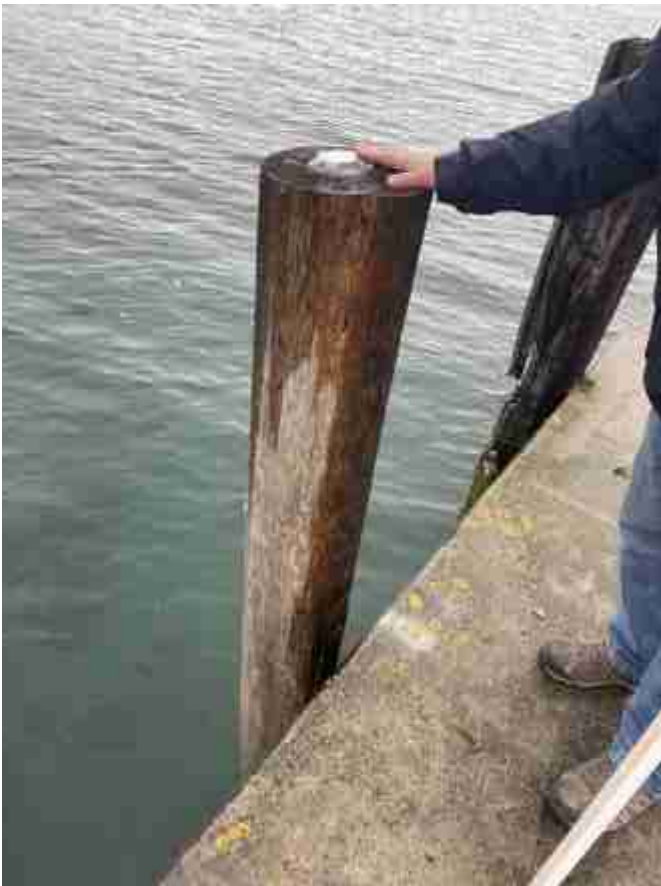
**136)** Bumper pile (north side)

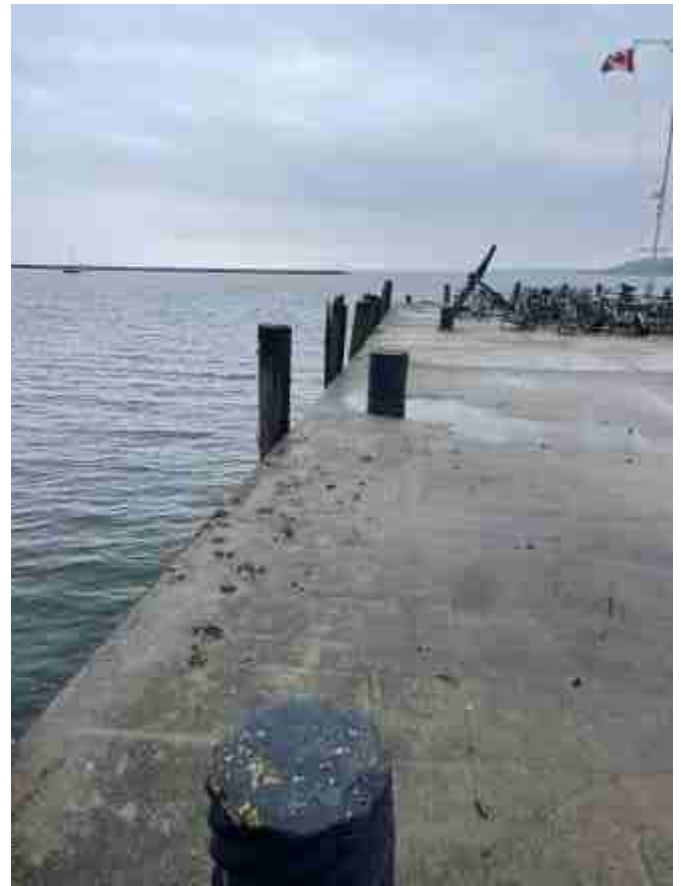
**137)** Bumper pile (north side)

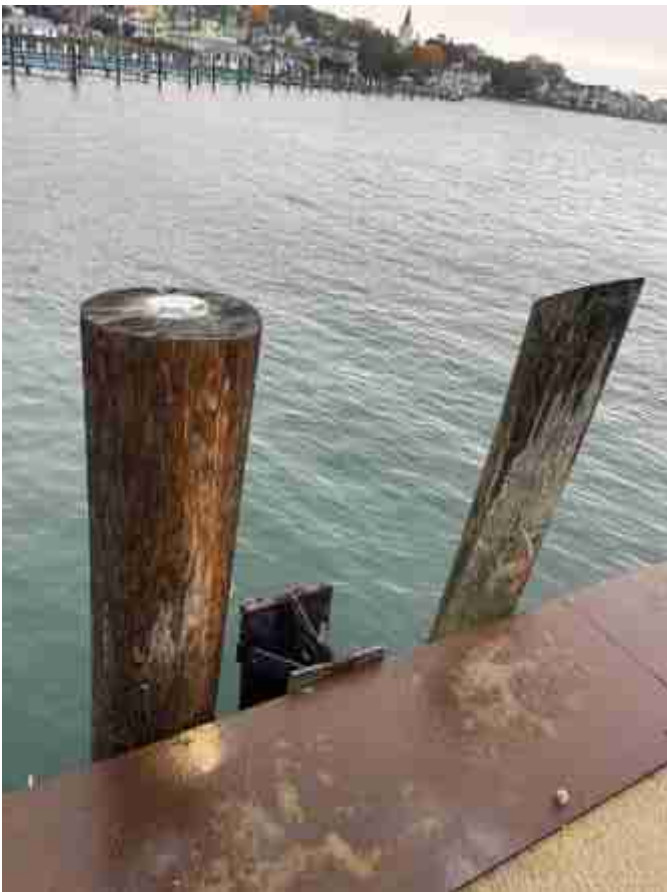
**139)** Reinforced deck (north side)

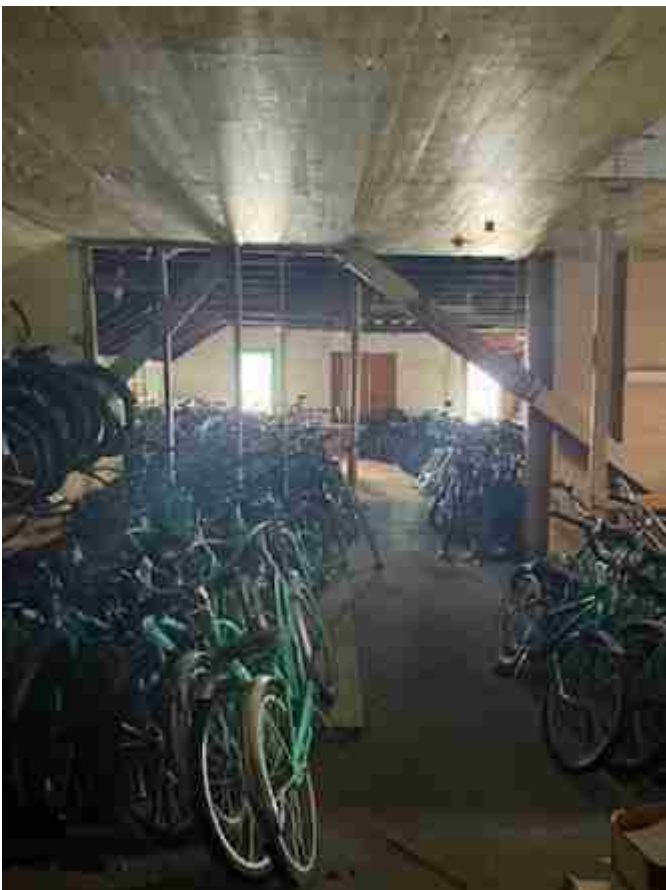
145) East end of warehouse with bike storage on the second level
