**FACILITY CONDITION REPORT: 250M CAPACITY - ELEVATED POTABLE WATER TOWER**

**MANGUM, OK - DOWNTOWN TOWER**

Potable Water Storage Tower (Location: Downtown Mangum, OK - Pigg St & Commerce)

12/14/2024 – Inspector: Alek Gray

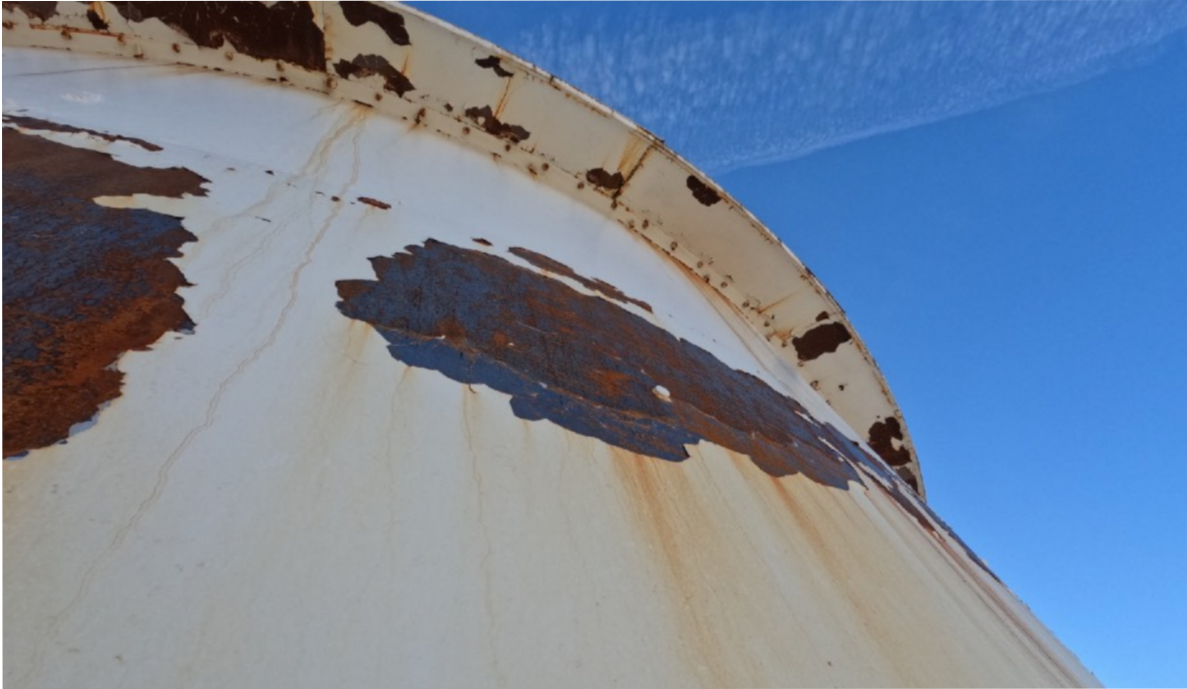
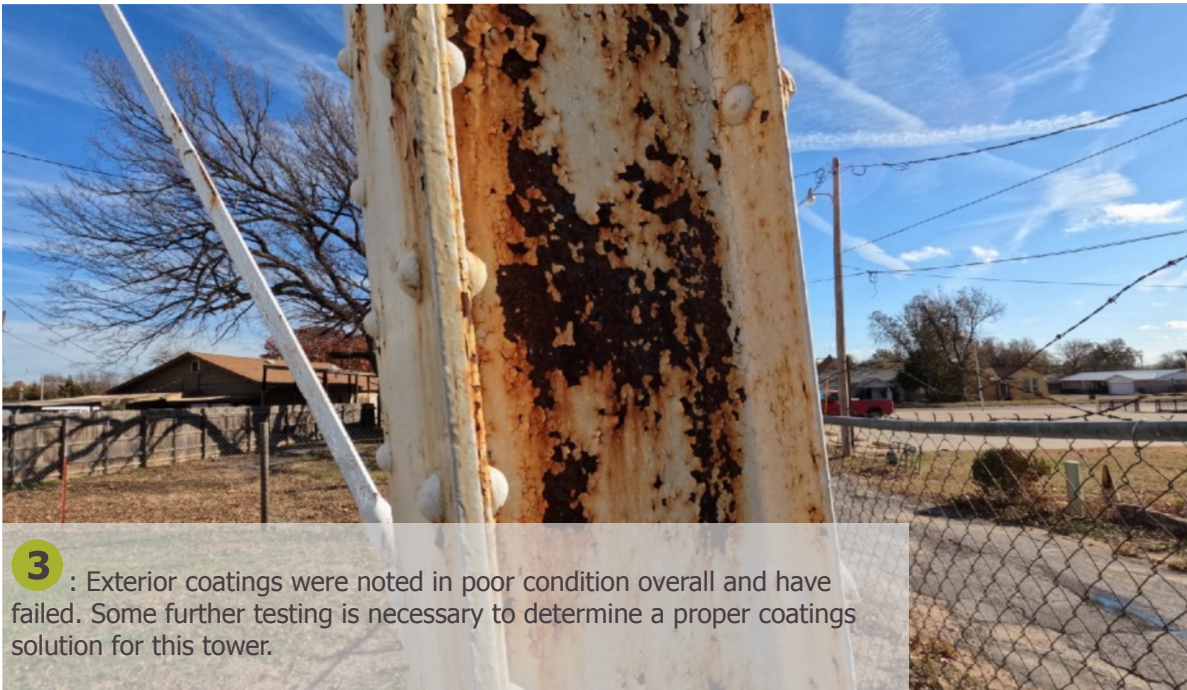
5

**2** : Coatings condition along the upper shell and roof eave.

<sup>5</sup> All coatings applications necessitate, at minimum, a cursory evaluation of existing coatings in effort to determine an appropriate preparation procedure, as there are several factors that are considered when making these procedural determinations. Coating specifications should be obtained by a selected paint manufacturer or engineer.

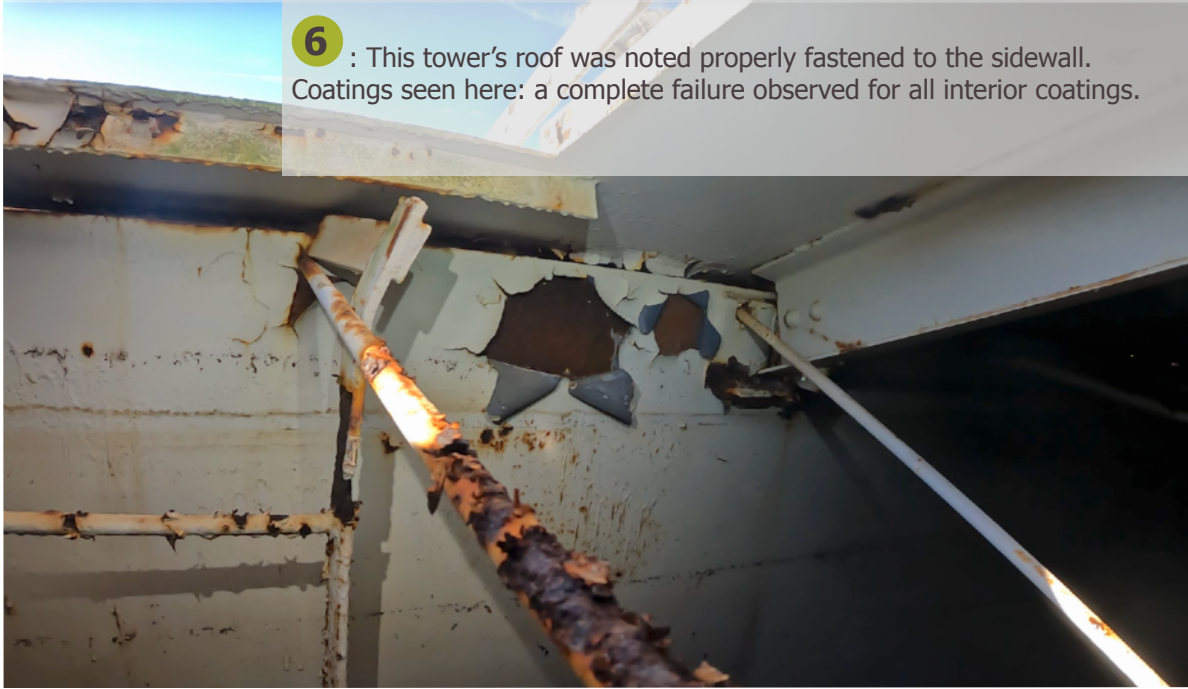
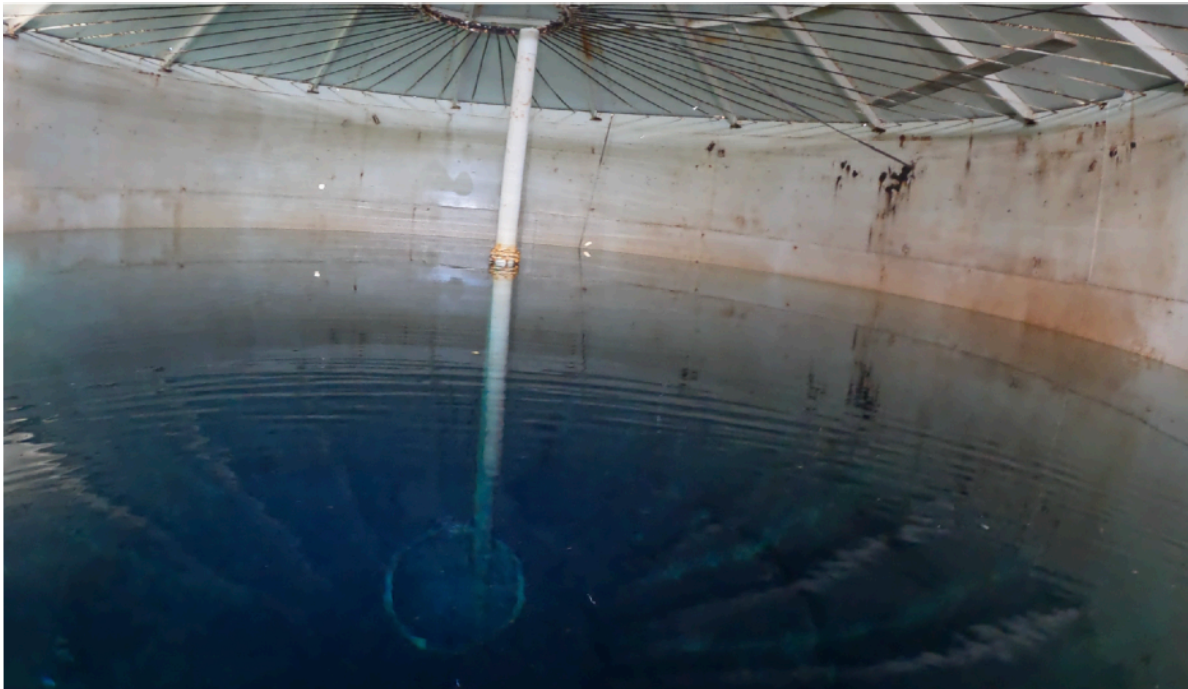
**5** : These rods seen here are the tower's original spider rods used for part of the rigging for the tower's construction. They are no longer necessary, and should be removed along with caulking the roof's lap joints and the opening between the roof and the sidewall seen here.
