# 2023 INFLOW & INFILTRATION INVESTIGATIONS PROJECT

## Preliminary Engineering Report

City of Manor  
Public Works Department

April 24, 2023

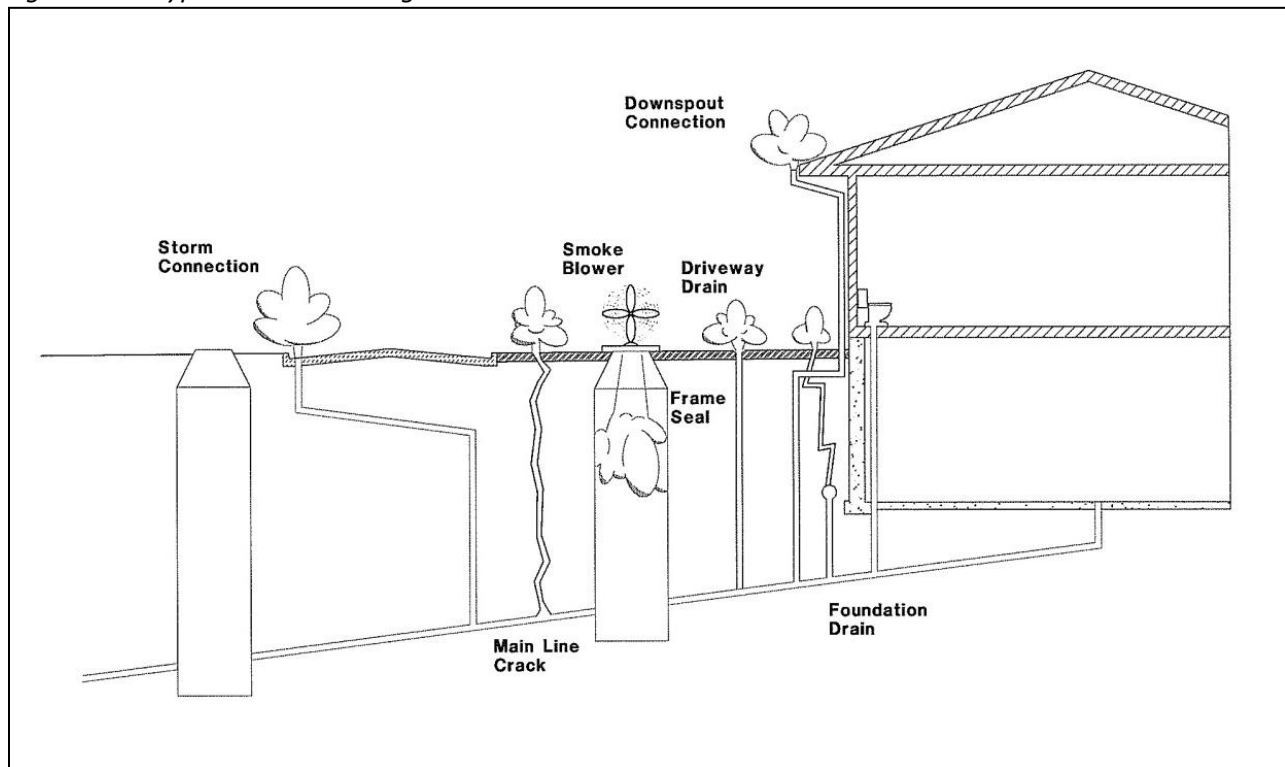
Figure 5-1 – Typical Smoke Testing Sources

Smoke testing is typically performed on sewer segments by introducing a non-toxic heated liquid smoke into the collection system. The smoke is forced through the system with a gas-powered blower. The smoke exits the system at locations where rainfall or groundwater can enter. A three-person crew visually inspects areas tributary to the line segment. Typical I&I sources identified during smoke testing are shown on Figure 5-1.

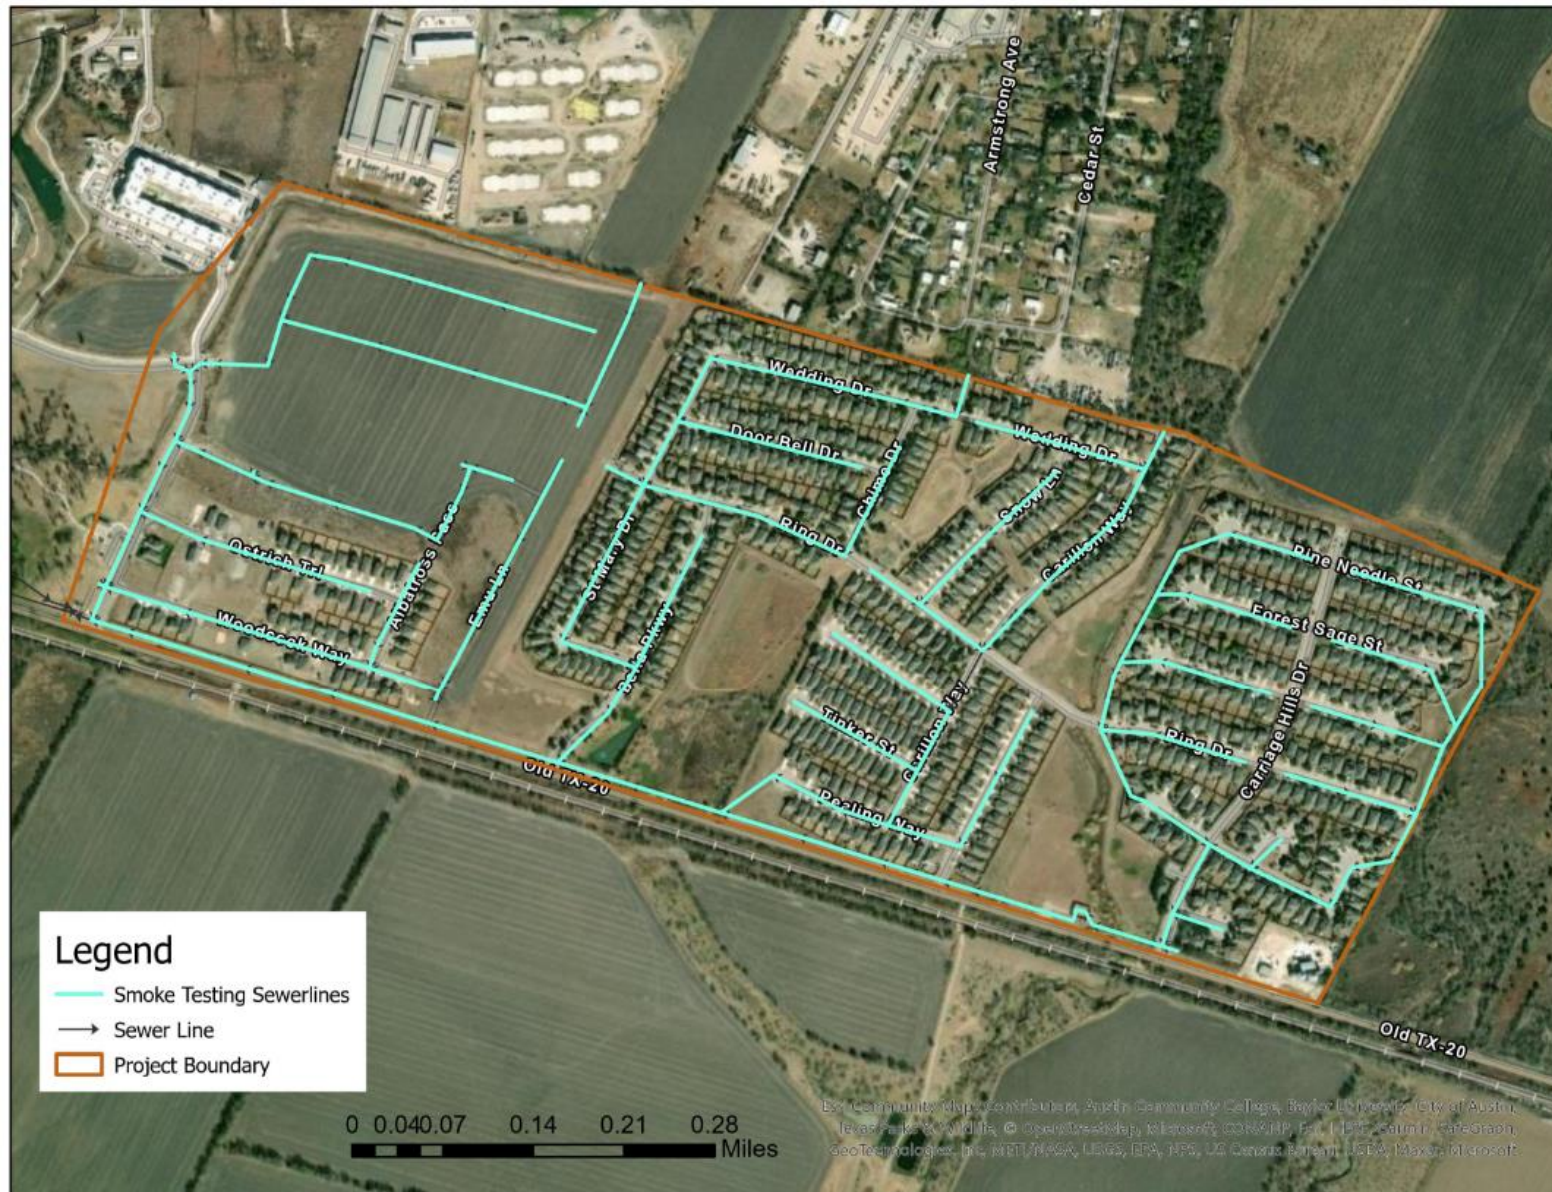
Figure 5-2 – Smoke Testing Lines

A total of 280 positive, 12 negative, and 1 suspect sources were identified during this process. Figures 5-2 and 5-3 show the lines smoke tested and the locations of the smoke sources identified during testing, respectively. All smoke testing sources are also included in a Table in Appendix B.
