July 31, 2025

PROJECT NO. MDBCH25002

**RE: LIMITED STRUCTURAL FLOOD HARDENING STUDY OF MADEIRA BEACH CITY HALL
MADEIRA BEACH CITY HALL RENOVATION & FLOOD HARDENING
300 MUNICIPAL DR.
MADEIRA BEACH, FL 33708**

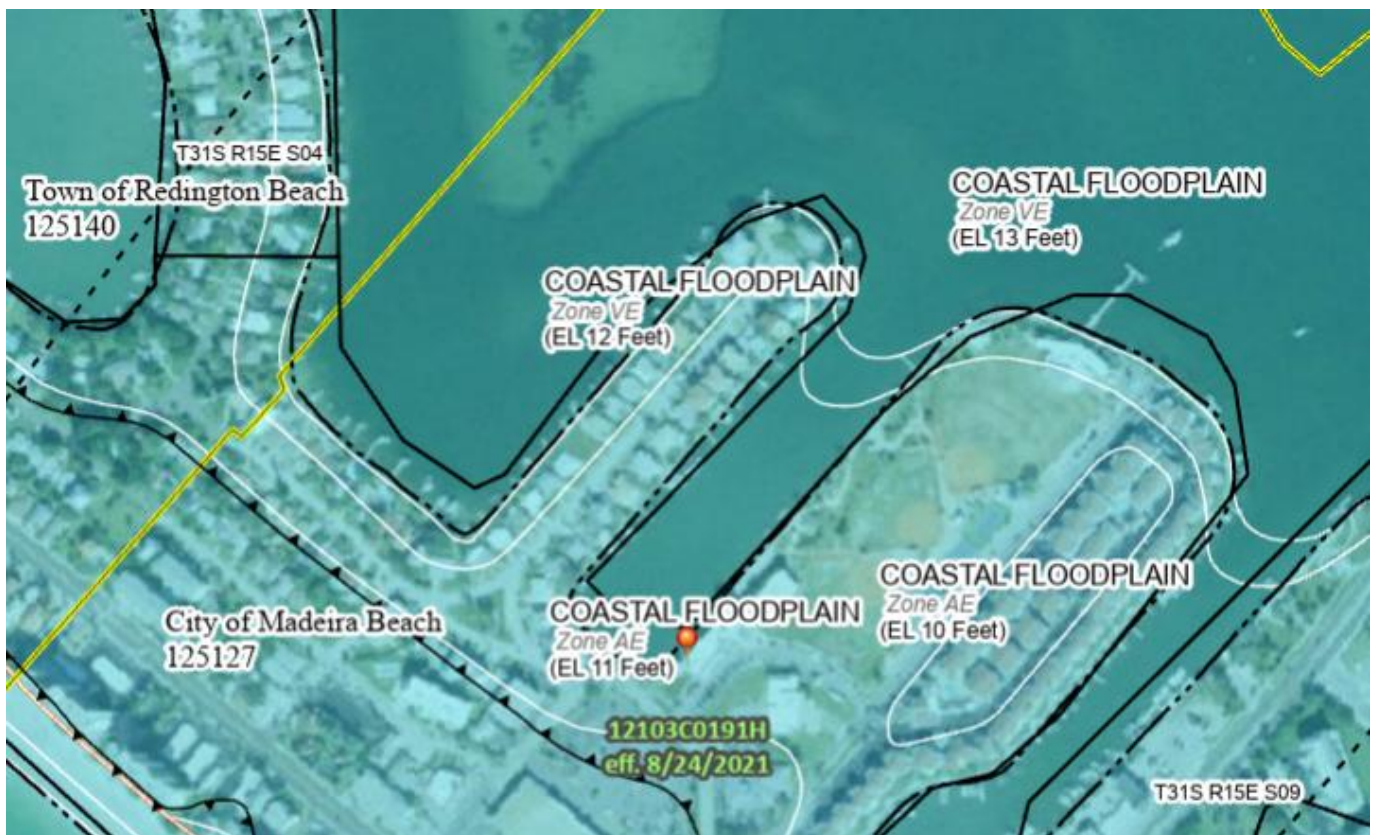
Figure 3 – Enlarged Area of Current FEMA Map

According to 2023, Florida Building code and latest FEMA maps, the subject building now located in a FEMA Special Flood Hazard Area Zone **AE11** in a coastal floodplain seaward of the Limit of Moderate Wave Action according to FIRM map dated 01-23-2025. The design flood elevation in Madeira, after adding the required freeboard of BFE + 4', is **15'**. It is recommended that an updated flood elevation certificate is obtained prior to proceeding with repair drawings to confirm current requirements. The current FEMA flood map is in **Exhibit C**.
