# Administrative Tree Activity Permit

Steve Burnstead  
116 Overlake Dr. E  
Medina, WA 98039

**Property Map: 116 Overlake Dr. E, Medina 98039.**

## Shoreline Tree Hazard & Mitigation:

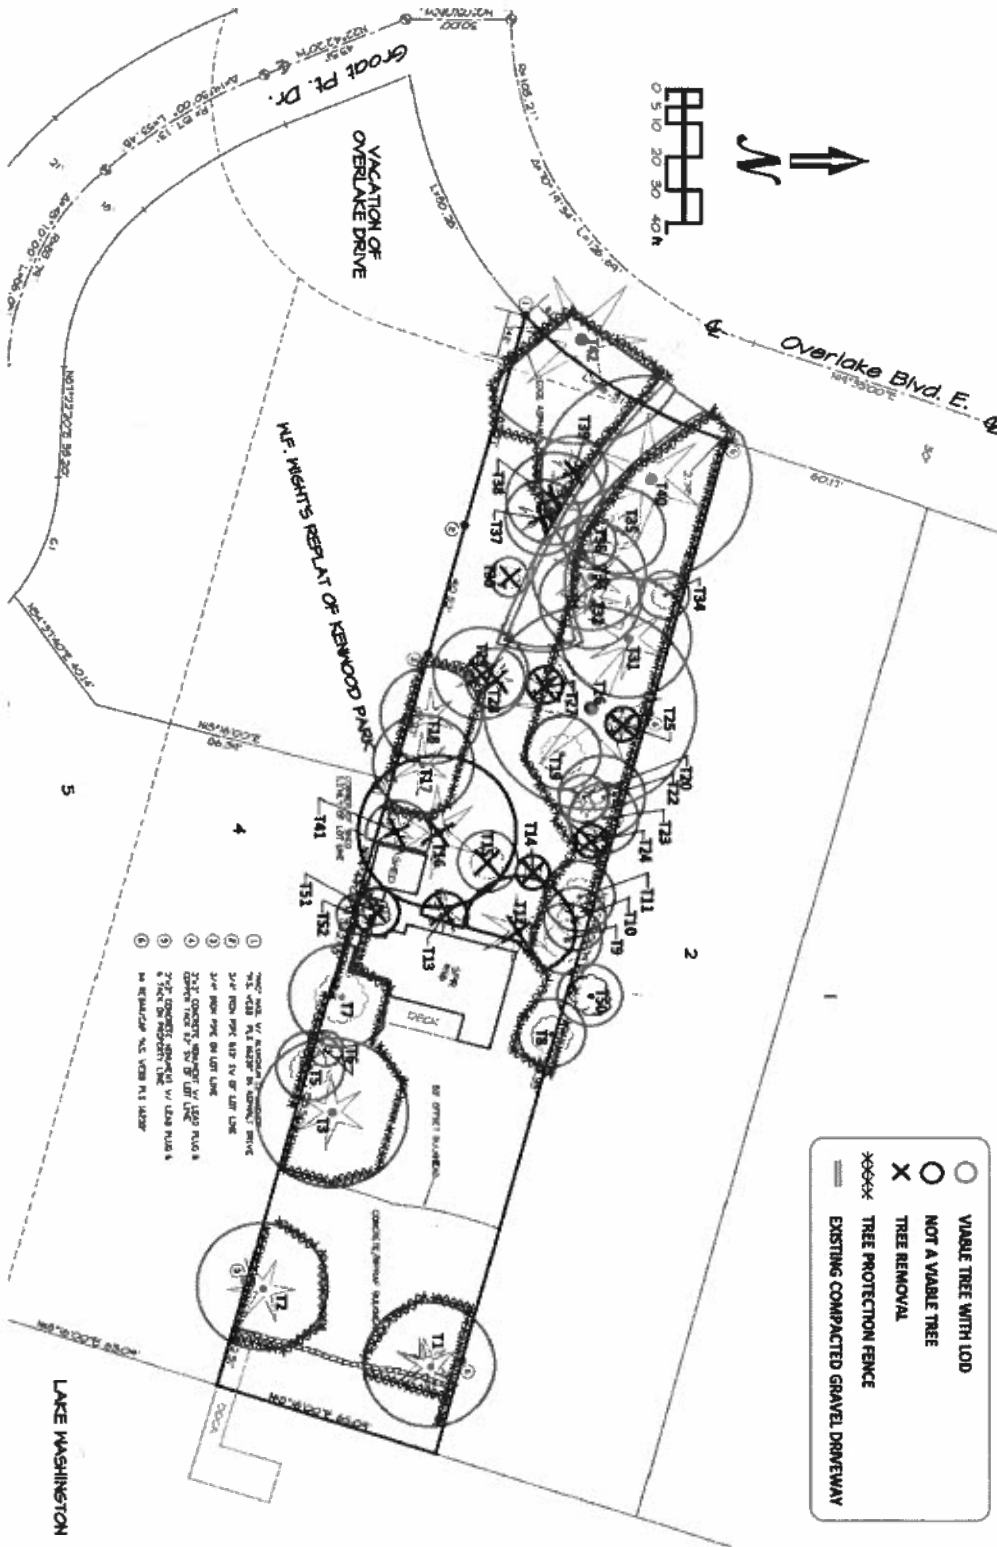
In order to maximize space for driveway and housing, with proper site conditions, development can encroach within the trees' LODs. 30% disturbance of the outer root zones can be allowed. The outer root zone is the area around the tree from the LOD line and half the distance to the trunk. For example, T26 can withstand the root disturbance on the outside of the protective fencing, displayed on the site map, last page. The resulting root disturbance for T26 is less than 30% of the root zone and not within the inner root zone.

Protective fencing is encouraged around the perimeters of the LOD for each retained tree, or grove of trees during grading and construction. Chain-link fencing is recommended for tree protection to preserve the trees from soil disturbance due to machines, foot traffic, and materials. Grading and construction should not be allowed within the protected area of retained trees unless approved by a Certified Arborist.
