Public Works Building Facility Conditions Assessment

AB6402 | February 6, 2024

Public Works Building: Facility Conditions Assessment Findings

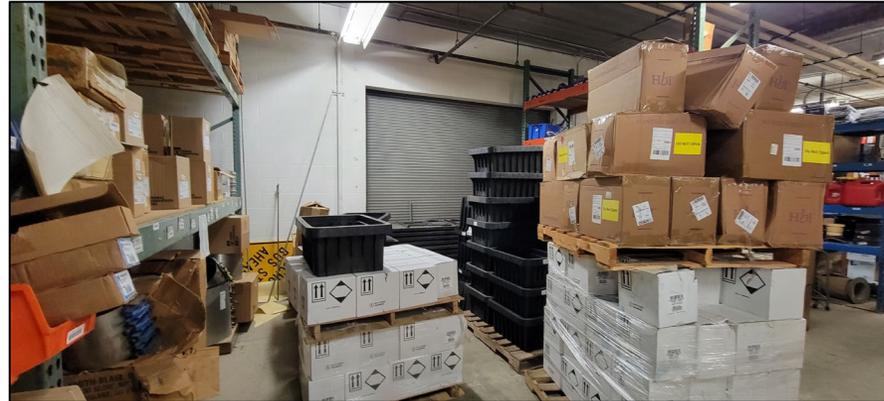
- The building does not have a fire suppression system.
- The existing system is comprised of fire/heat **detection** only.
- This is of particular concern in the Mechanic's Shop and Warehouse where flammable materials and liquids are stored.
