City of Mercer Island

# ADA Transition Plan

2022

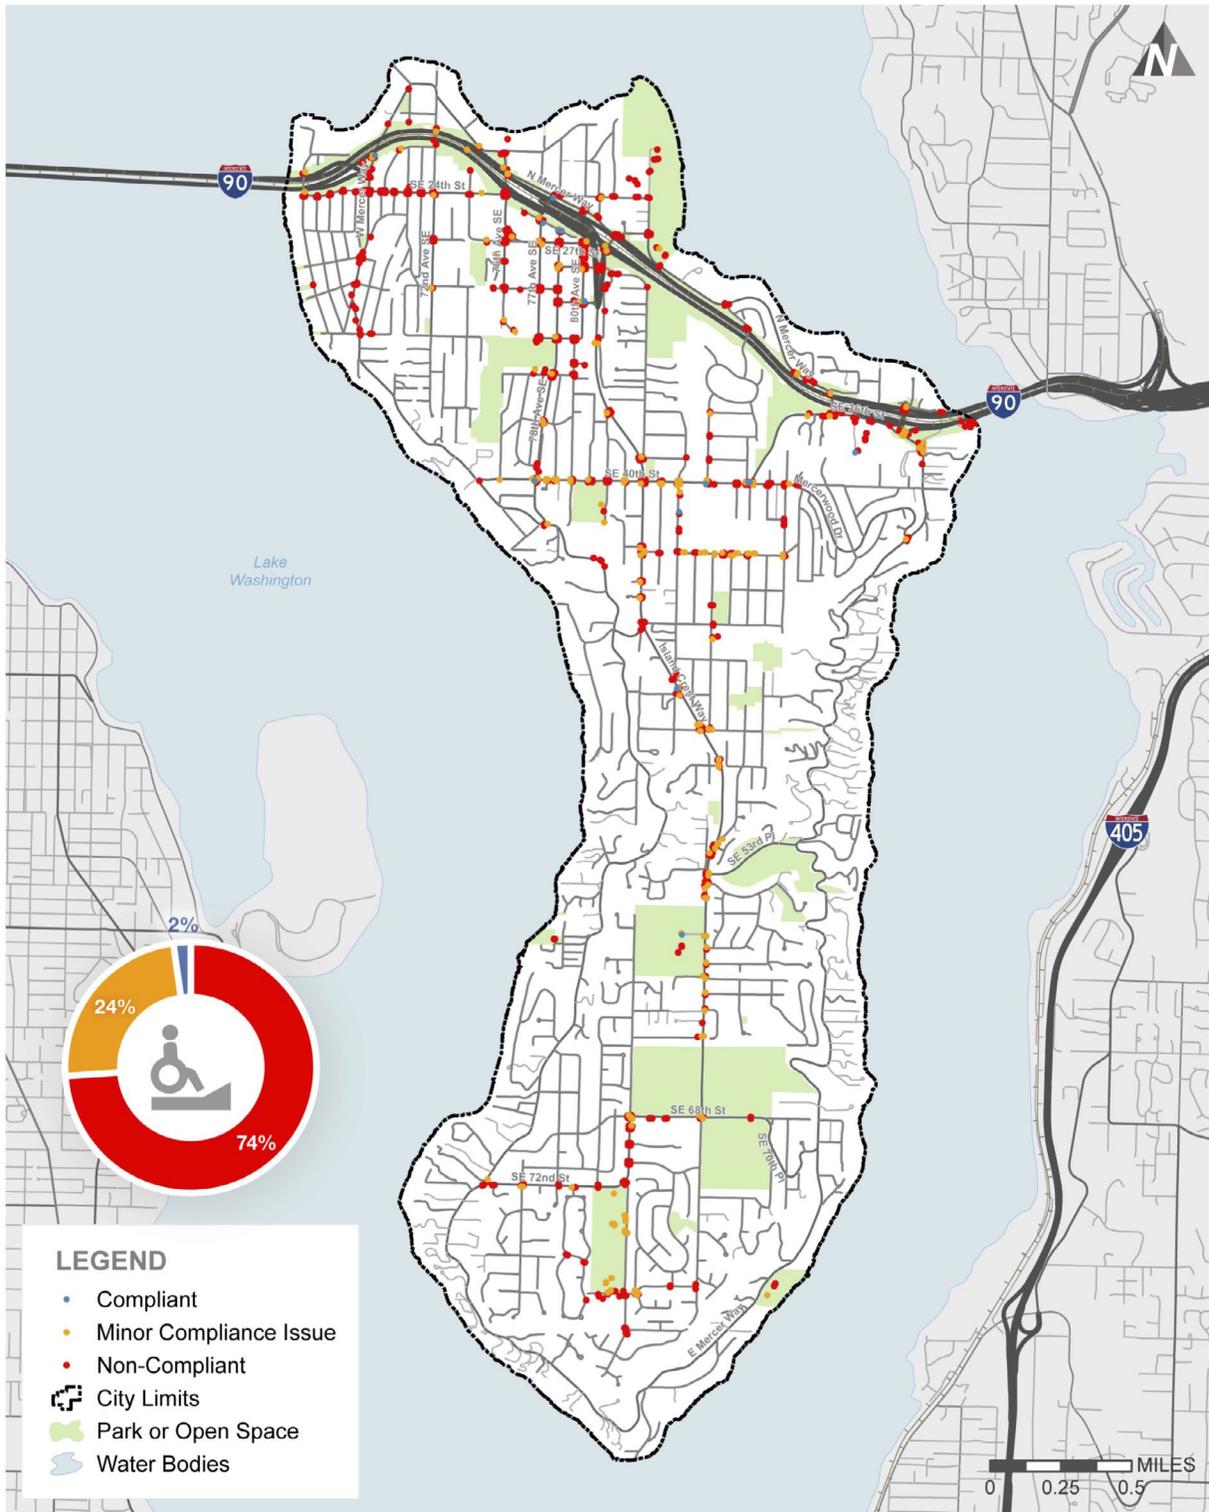
## Non-Compliant Curb Ramp

Curb Ramp Compliance	Total	
	Miles	% of Total
Significant Compliance Issue	589	74%
Minor Compliance Issue	187	24%
Compliant Ramps	16	2%
<b>Total</b>	<b>792</b>

Curb ramps are designed and constructed to tie into the existing roadway. As noted previously, steep or otherwise constrained locations may make it infeasible to meet ADA grade standards. When it is not feasible to remove all curb ramp barriers, ramps may be built to the maximum extent feasible (MEF) to satisfy ADA requirements. This planning level Self-Evaluation did not examine whether non-compliant ramps were built to the maximum extent feasible. See Section 5.1 for additional information regarding MEF documentation.

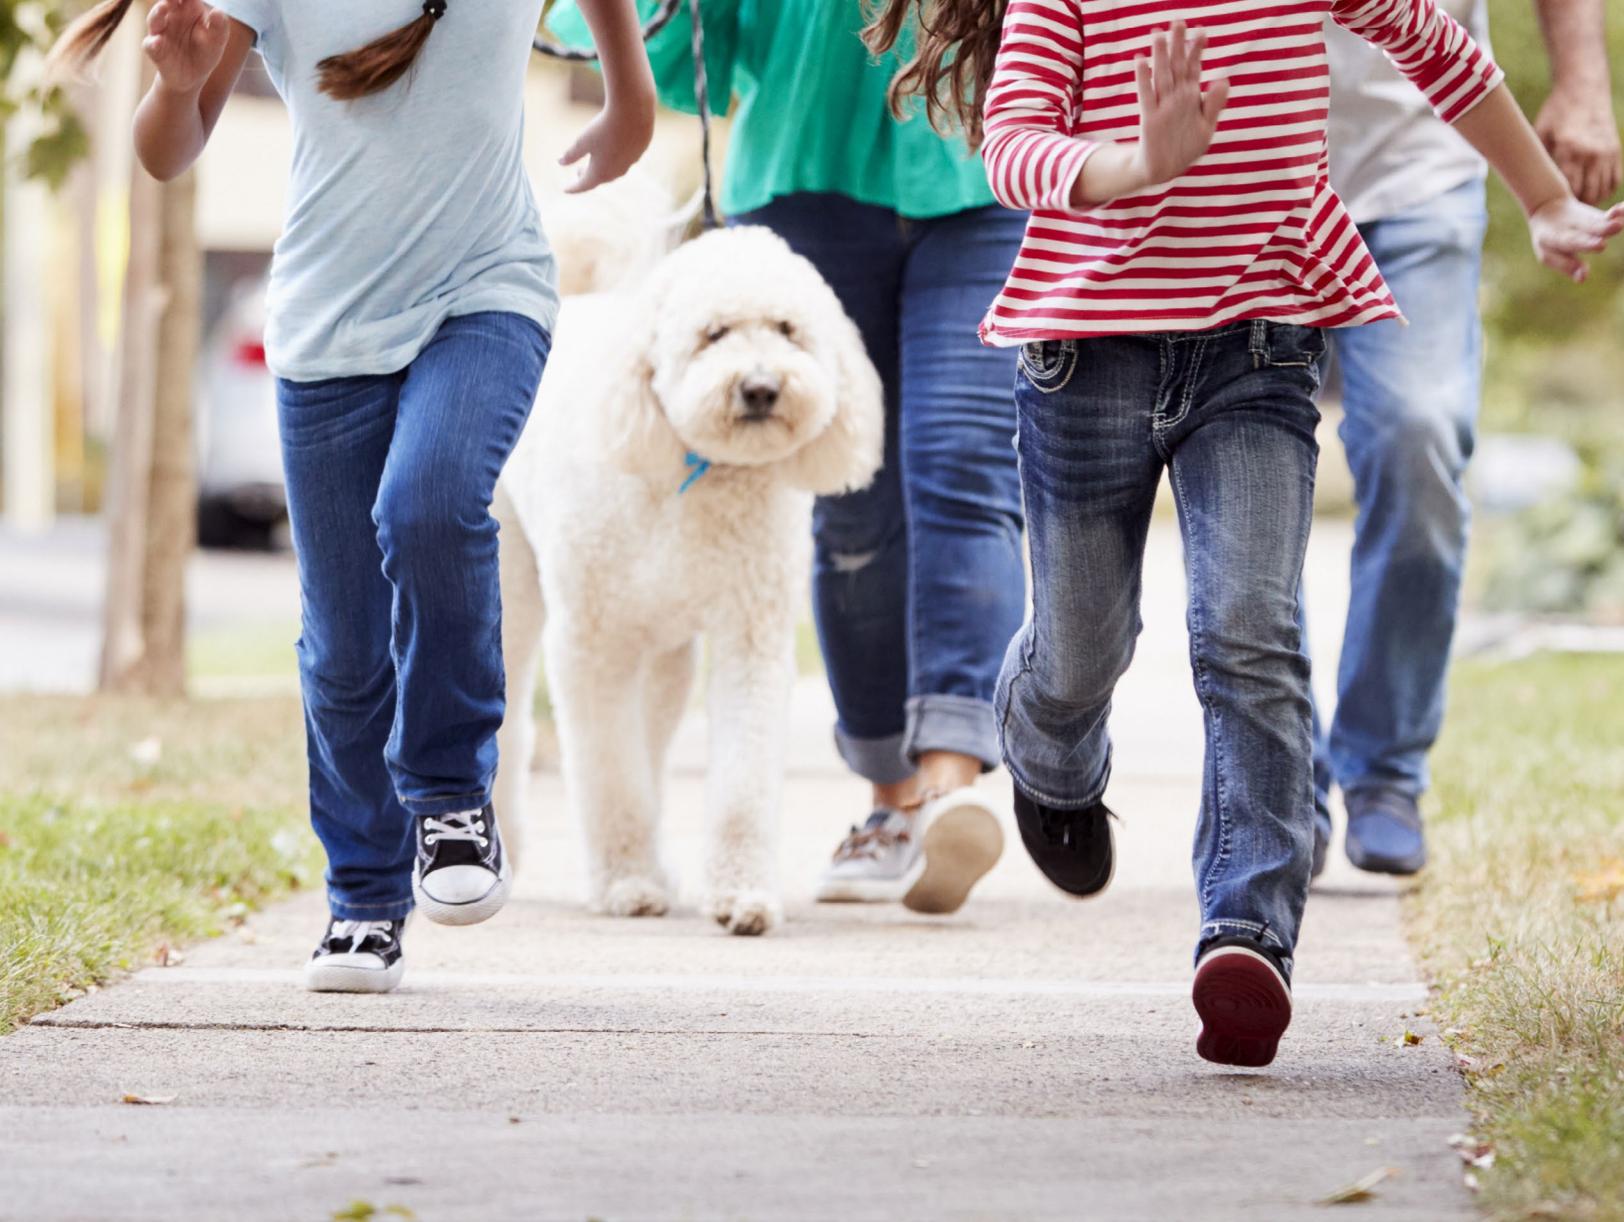
Approximately 34 miles of sidewalk were inventoried with approximately 98% not meeting ADA standards (see Table 2-2 and Figure 2-12). Grinding, patch repair, and full reconstruction are potential solutions for removing the sidewalk barriers depending on the severity of the barrier.

Sidewalk Compliance	Total	
	Miles	% of Total
Significant Compliance Issue	1	3%
Minor Compliance Issue	32	95%
Compliant	1	2%
<b>Total</b>	<b>34</b>

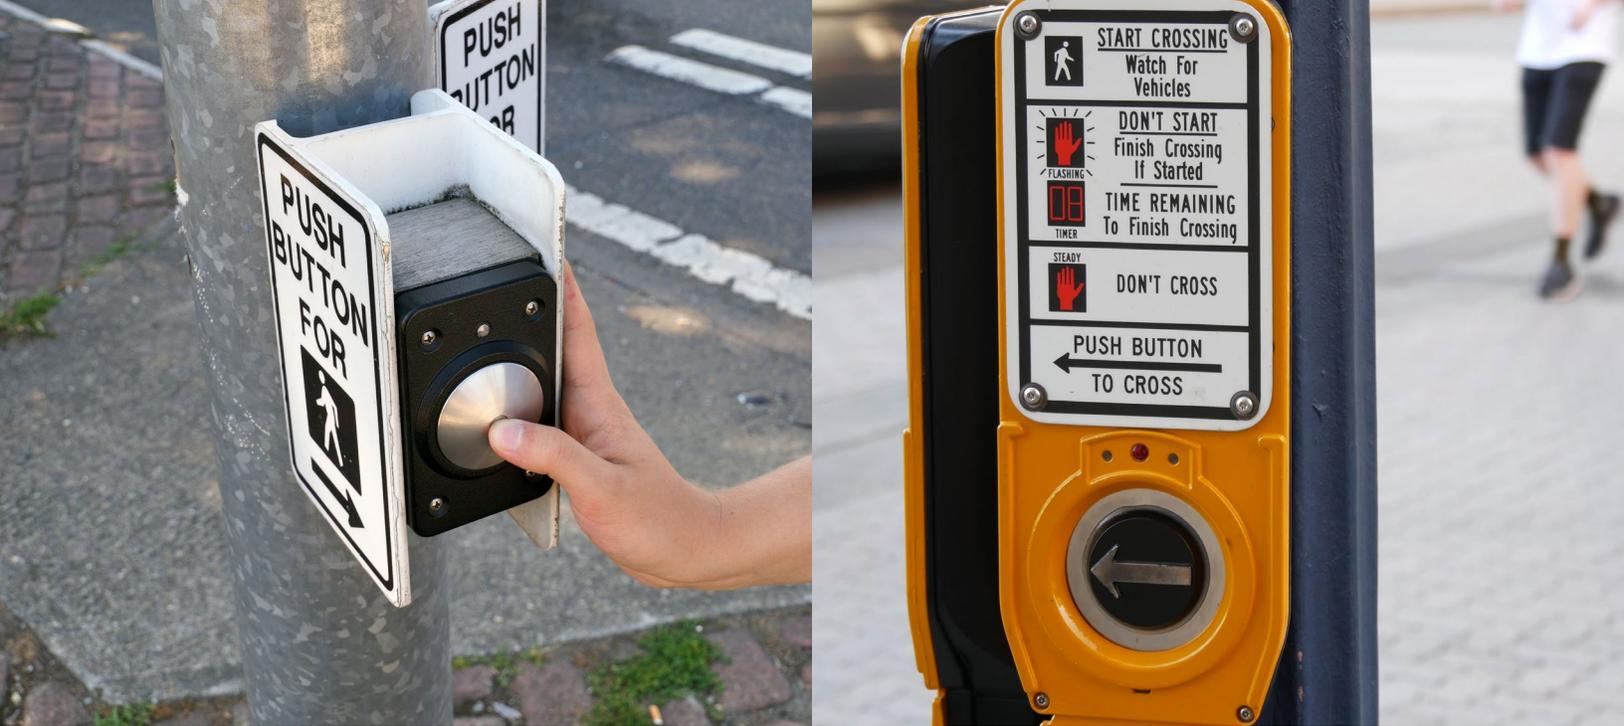
Figure 2-17 “H-style” (left) and APS-style pedestrian pushbutton (right)

All of the 84 inventoried pedestrian pushbuttons were not fully ADA compliant. The non-compliant pedestrian pushbuttons include non-APS style buttons to be replaced and APS-style buttons to be reprogrammed or relocated.

Approximately 86% of pedestrian pushbuttons in the city are an older “H-style” design (see Figure 2-17 top). This style of pushbutton can be upgraded to increase accessibility but must be fully replaced with an accessible pedestrian signal (APS)-style pushbutton to achieve full ADA compliance (see Figure 2-17).

The requirement to use APS-style pushbuttons is relatively new and lack of compliance is typically due to a crossing not being upgraded over time to reflect evolving requirements. Pushbuttons are typically upgraded to APS-style in groups rather than individually. As a result, APS-style additions and upgrades usually occur on an intersection-by-intersection basis.

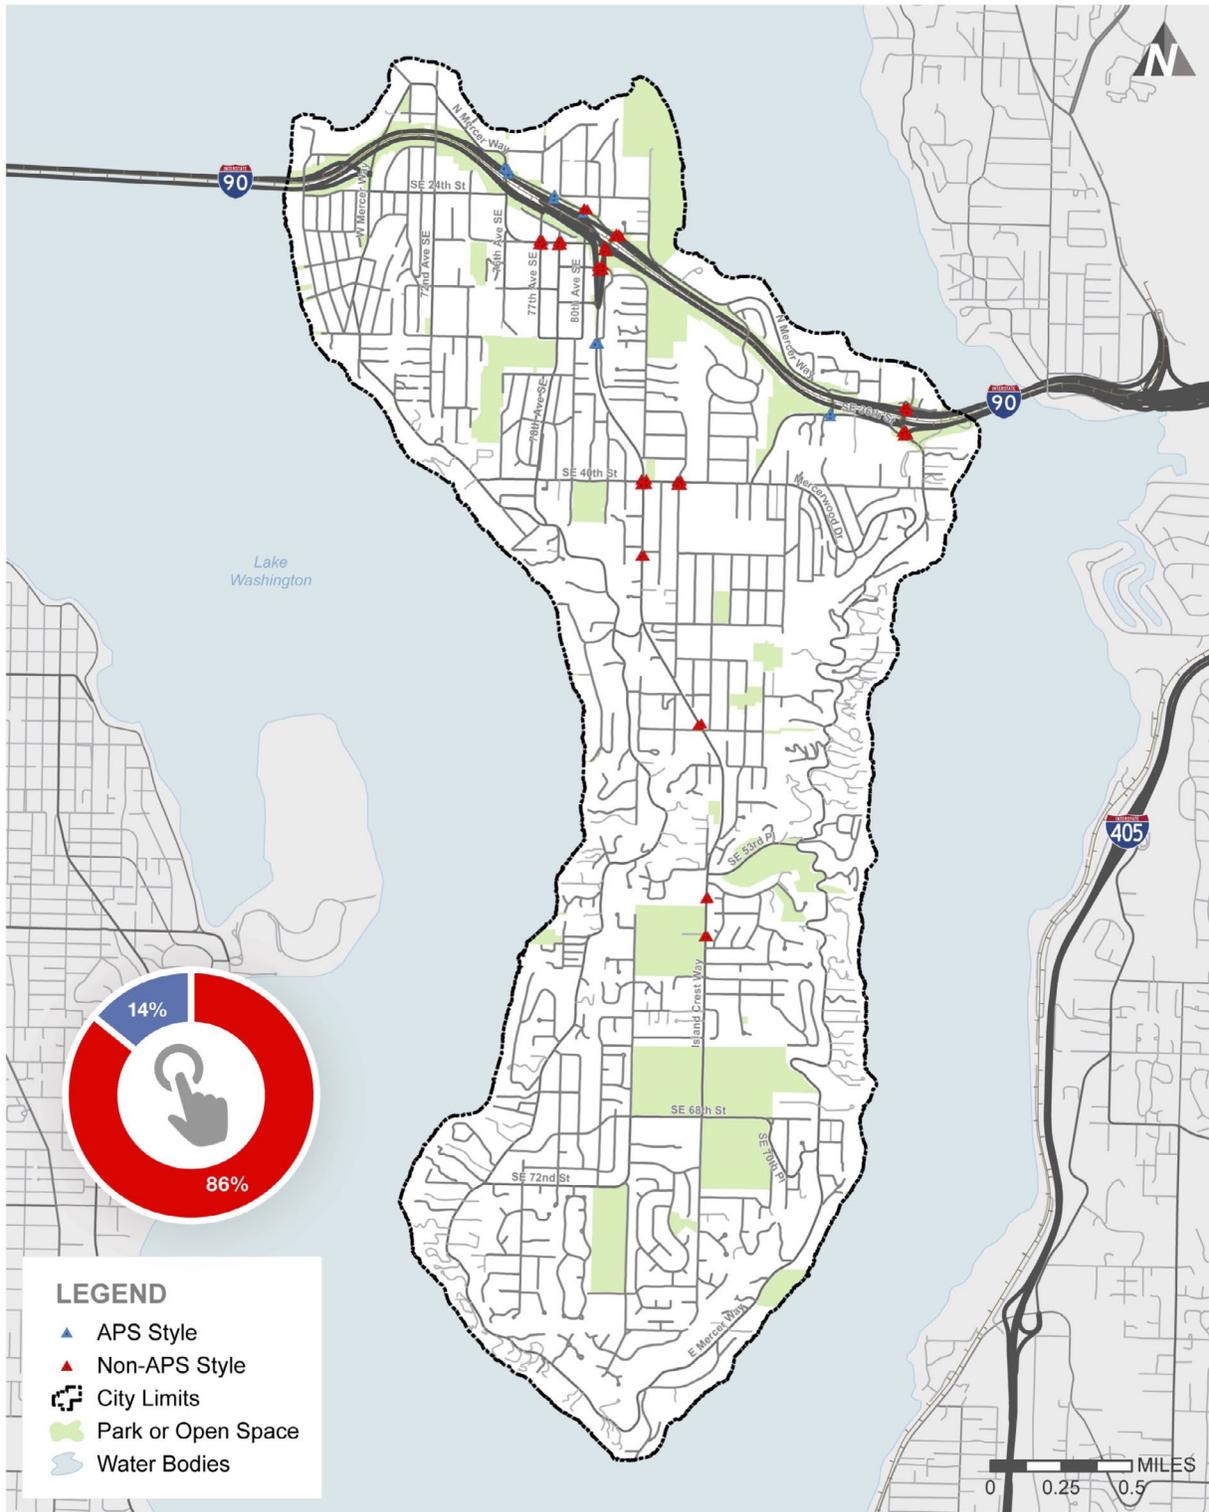
## Signal Push Buttons: APS and Non-APS

Figure 2-18 demonstrates the type and locations of these pushbuttons throughout the city.

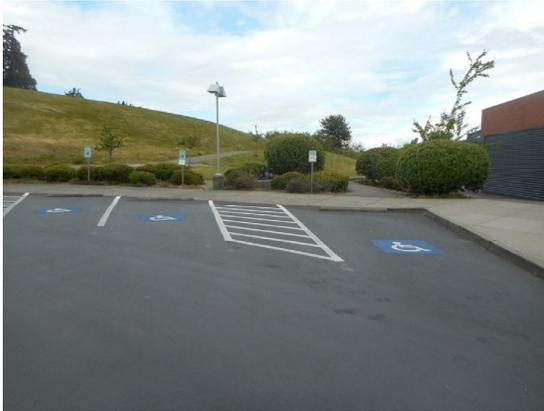
Upper Left: Accessible parking signs are mounted too low.

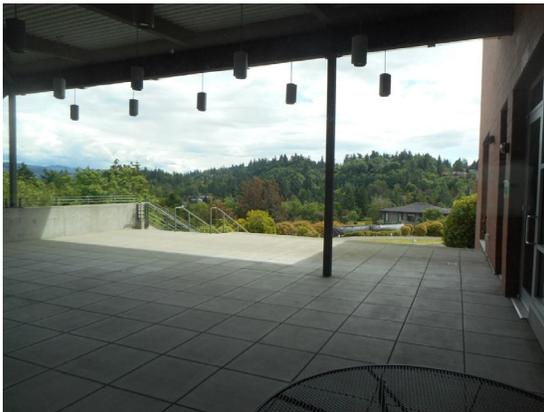
- Upper Left: Terrace does not provide edge protection &/or a guardrail between terrace and seating steps.
- Upper Right: Door between Mercer Rm. & Landing Rm. is recessed 11", and does not provide the required clearance on the push side.
- Lower Left: Fire alarm pull stations are mounted too high. 48" max. AFF required.

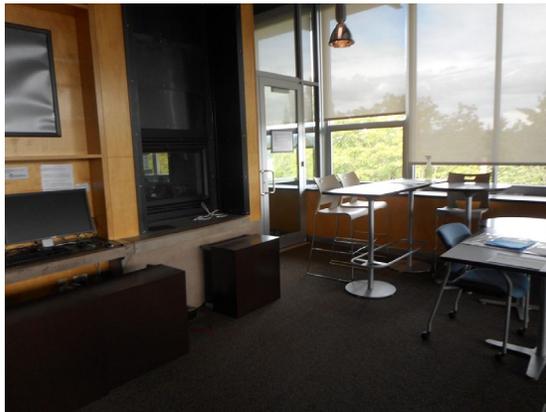
- Upper Left: Landing Rm. & Game Rm. require tables with accessible seating.
- Upper Right: Numerous door have 7-1/2" high bottom rail with hold open devices. Bottom surface of door on push side is required to be a smooth surface to 10" AFF.
- Lower Left: Surface mounted latching mechanisms obstruct the required 10" bottom smooth surface required on the push side.

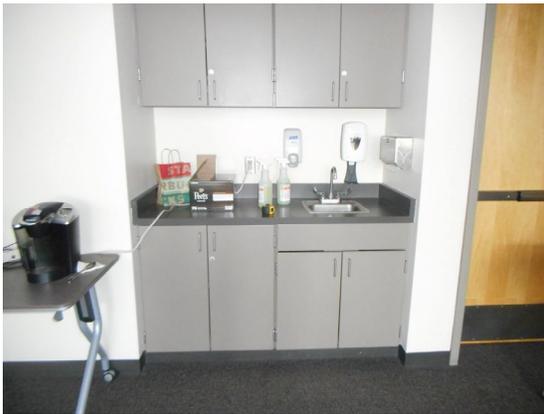
- Upper Left: Entry level meeting rooms have countertops with sinks above the required 34" max. AFF height, and do not provide the forward approach knee space below sink.
- Upper Right: Slater Rm. public restroom does not provide an accessible stall of the min. required size.
- Lower Left: Mercer Rm. above countertop outlets and switches are not accessible for a side reach.

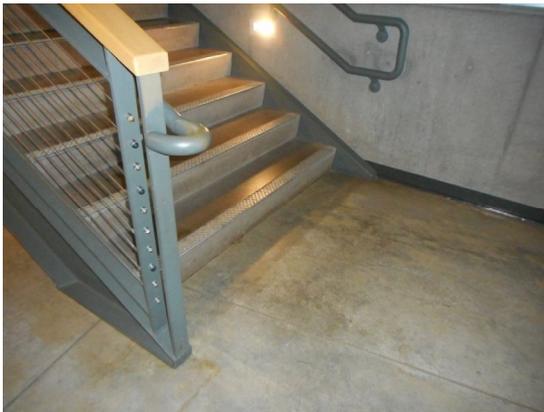
- Upper Left: Stair handrail protrudes into the accessible route.
- Upper Right: Gymnasium does not provide an accessible drinking fountain at required height, and with a forward approach knee space.
- Lower Left: Fitness Rm. drinking fountain is mounted at standing person height. An accessible drinking fountain at required height, and with a forward approach knee space is required.

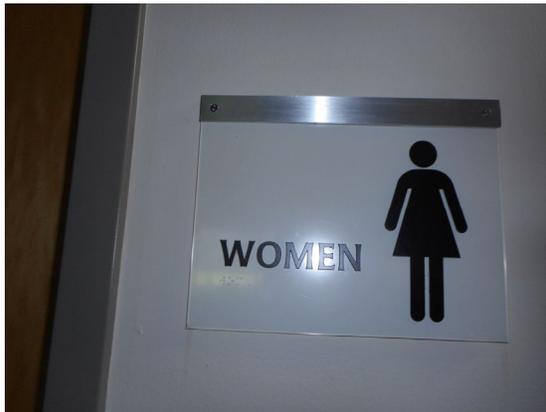
- Upper Left: Restroom signage does not provide the International Symbol of Accessibility.
- Upper Right: Locker room benches do not provide the required back support, and are not of the required size for accessibility. Each locker room requires an accessible bench.
- Lower Left: Toilet in the accessible stall is required to be 16" min. - 18" max. from the side wall. Many of these toilets are mounted too far from wall.

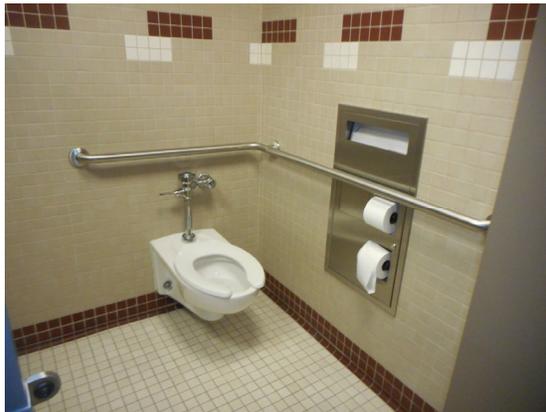
- Upper Left: The length of the L-shaped grab bar section behind toilet is too short. Many grab bars are mounted too high. 1-1/2" between the grab bar and adjacent surface is required. Dispenser encroaches on clearance.
- Upper Right: Height of the sink rim exceeds the max. 34" AFF.
- Lower Left: At least one of the large lockers must be accessible.

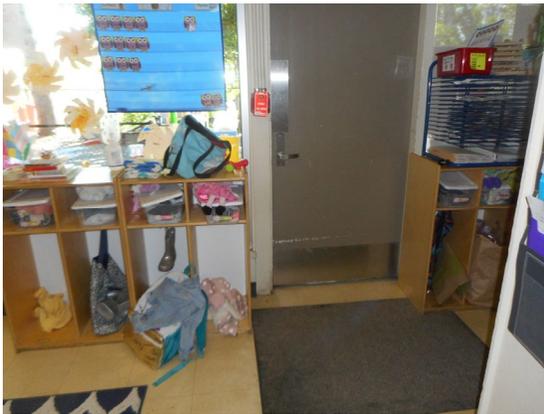
- Upper Left: Cabinetry blocks the required door maneuvering clearance at Daycare entry door.
- Upper Right: Wall mounted cabinets protrude into the required clear floor space at toilet. The length of the L-shaped grab bar section behind toilet is too short.
- Lower Left: Picnic tables in Daycare Center do not provide an accessible seat.

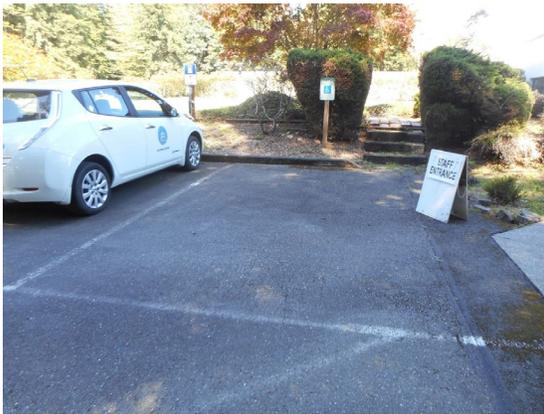
- Upper Left: Accessible parking sign is required to be remounted to 60" min. above pavement to bottom surface.
- Upper Right: Entry door lacks the required maneuvering clearance space.
- Lower Left: Entry door hardware is mounted above accessible reach.

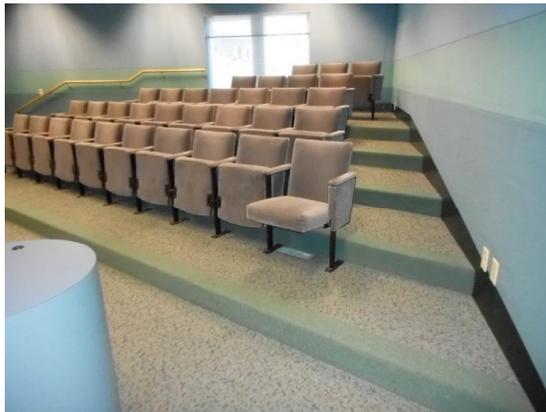
- Upper Left: Council Room requires accessible seating adjacent to a companion seat.
- Upper Right: Speaker's podium in Council Room to provide a forward approach to accessible microphone.
- Lower Left: Ramp to judge's platform in Council Room requires additional handrail.

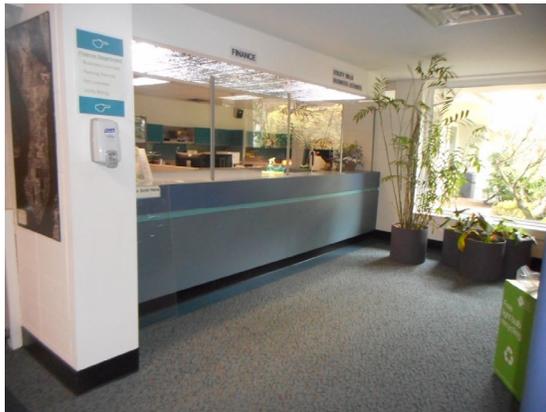
- Upper Left: Business License area requires an accessible counter.
- Upper Right: Fire extinguishers and their cabinets required to be located at an accessible height.
- Lower Left: Accessible restroom signage is required.

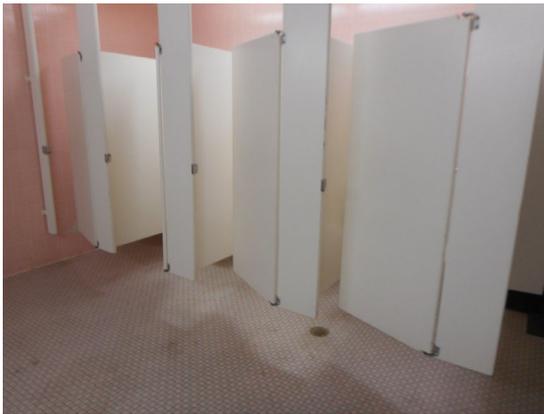
- Upper Left: Restrooms adjacent to Licensing area shall provide an accessible stall.
- Upper Right: Men's restroom adjacent to Licensing area shall provide an accessible urinal.
- Lower Left: Men's restroom adjacent to Licensing area shall provide an accessible lavatory with compliant knee & toe space.

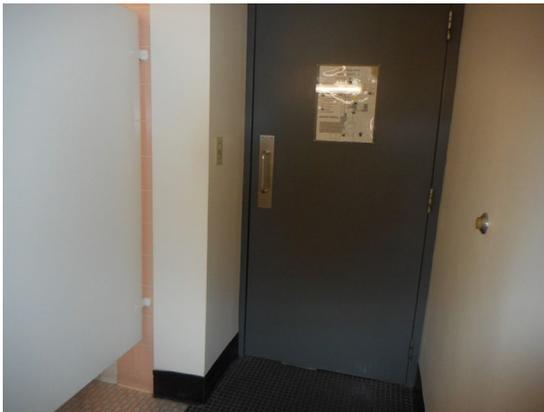
- Upper Left: Restroom entry doors require min. 18" maneuvering clearance on pull side (or a power door operator).
- Upper Right: Restroom entry doors require min. 18" maneuvering clearance on pull side (or a power door operator).
- Lower Left: Women's restroom near Licensing shall have at least one lavatory with accessible controls on faucets, and exposed pipes isolated from contact.

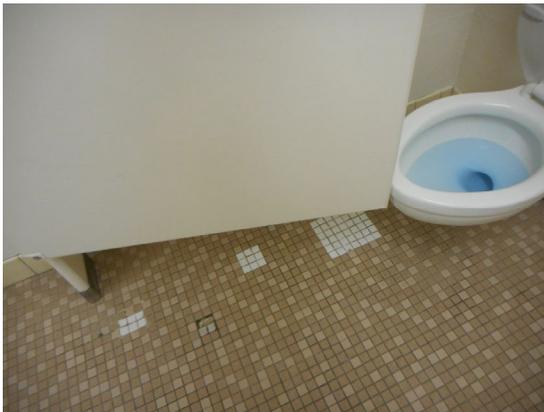
- Upper Left: Women's restroom near Courtroom: door to accessible compartment located on wrong side of compartment and swings in.
- Upper Right: Women's restroom near Courtroom: toilet location should be adjusted. Flush control should be on open side.
- Lower Left: Men's restroom near Courtroom: one urinal should be accessible.

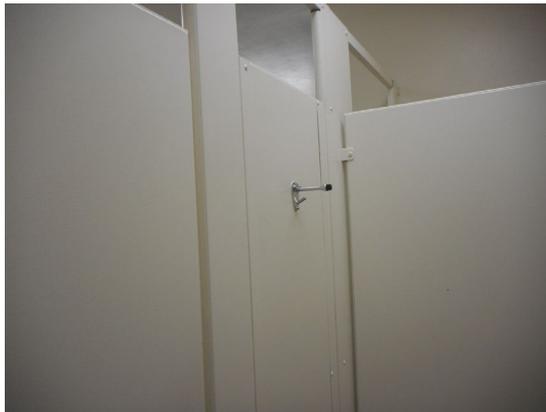
- Upper Left: Coat hooks and dispensers in accessible toilet stalls shall be mounted at accessible heights.
- Upper Right: Rubber mats at entries shall be secured.
- Lower Left: Drinking fountain near courtroom entry should be a hi-low type for both wheelchair users and standing persons.

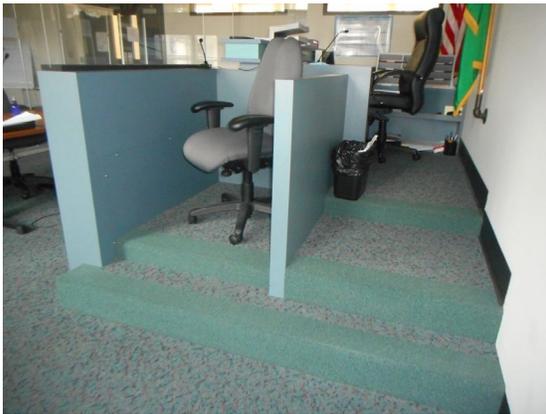
- Upper Left: Courtroom: witness box and judge's platform have stairs (no accessible route).
- Upper Right: Courtroom: juror's area has stairs (no accessible route).
- Lower Left: Courtroom: court clerk counter required to be lowered to 36" AFF max.

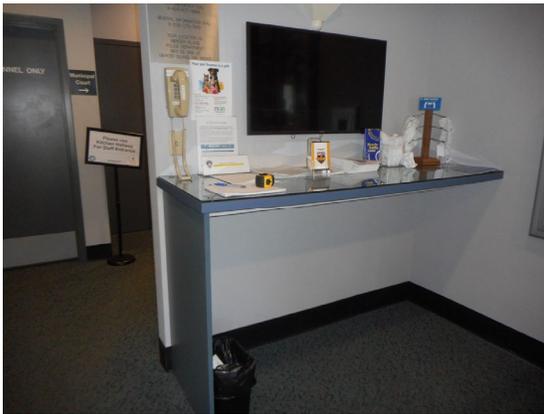
Upper Left: Police Lobby: telephone and counter should be lowered to accessible height.

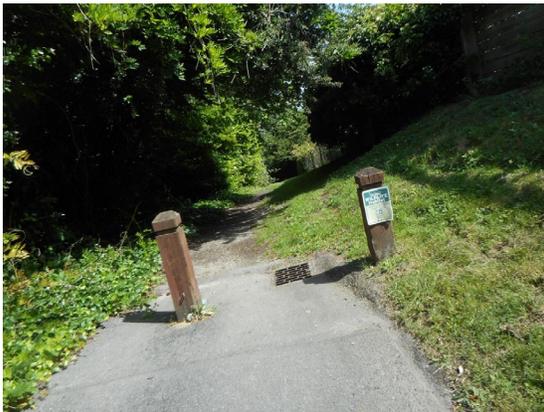
Upper Left: Park entry lacks an accessible route. No parking is provided.

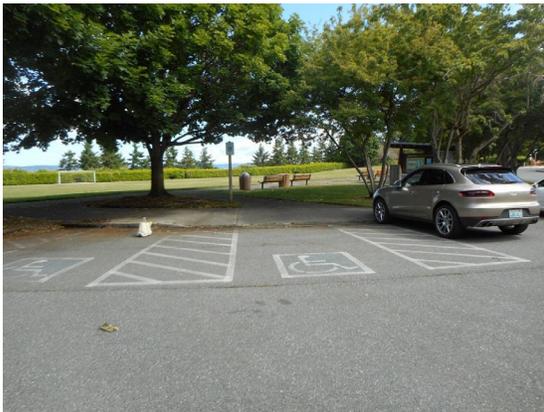
- Upper Left: Accessible parking sign is required on westernmost stall in the western parking lot
- Upper Right: 30"x48" clear floor space is required on one end of bike rack.
- Lower Left: 30"x48" clear floor space is required on one end of bench.

LOCATION	RECOMMENDATION	COMMENTS	TYPE	RESP CODE	PRI	QTY	UNITS	BUDGET
<b>Accessible Parking</b>								
Barrier	540	The accessible stall lacks compliant accessible parking signage, or existing signage is not 60" min. high measured to the bottom of sign.	Citation	2010 ADA Stds. 502.6, 703.7.2.1, 216.5				
<b>ITEM 1: PARKING LOT AT FERONGLIA FIELDS - ACCESSIBLE PARKING</b>	Provide new sign posts to raise existing signs to accessible height.	Signs shall be 60" min. AFF or ground surface, measured to bottom of the sign. Existing condition: Signs provided measured 39" high.	P	O	1	1	2 EA	\$580
<b>ITEM 2: WEST PARKING LOT - ACCESSIBLE PARKING</b>	Add new sign displaying the International Symbol of Accessibility at one existing accessible stall.	Signs shall be 60" min. AFF or ground surface, measured to bottom of the sign. Existing condition: No sign is provided at one accessible parking space (other accessible space has sign).	P	O	1	1	1 EA	\$290

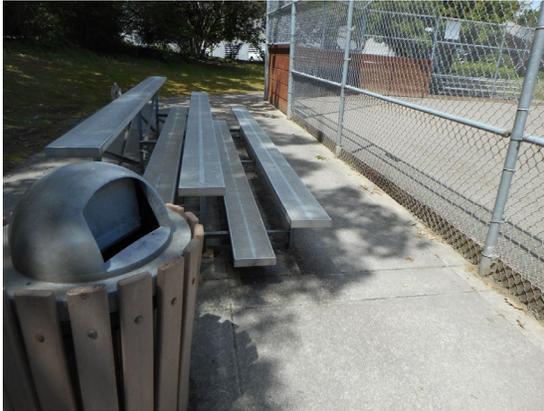
- Upper Left: Bleachers require wheelchair seating (with signage).
- Upper Right: Only low level drinking fountain is provided. Hi-low drinking fountain required.
- Lower Left: Team dugout gates require 32" min. wide openings with maneuvering space on pull side.

LOCATION	RECOMMENDATION	COMMENTS	TYPE	RESP CODE	PRI	QTY	UNITS	BUDGET
<b>Assembly Areas - Indoor / Outdoor</b>								
<b>ITEM 5: WEST BALLFIELD - SOUTH BLEACHERS, FERROGLIA FIELDS</b>	Designate min. 66"x48" space between bleachers and dugout for 1 wheelchair space and 1 companion seat (aligned with front edge of bleachers). Move bleachers as required away from dugout and ballfield fencing to maintain 36" min. wide accessible route (44" min. per Code). Relocate trash and recycling receptacles as required (ensuring 30"x48" level clear floor space adjacent opening). Costs are for 2 signs, not for moving the bleachers.	Existing bleachers provide seating for approximately 18 people - 1 wheelchair space and 1 companion space required. Quantity required: For (4 to 25) fixed seats= 1 space; (26 to 50) = 2 spaces; (51 to 150) = 4 spaces; (151 to 300) = 5 spaces; (301 to 500) = 6 spaces; (501 to 5000) = 6 plus 1 for each 150 of fraction thereof between 501 through 5000 spaces; (5001 and over) = 36 plus 1 for each 200 or fraction thereof over 5000 spaces.	P	O	1	2	2 EA	\$102

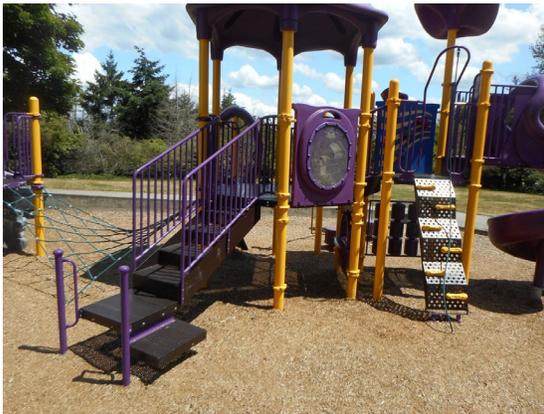
- Upper Left: Ground surfaces of all play areas must be compliant and require periodic inspections & maintenance.
- Upper Right: A compliant ramp is required for the play area east of Feraglia Fields.
- Lower Left: 5% of picnic table seating should be accessible.

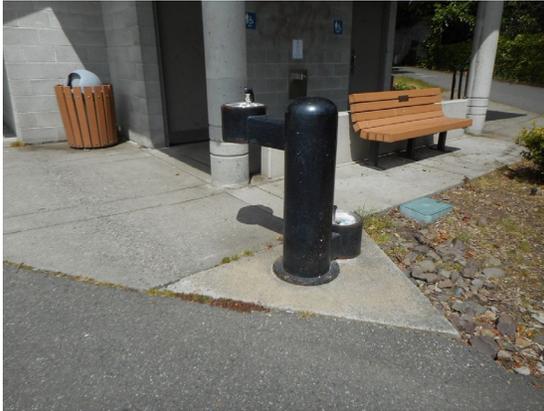
- Upper Left: Only low level drinking fountain is provided. Hi-low drinking fountain required.
- Upper Right: Toilet in Men's restroom by Feroglia Fields should be relocated (centerline is in excess of 18" from corner).
- Lower Left: 1 urinal in Men's restroom by Feroglia Fields should be lowered to accessible height (17" max. AFF).

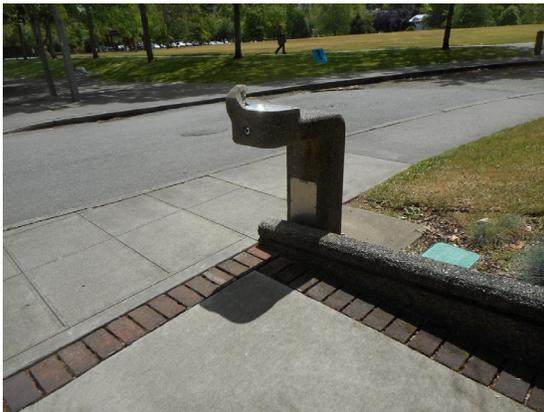
- Upper Left: Only low level drinking fountain is provided. Hi-low drinking fountain is required for both wheelchair users and standing persons.
- Upper Right: Restroom signage lacks Braille.
- Lower Left: Women's restroom: toilet location should be adjusted, rear wall grab bar is required, and dispensers should be relocated within accessible reach ranges.

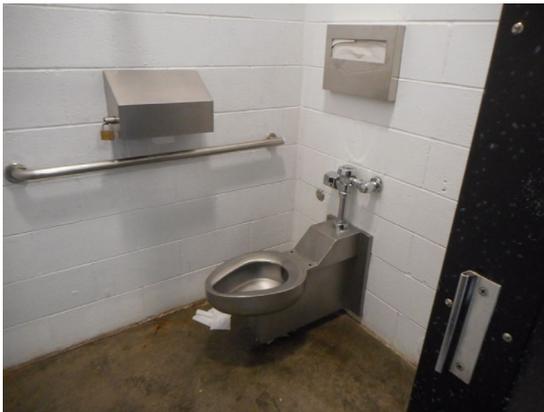
- Upper Left: Men's restroom: toilet seat height is non-compliant, rear wall grab bar is required, dispensers shall be relocated within accessible reach ranges.
- Upper Right: Restroom door closers should be adjust due to excessive force required to open.
- Lower Left: Women's accessible stall door should be self-closing.

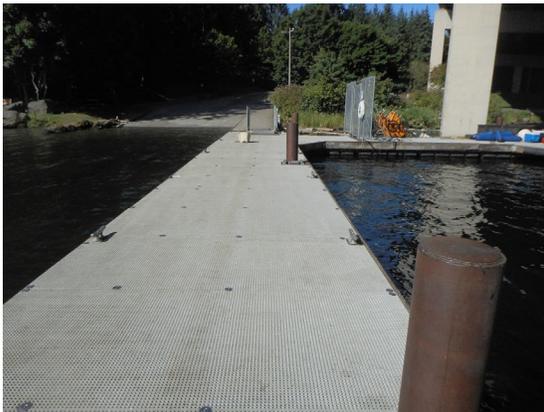
Upper Left: Gangway to boat launch pier requires an accessible route.

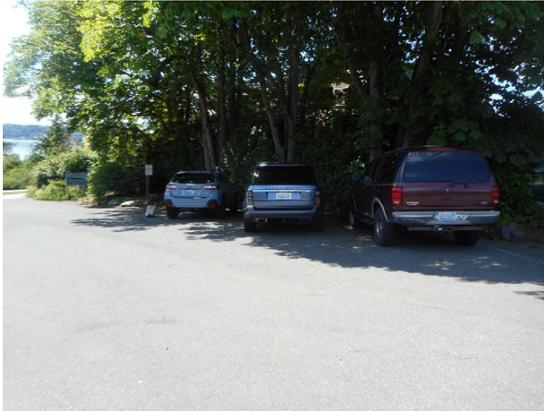
- Upper Left: Parking is provided for 3 vehicles, however no accessible parking is provided.
- Upper Right: Knee clearance at accessible picnic table seat is encroached on by steel supports.
- Lower Left: Bench requires an adjacent clear floor space at one end.

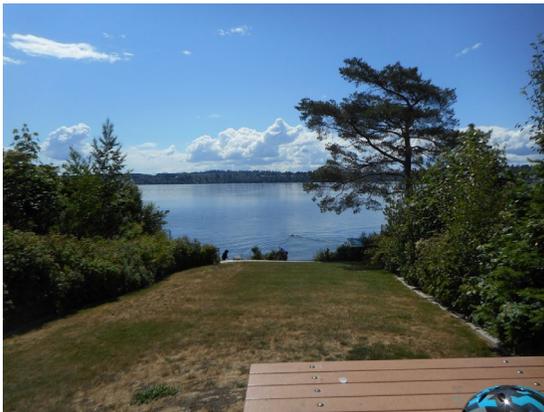
- Upper Left: Accessible sidewalk ends at picnic table.
- Upper Right: No accessible route is provided to the beach.
- Lower Left: No accessible route is provided to the beach.

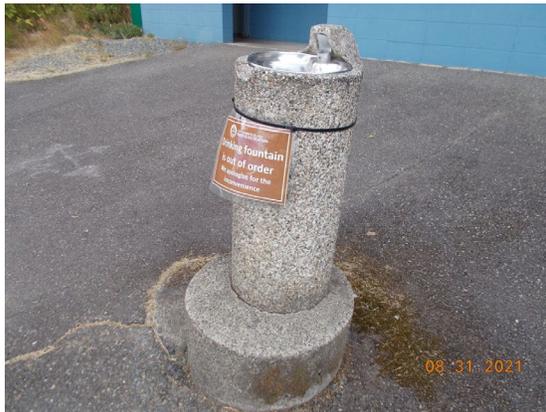
Upper Left: Hi-low drinking fountain required adjacent to restrooms.

<b>ITEM 3: RESTROOMS NEAR BEACH</b>	Replace the fountain with a hi-low model with new 30"x48" min. clear floor space near new ramp landing.	Where provided, min. 2 water fountains are required. 1 is required to meet 602.1 - 602.6 for clear floor space, height, operable parts, and water flow, and 1 is required to meet 602.7 which is height for standing persons. If a water fountain is provided that meets both requirements, it may be substituted for 2 fountains. Spout outlets shall be 36" max. AFF or ground. Drinking fountains for standing persons: Spout outlets of drinking fountains for standing persons shall be 38" min. and 43" max. AFF. Existing condition: Only drinking fountain is provided which is not operable and has steep clear floor space.	P	O	1	4	1	EA \$4,650

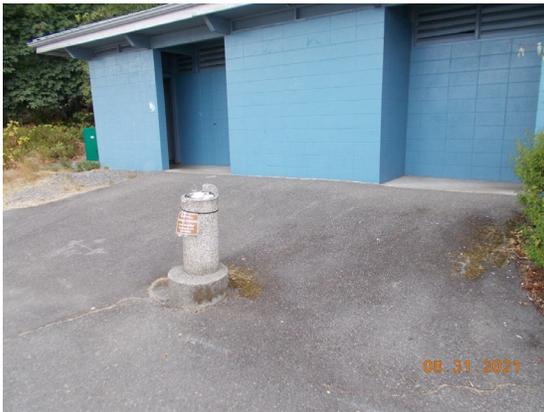
- Upper Left: Route to restrooms has an excessive slope.
- Upper Right: Restroom signage lacks an adjacent clear floor space below.
- Lower Left: 30"x48" clear floor space is required along each leg of the pier's continuous bench.

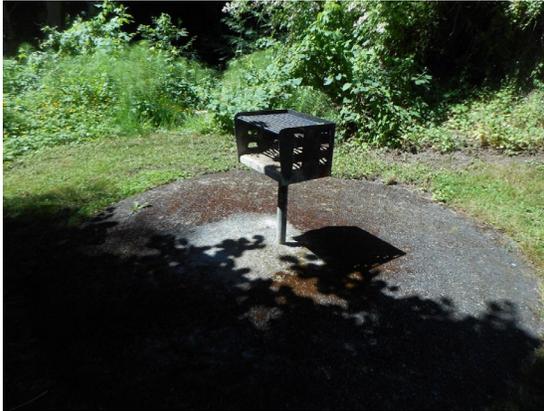
- Upper Left: 30"x48" clear floor space, paved and level, is required at BBQ grill closest to accessible picnic table.
- Upper Right: 30"x48" clear floor space, paved and level, is required at one end of one of the benches by the sand play area.
- Lower Left: 5% of picnic tables in each seating area require an accessible seat.

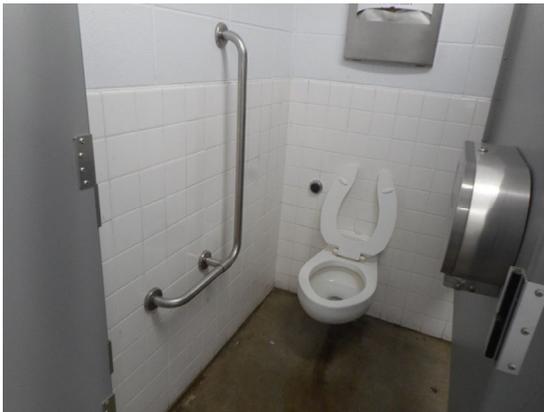
Upper Left: Restrooms are substantially non-accessible. Accessible stall in each restroom is non-compliant in size, grab bars are not compliant, flush control in Women's is incorrectly located, turn-around not provided in Men's restroom. Other issues were recorded.

LOCATION	RECOMMENDATION	COMMENTS	TYPE	RESP CODE	PRI	QTY	UNITS	BUDGET
<b>Restrooms / Bathrooms</b>								
Barrier	698	The restroom is substantially inaccessible - lacks overall turning space, clear floor space at fixtures, and/or compliant fixtures and dispensers.	Citation	2010 ADA Stds. 603				
<b>ITEM 14: RESTROOMS NEAR BEACH</b>	Demolish the interior fixture layout and completely renovate the restroom and dressing room within its current footprint.	Restrooms and dressing rooms are substantially non-compliant requiring significant renovation. Cost shown is an allowance, until further design studies are carried out.	P	O	1	3	1	EA \$35,000
<b>Total for Building: Clarke Beach</b>								<b>\$69,963</b>

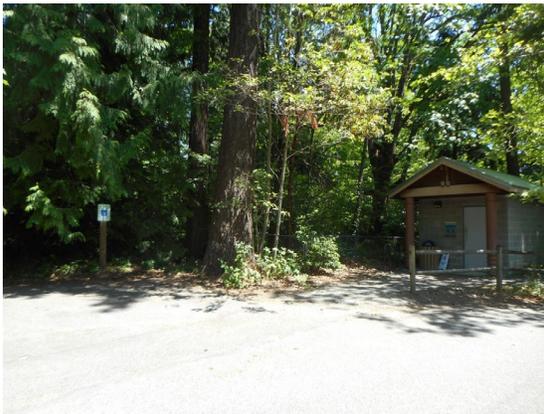
- Upper Left: Van accessible parking sign is mounted too low.
- Upper Right: Pavilion lacks a picnic table with an accessible seat with knee & toe clearance. 5% of picnic tables in each seating area require an accessible seat.
- Lower Left: Bench lacks a paved clear floor space at one end.

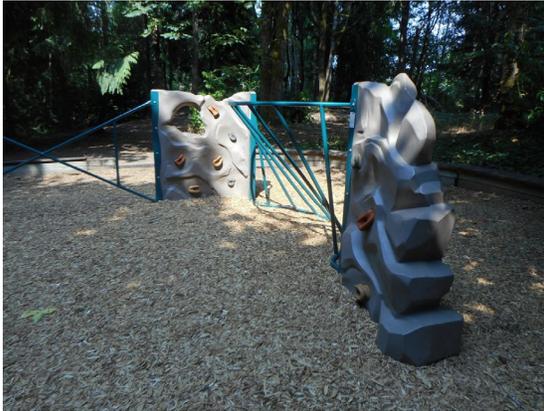
- Upper Left: Play area requires compliant ground surfaces, which must be periodically inspected and maintained.
- Upper Right: Wood border at play areas block accessible route. Removal of wood border and installation of ramp to play areas required.
- Lower Left: Bike rack lacks an adjacent (paved) clear floor space along one side.

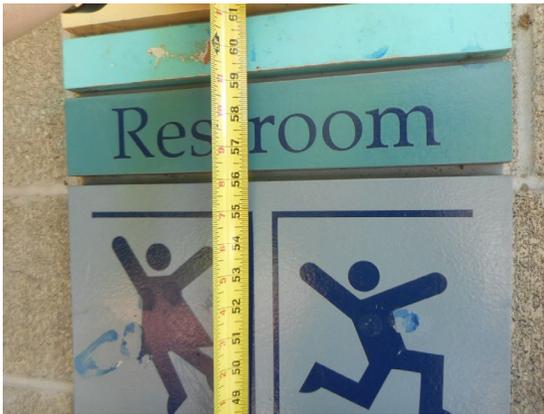
- Upper Left: Restroom signage lacks raised lettering, and is non-compliant in mounting height.
- Upper Right: Entry door into restroom lacks sufficient area for door maneuvering clearance. Concrete walk to be enlarged, and garbage can relocated.
- Lower Left: Grab bars at toilet are non-compliant in length & height. Wall surface behind toilet to be revised for grab bar. Seat cover dispenser lacks a forward approach. Toilet non-compliant for children's use.

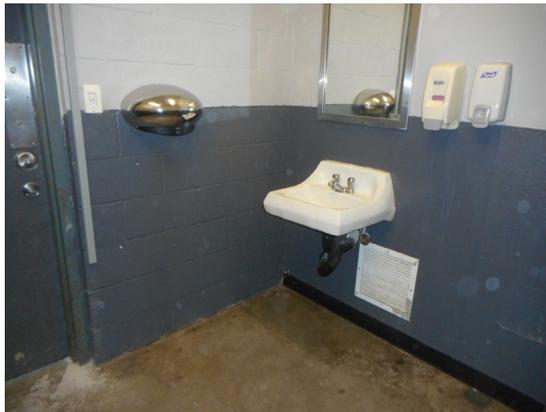
Upper Left: Lavatory does not provide knee & toe clearance and is mounted too high for children's use. Mirror is mounted too high.

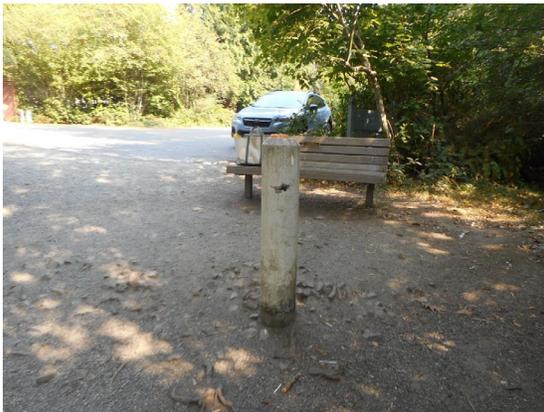
- Upper Left: Park lacks a paved accessible route to bench, and one end of the bench required a paved clear floor space.
- Upper Right: Boardwalk lacks an accessible route to it.
- Lower Left: Boardwalk ends have level changes exceeding 1-1/2".

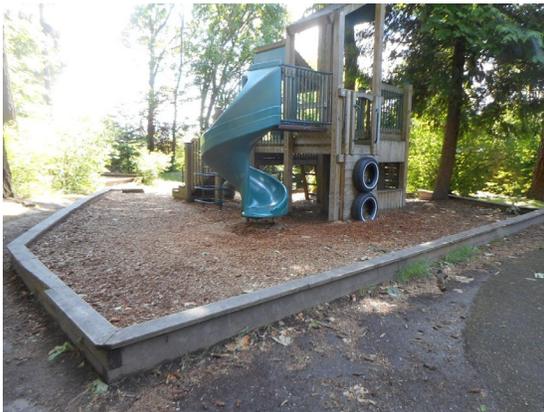
**First Hill Park**

Upper Left: Ground surfaces of all play areas must be compliant and require periodic inspections & maintenance. An accessible route is required into the play area.

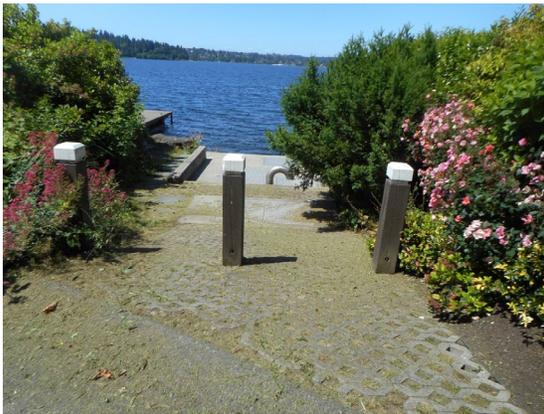
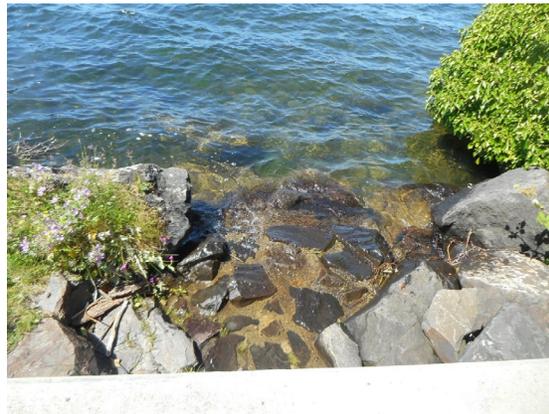
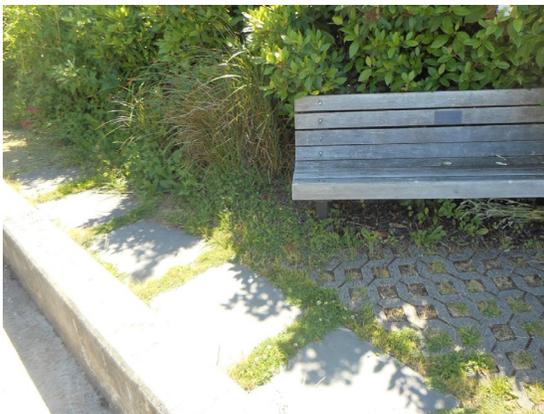
**Forest Landing**

- Upper Left: Site has a path consisting of pavers and stepping stones. No accessible route is provided to site amenities.
- Upper Right: Stone steps to beach. No accessible route is provided.
- Lower Left: Bench requires an adjacent clear floor space at one end, and an accessible route.

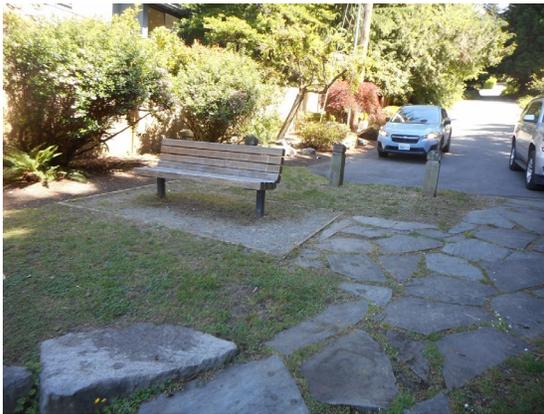
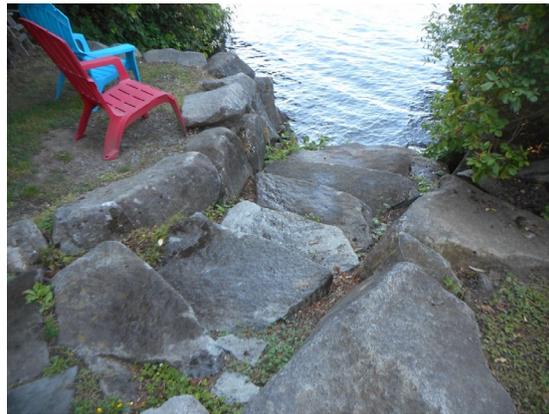
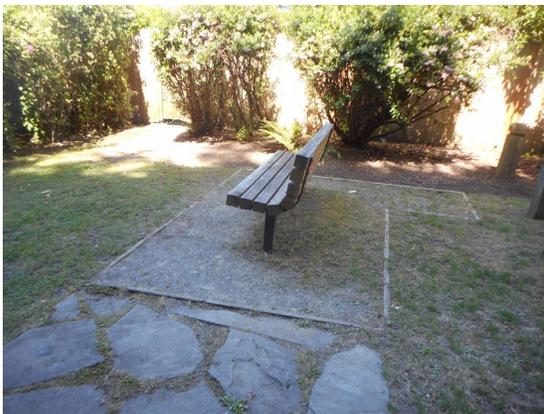
**Franklin Landing**

- Upper Left: A paved accessible route is lacking to the bench.
- Upper Right: A paved accessible route is lacking to the water's edge.
- Lower Left: Bench requires a paved adjacent clear floor space at one end.

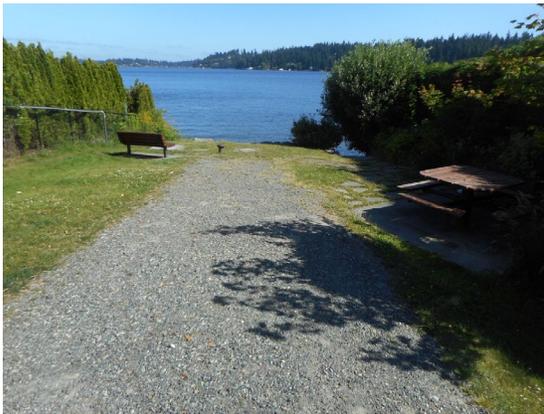
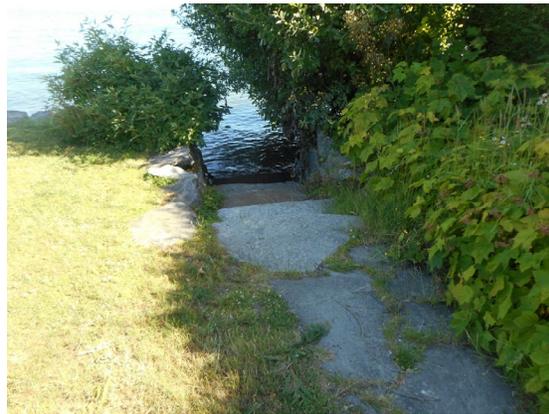
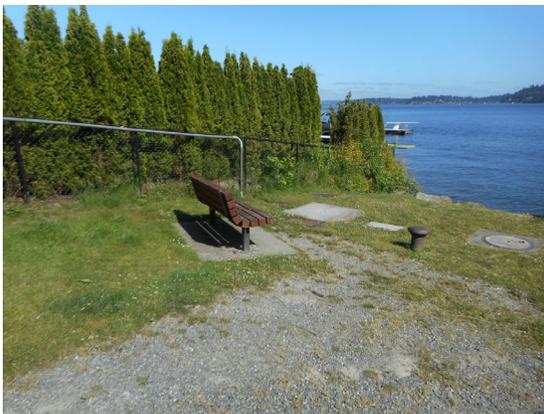
**Fruitland Landing**

- Upper Left: A paved accessible route is lacking to the picnic table, bench, and waterfront. Picnic table does not provide an accessible seat area with a paved clear floor space below.
- Upper Right: A paved accessible route is lacking to the waterfront.
- Lower Left: Bench requires an adjacent clear floor space at one end.

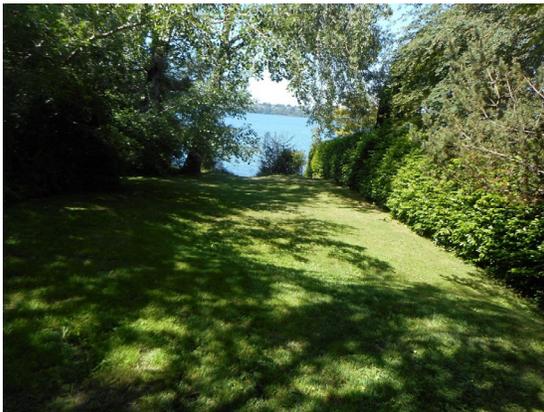
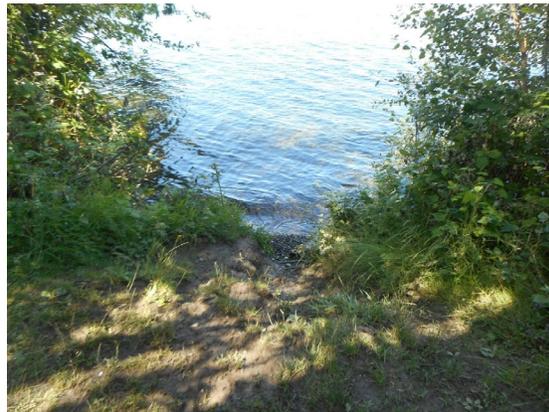
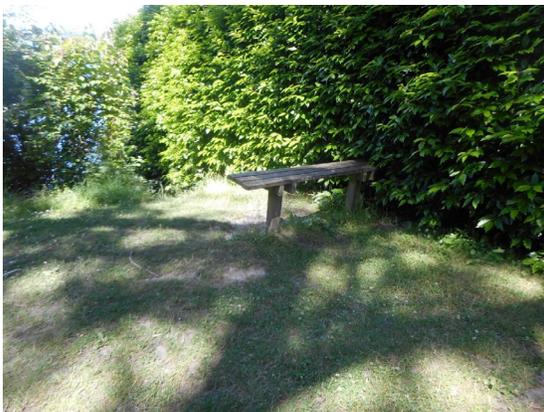
**Garfield Landing**

- Upper Left: The site has a lawn area only. A paved accessible route is lacking to the bench and water's edge.
- Upper Right: No accessible route is provided to the water's edge.
- Lower Left: The bench requires an adjacent clear floor space at one end.

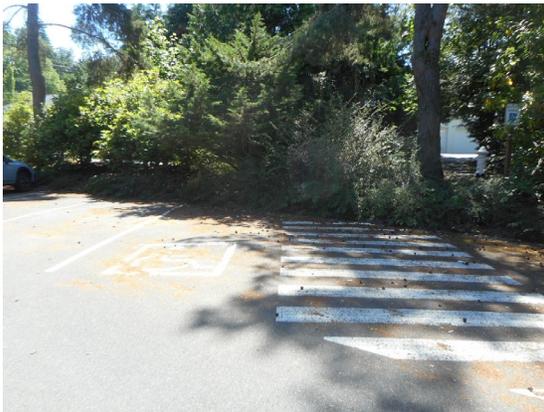
**Groveland Beach Park**

Upper Left: Accessible parking stall lacks signage.
