City of Mercer Island

# ADA Transition Plan

2022

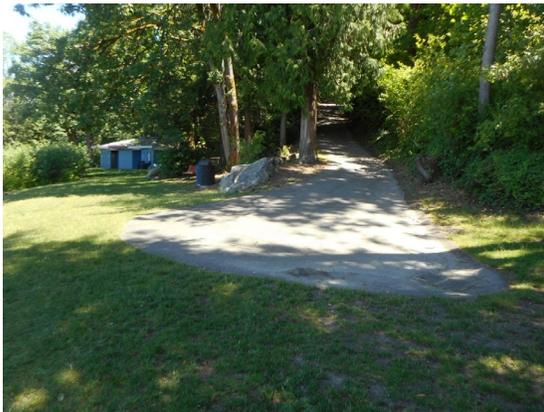
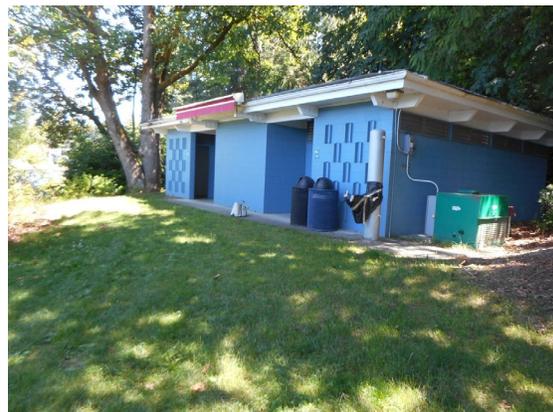
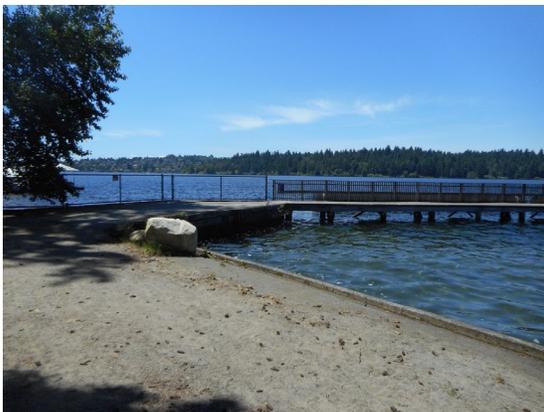
**Groveland Beach Park**

- Upper Left: Paved road ends. No accessible route is provided to beach, restrooms, volleyball court, or pier.
- Upper Right: No accessible route is provided through the lawn to the restrooms.
- Lower Left: No accessible route is provided to the beach or pier.

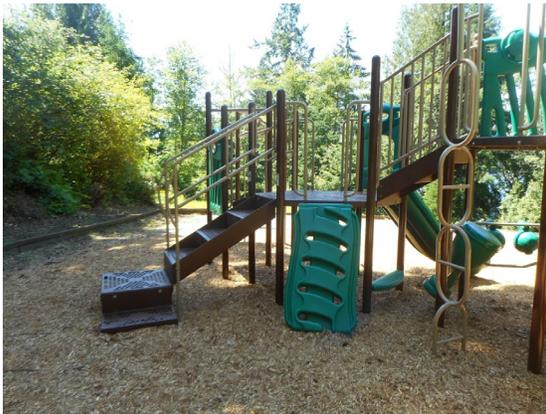
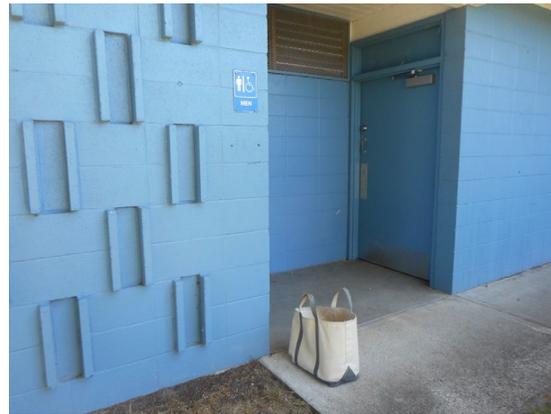
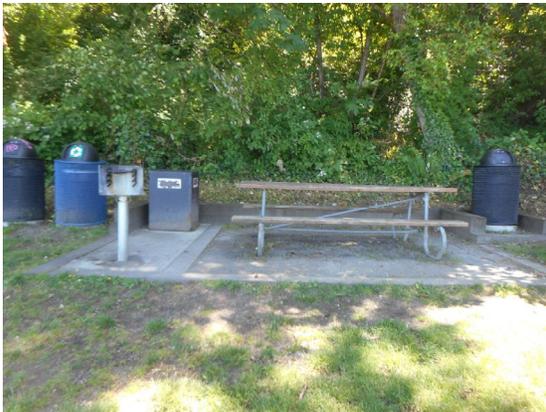
**Groveland Beach Park**

- Upper Left: Play area requires compliant ground surfaces, which must be periodically inspected and maintained.
- Upper Right: Restroom signage lacks an adjacent clear floor space below.
- Lower Left: The picnic table lacks an accessible seat, clear floor space, and accessible route.

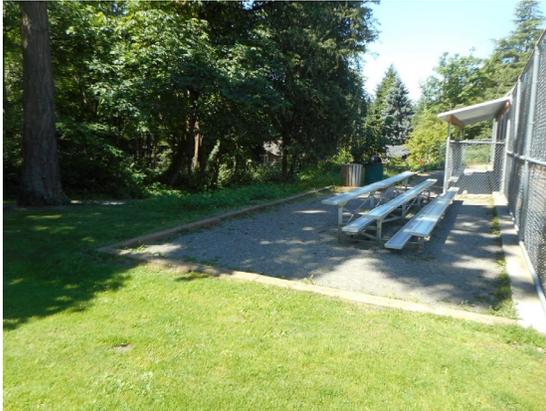
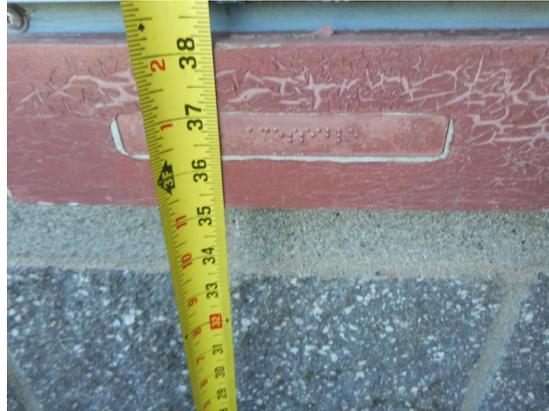
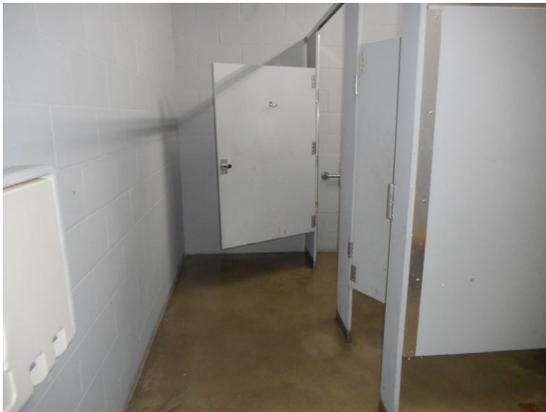
**Homestead Park**

- Upper Left: Ballfields lack an accessible route.
- Upper Right: Restroom signage is mounted too low.
- Lower Left: Accessible toilet stall doors are required to be self-closing, have a pull on the inside surface, and have coat hooks at 48" max. AFF.

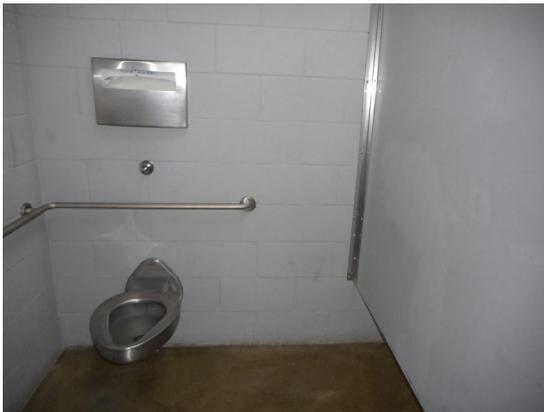
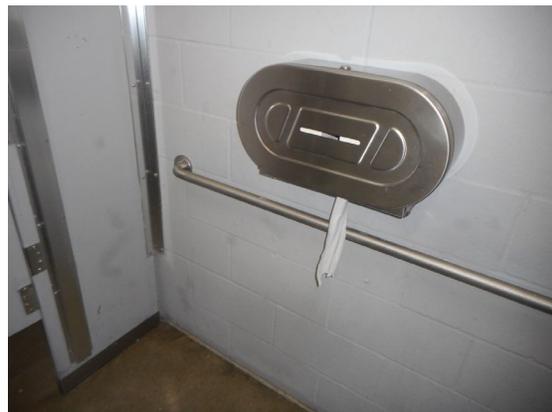
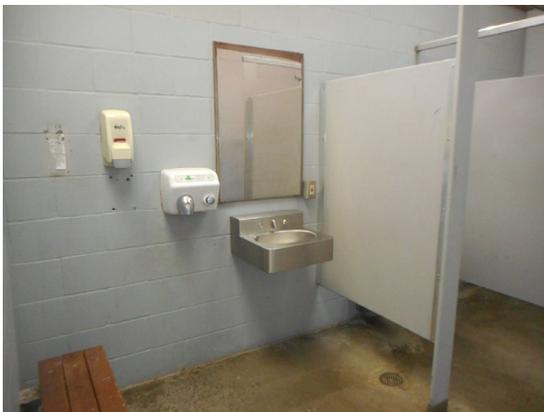
**Homestead Park**

- Upper Left: Grab bars in accessible toilet stalls are not compliant in length and mounting height. Seat cover dispensers mounted behind toilet are not accessible. Toilets are too far from wall (should be located 16" min. - 18" max. from side wall).
- Upper Right: Toilet paper dispensers are mounted within the required 12" clearance space above the grab bar.
- Lower Left: Men's lavatory does not provide compliant knee clearance. Soap dispenser is mounted too high.

ITEM 35: MEN'S RESTROOM		Replace lavatory with an accessible model.		P	O	1	3	1 EA \$2,340

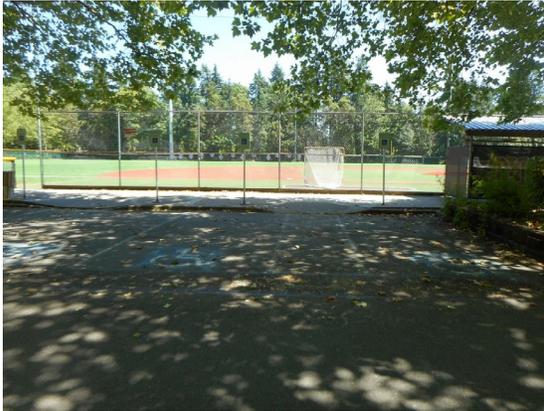
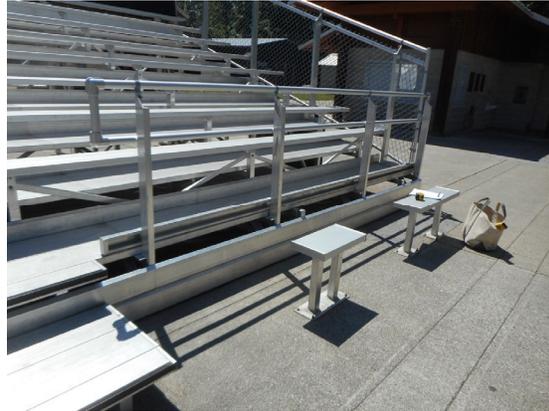
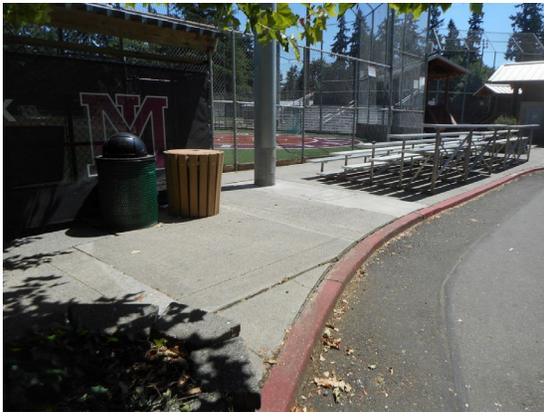
**Island Crest Park**

- Upper Left: Van accessible parking space is insufficient in width. Relocation of signage is required due to restriping.
- Upper Right: Ballfield #1 Home Team bleachers — companion seats do not provide the required width for adjacent wheelchair seating.
- Lower Left: Ballfield #1 Visitor Team bleachers — space is not sufficient for wheelchair seating, including accessible route.

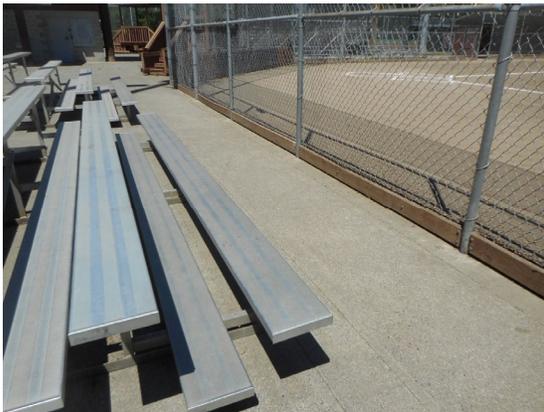
**Island Crest Park**

Upper Left: Ballfield #2 Home Team bleachers are too close to fencing to provide an accessible route in front of the required wheelchair spaces.

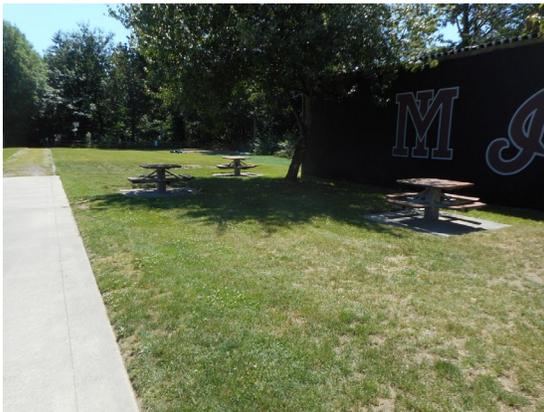
**Island Crest Park**

Upper Left: 1 picnic table is required to provide an accessible seat. An accessible route is required to table.

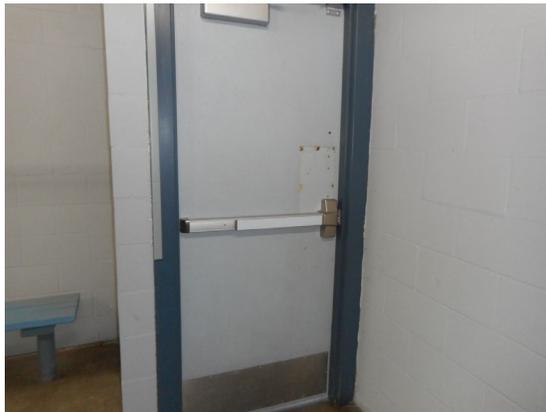
**Island Crest Park**

Upper Left: Restroom doors have a latch and a closer, requiring 12" min. width on the push side.

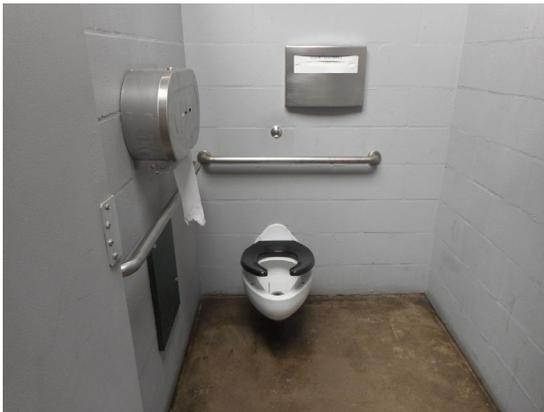
**Island Crest Park**

- Upper Left: Accessible toilet stall in each restroom is insufficient in width. Seat heights are too low. Grab bars require relocation. Flush control in Men's accessible stall is incorrectly located. Photo is Men's restroom.
- Upper Right: The accessible toilet stall in each restroom requires toilet paper & seat cover dispensers to be relocated. Photo is Women's restroom.
- Lower Left: Restroom signage is non-compliant (requires raised lettering and braille), and is non-compliant in location.

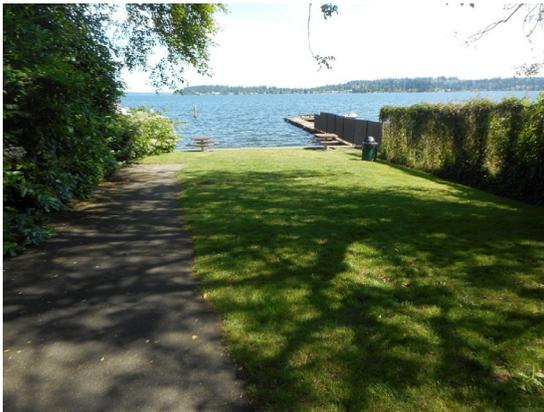
**Lincoln Landing**

- Upper Left: No accessible route is provided to picnic tables.
- Upper Right: Neither of the 2 picnic tables provides an accessible seat with the required knee and toe clearance. 1 accessible picnic table must be provided.
- Lower Left: The accessible picnic table requires a paved clear floor space at the accessible seat, and an accessible route to it.

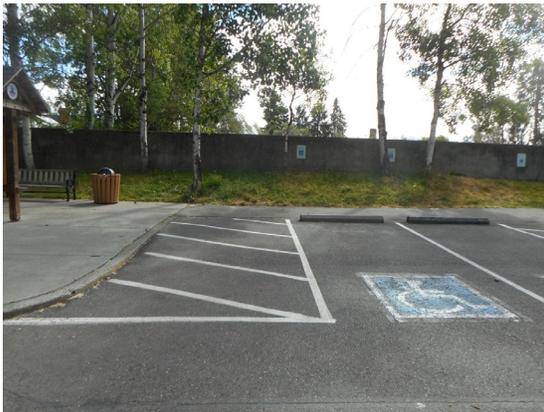
**Luther Burbank Park**

- Upper Left: Accessible parking signs are mounted too low (and too far from stall). Provide pole mounted signs at head of stalls.
- Upper Right: Amphitheatre lacks an accessible route to seating area and stage.
- Lower Left: There are no accessible seating areas in the Amphitheatre. Wheelchair accessible area next to a companion seat could be accommodated near paths on both sides of stage.

LOCATION	RECOMMENDATION	COMMENTS	TYPE	RESP CODE	PRI	QTY	UNITS	BUDGET
<b>Accessible Parking</b>								
Barrier	540	The accessible stall lacks compliant accessible parking signage, or existing signage is not 60" min. high measured to the bottom of sign.	Citation	2010 ADA Stds. 502.6, 703.7.2.1, 216.5				
<b>ITEM 1: NORTH PARKING LOT - ACCESSIBLE PARKING</b>	Mount existing signs displaying the International Symbol of Accessibility on new permanent posts directly beyond head of spaces at compliant height of 60" min. to bottom edge of signs.	Signs shall be 60" min. AFF or ground surface, measured to bottom of the sign. Existing condition: Compliant signs are provided, but mounted on wall (far back from head of spaces) at height of 44" above grade.	P	O	1	1	5 EA	\$1,450

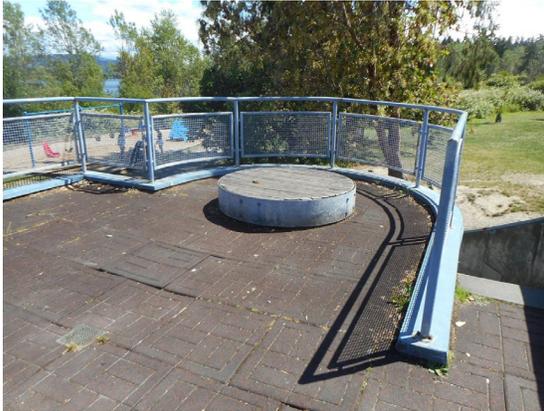
**Luther Burbank Park**

Upper Left: Rooftop viewing platform is provided above the restrooms near the tennis courts.

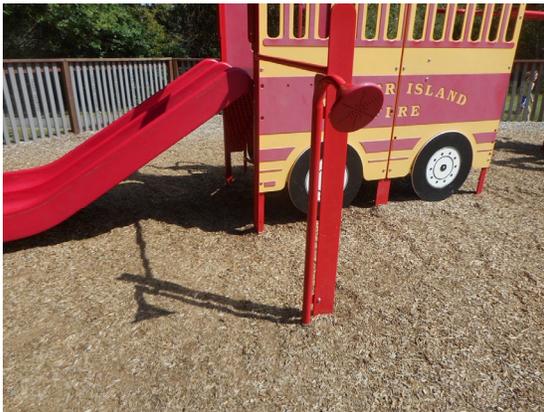
**Luther Burbank Park**

- Upper Left: Ground surfaces of all play areas must be compliant and require periodic inspections & maintenance.
- Upper Right: Service counter at Guard station lacks an accessible route and is too high. An accessible portion is required.
- Lower Left: Dog wash area lacks an accessible route, and water control is above accessible reach.

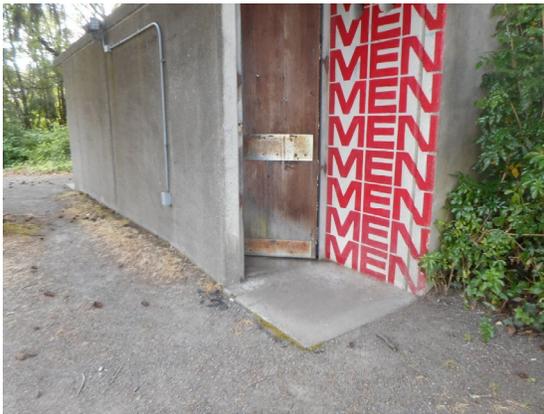
**Luther Burbank Park**

- Upper Left: Restrooms near Picnic Area C are substantially non-accessible.
- Upper Right: Designated accessible stalls are significantly too small, toilets are mounted too far from side wall, dispensers require relocation, grab bars are not compliant in location.
- Lower Left: Door maneuvering space is too narrow and shallow.

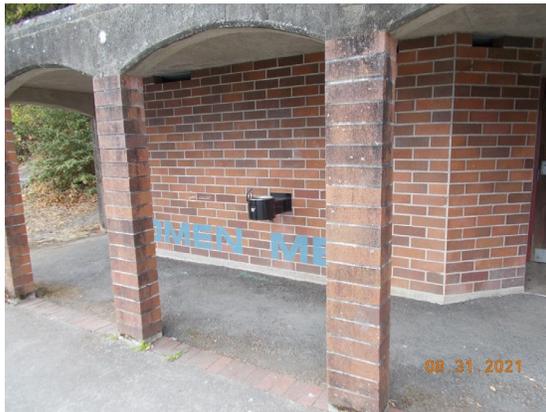
**Luther Burbank Park**

Upper Left: Restrooms near the old boiler room are substantially non-accessible.

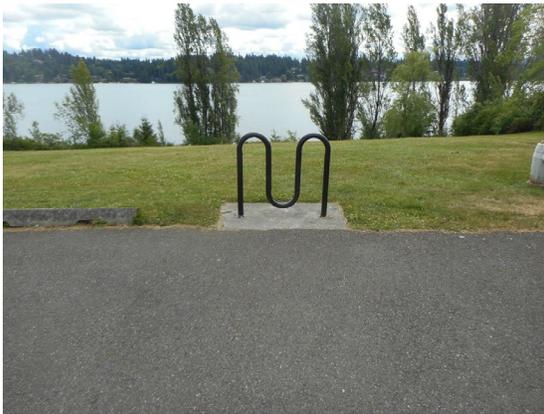
**Luther Burbank Park**

- Upper Left: Bike rack lacks a paved clear floor space at one end.
- Upper Right: Min. 1 bench in each area should have a clear floor space on one end and be on an accessible route.
- Lower Left: BBQ grill and hot coal disposal unit lack an accessible route and paved clear floor space directly adjacent.

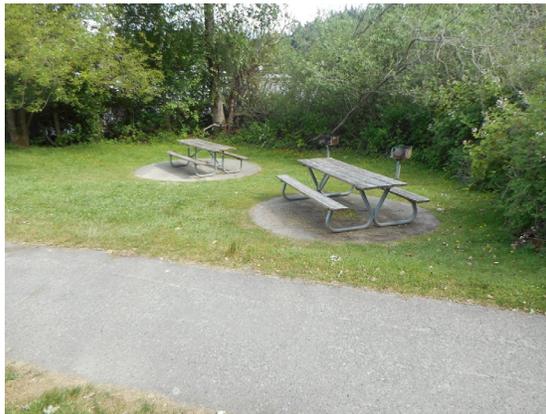
**Luther Burbank Park**

- Upper Left: An accessible picnic table in each area requires a paved accessible route and an accessible seat.
- Upper Right: Picnic Area B provides 1 table designated as accessible, however support angles encroach on the required knee space clearance and no paved clear floor space is provided.
- Lower Left: Door maneuvering space at gates to dog parks are too narrow and lack paving.

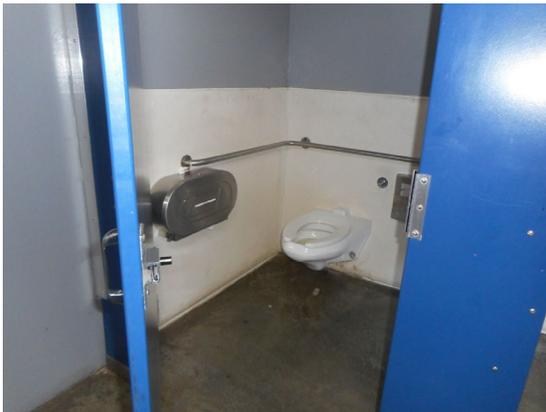
**Luther Burbank Park**

- Upper Left: Grab bars in restrooms near tennis courts are too short. Toilet paper dispenser is too close to grab bar and toilet in Men's restroom is too far from wall.
- Upper Right: Both restrooms near tennis courts have lavatories without compliant knee space clearance and pipes are not insulated.
- Lower Left: Handrails do not extend low enough to prevent a protruding object of more than 4" into accessible route.

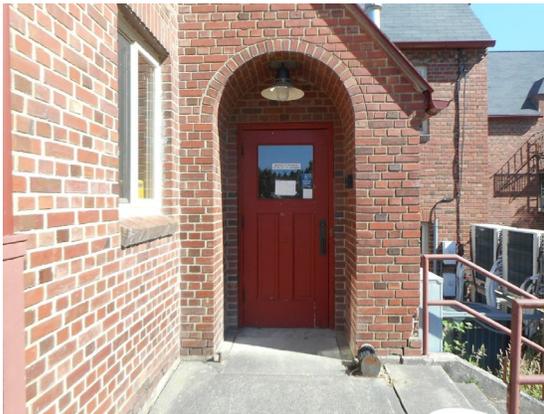
**Luther Burbank Park Administration Building**

- Upper Left: South entry is designated as accessible entry, but door is recessed 34" (8" max. allowed) into required door maneuvering space. Consider abandoning entry.
- Upper Right: A hi-low drinking fountain is required.
- Lower Left: Turning space is not provided, and lavatory encroaches on door maneuvering space at second floor restroom.

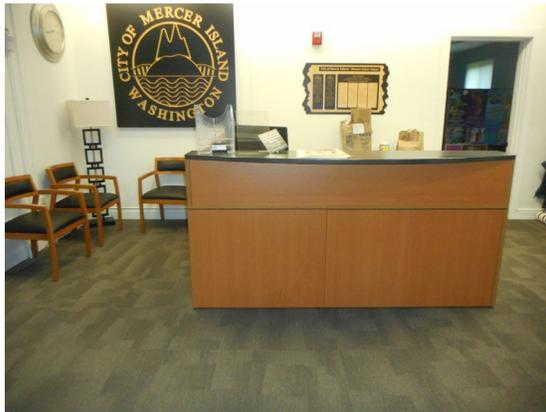
**Luther Burbank Park Administration Building**

- Upper Left: First floor reception desk does not provide an accessible height counter.
- Upper Right: Office door is too narrow. Remove door and provide 32" min. wide framed opening (otherwise door opening needs to be widened).
- Lower Left: Doors have knob type hardware. Lever-type is required for accessibility.

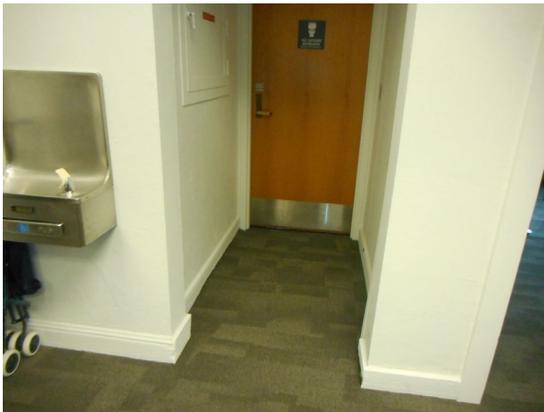
- Upper Left: Restroom signage is non-compliant. The International Symbol of Accessibility is required.
- Upper Right: Grab bar encroaches on door maneuvering space; should be 1-1/2" from the side wall behind. Revised side wall (and door opening) is required. Toilet requires seat height between 17" - 19" AFF and flush control shall be on open side of toilet.
- Lower Left: Pipes below lavatory are not insulated.

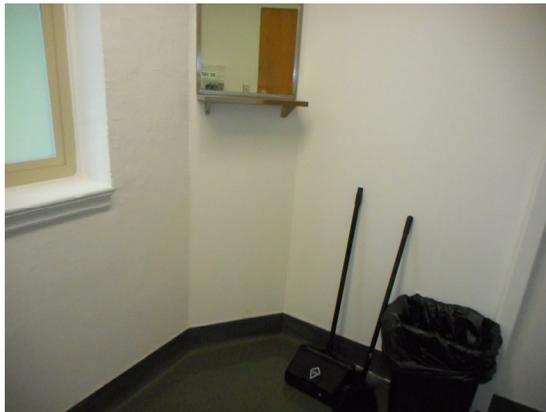
- Upper Left: Existing shelf/mirror unit is mounted too high. Shelf to be 40" - 48" AFF. An additional tall mirror is required.
- Upper Right: Coat hook is mounted above the required 48" max. height.

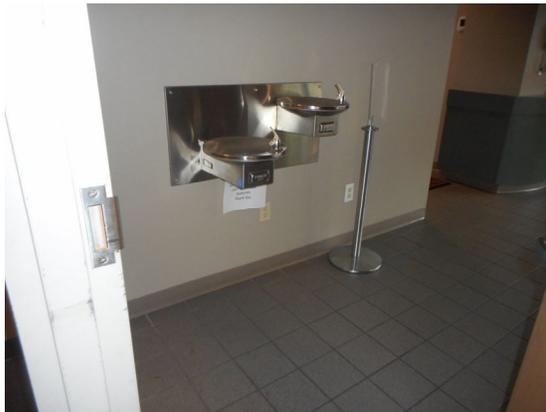
- Upper Left: The high level drinking fountain protrudes into the path of travel, with the bottom surface at 34-1/2" AFF.
- Upper Right: Lavatory is not compliant and encroaches on door maneuvering space. Restrooms require renovation.
- Lower Left: Toilets in both restrooms are too far from the side wall. Grab bars are too short. Seat cover dispenser encroaches on 12" clearance above grab bar and is not accessible.

LOCATION	RECOMMENDATION	COMMENTS	TYPE	RESP CODE	PRI	QTY	UNITS	BUDGET
<b>Drinking Fountains</b>								
Barrier	7380	The standing persons water fountain is a protruding object.	Citation	2010 ADA Stds. 602.7				
<b>ITEM 2: DRINKING FOUNTAINS</b>	Provide a cane detection device less than 27" AFF.	High level drinking fountain is on the open end, near path of travel, with bottom edge at 34-1/2" AFF.	P	O	1	4	1	EA \$530

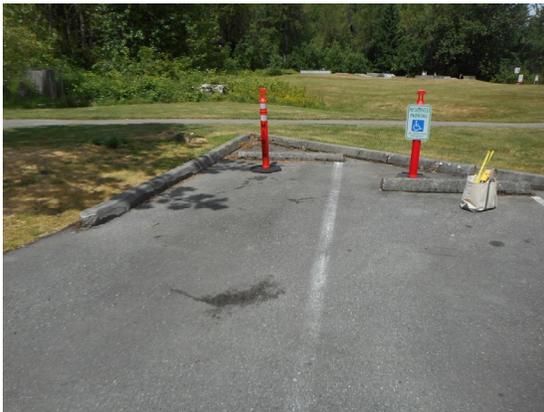
- Upper Left: Accessible parking sign is required to be 60" min. above paving to bottom of sign.
- Upper Right: Ground surfaces of fitness areas must be compliant and require periodic inspections & maintenance
- Lower Left: Ground surfaces of play area must be compliant and require periodic inspections & maintenance

LOCATION	RECOMMENDATION	COMMENTS	TYPE	RESP CODE	PRI	QTY	UNITS	BUDGET
<b>Accessible Parking</b>								
Barrier	540	The accessible stall lacks compliant accessible parking signage, or existing signage is not 60" min. high measured to the bottom of sign.	Citation	2010 ADA Stds. 502.6, 703.7.2.1, 216.5				
<b>ITEM 1: PARKING LOT NEAR THRIFT SHOP - ACCESSIBLE PARKING</b>	Mount existing sign displaying the International Symbol of Accessibility on new permanent post at compliant height of 60" min. to bottom edge of sign.	Signs shall be 60" min. AFF or ground surface, measured to bottom of the sign. Existing condition: Compliant sign is provided at one parking space, but mounted on temporary traffic cone at height of 22" above paving.	P	O	1	1	1	EA \$290

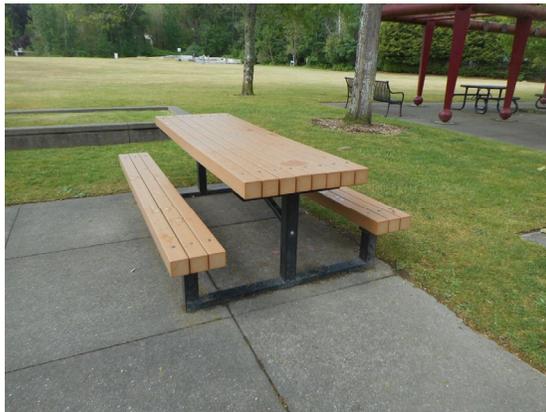
Upper Left: Picnic table does not provide an accessible seat with knee & toe space.

<b>ITEM 2: ACCESSIBLE PICNIC TABLES - NORTHEAST PLAZA</b>	Assuming 6 people per metal picnic table and 8 people per faux wood picnic table, replace 3 existing tables (either metal or faux wood) with accessible picnic tables with knee space 30" min. wide, 27" min. high and 17" min. deep on one end of table. Locate tables so that slab for 30"x48" clear floor space at accessible end of table has slope of 2% (1:48).	Existing metal picnic tables have elliptical table top with knee space measuring 16-1/2" deep at deepest point. Existing wood picnic tables have knee space measuring only 7" deep.	P	O	1	2	3	EA	\$7,500
---	---	---	---	---	---	---	---	----	---------

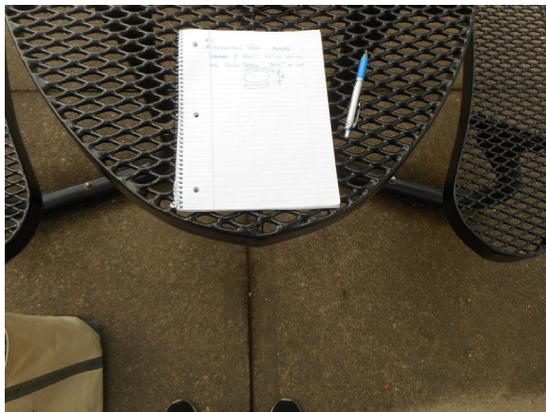
Lower Left: Picnic table does not provide an accessible seat with knee & toe space.

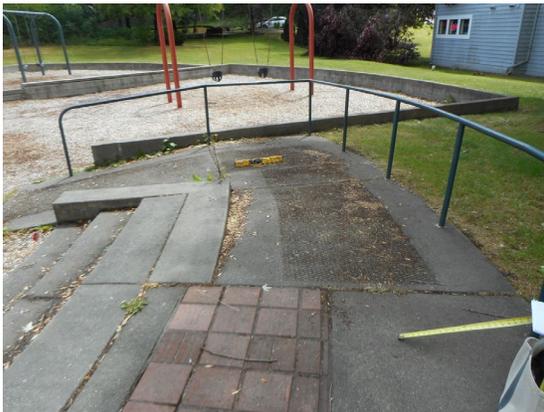
- Upper Left: Ramp and top landing have excessive slopes and lacks compliant handrails on both sides.
- Upper Right: Ramp has excessive slope and lacks handrails on both sides.
- Lower Left: Fitness stations lack an accessible route thru wooden borders.

ITEM 3: PLAY AREA EAST HALF	Remove existing curb ramp and provide new compliant ramp with continuous handrails both sides with 12" min. extension at top and bottom of ramp.	Max. running slope is 1:12 (8.33%). Max. cross slope is 1:48 (2%). A slope of 1:20 (5%) is not considered a ramp. Existing condition: Change in level is greater than 6" (too high for a curb ramp) and curb ramp is provided with slope measuring 8.5% and flare with slope measuring 21%.	P	O	1	1	10	LF \$3,500

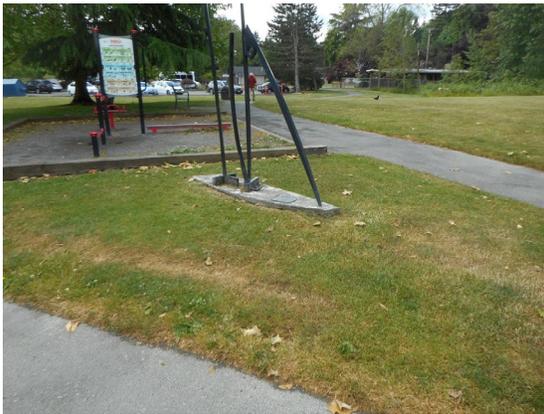
- Upper Left: Sculpture lacks a clear floor space and accessible route to the information plaque.
- Upper Right: Adjacent clear floor space at either end of bench has excessive slope.
- Lower Left: Bench requires a clear floor space at one end.

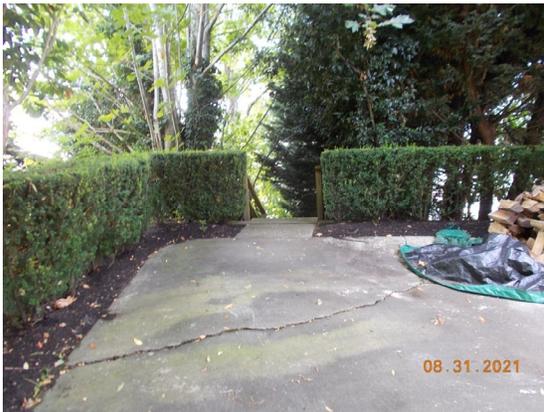
Upper Left: This landing is not accessible, as change in level is substantial and property is narrow. Provide signage indicating that landing is not accessible.

LOCATION	RECOMMENDATION	COMMENTS	TYPE	RESP CODE	PRI	QTY	UNITS	BUDGET
<b>Signage</b>								
Barrier	30244	There is no directional signage providing direction to accessible interior spaces, exterior spaces, facilities and/or elements.	Citation	2010 ADA Stds. 216.6, 703.5				
<b>ITEM 1: VEHICULAR APPROACH TO MILLER LANDING</b>	Provide new pole mounted directional sign along vehicular access route indicating that landing is not accessible.	Change in level is substantial and property is narrow. May cause an "undue burden" to provide accessible route to water's edge. It is a risk management decision to allow access to able bodied persons but not wheelchair users or other disabilities that may have problems traversing the terrain.	P	O	1	2	1	EA \$710
<b>Total for Building: Miller Landing</b>								<b>\$710</b>

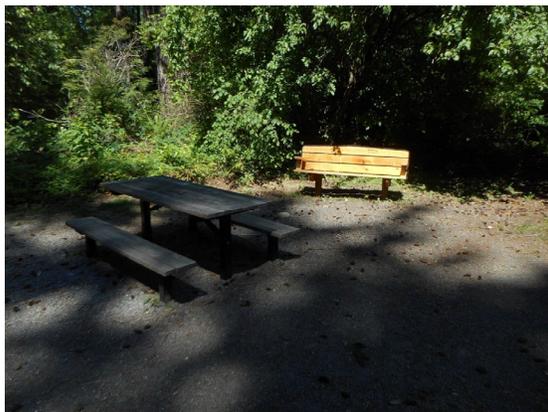
- Upper Left: Accessible routes are required to accessible picnic tables and benches.
- Upper Right: Picnic tables do not provide an accessible seat and clear floor space.
- Lower Left: Clear floor space and accessible route is required at min. 5% of dog waste and trash receptacles.

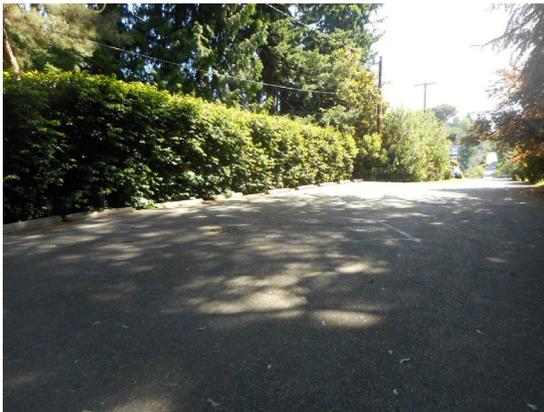
Upper Left: 12 parking spaces; no accessible parking is provided.

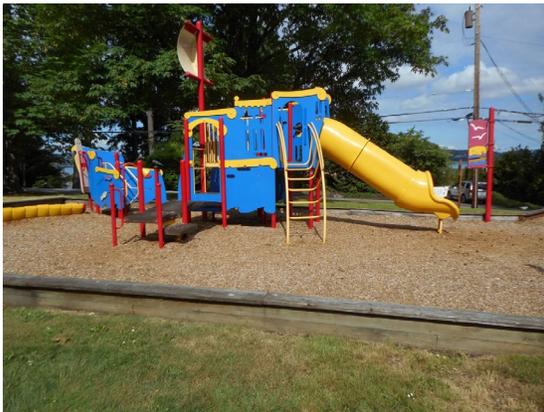
- Upper Left: Play area requires compliant ground surfaces, which must be periodically inspected and maintained
- Upper Right: Picnic table does not provide an accessible seat and clear floor space.
- Lower Left: Picnic table does not provide an accessible seat and clear floor space.

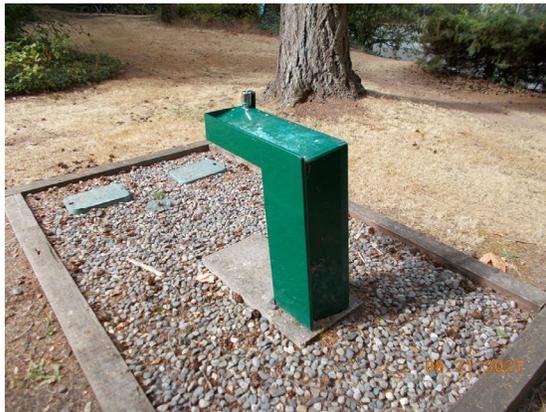
Upper Left: Low level only fountain is provided. Drinking fountain requires a hi-low model for both wheelchair users and standing persons.

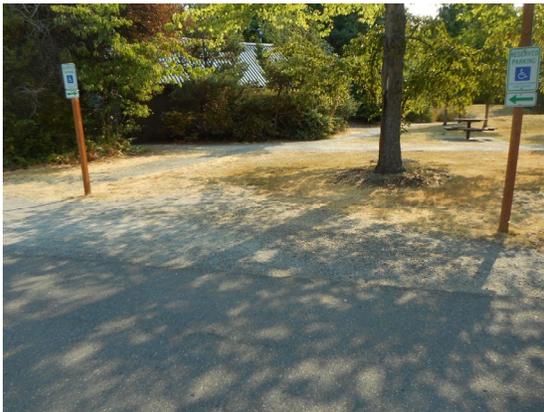
Upper Left: Accessible parking space is not paved, and has no access aisle.

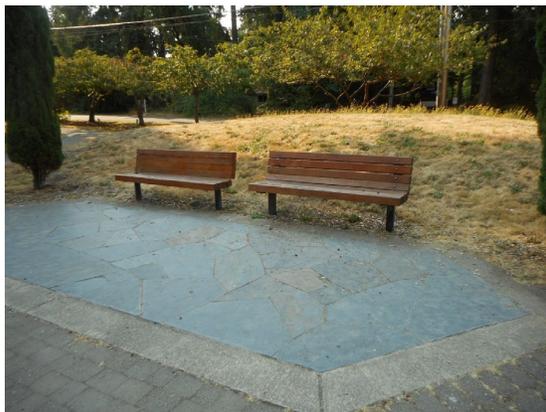
- Upper Left: Benches do not have a paved clear floor space on one end.
- Upper Right: Play area has a step, and requires an accessible ramp.
- Lower Left: Play area has lava rock for a ground surface. Ground surface must be one that complies with ASTM F 1951.

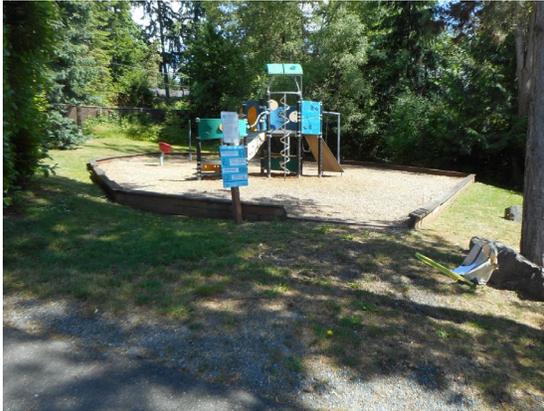
- Upper Left: Play area requires compliant ground surfaces, which must be periodically inspected and maintained.
- Upper Right: Play area requires an accessible route and a ramp down to play area.
- Lower Left: Picnic table does not provide an accessible seat and clear floor space. An accessible route is required to trash can, picnic table, and play area.

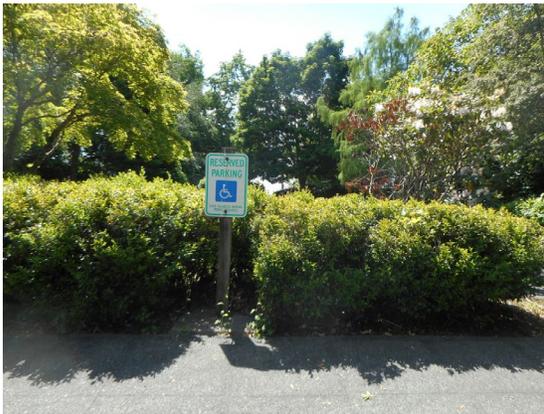
- Upper Left: Accessible parking sign is too low and should be raised to 60" min. AFF.
- Upper Right: Picnic table does not provide an accessible seat and clear floor space.
- Lower Left: Benches in various areas of the park require a clear floor space on one end and be on an accessible route.

LOCATION	RECOMMENDATION	COMMENTS	TYPE	RESP CODE	PRI	QTY	UNITS	BUDGET
<b>Accessible Parking</b>								
Barrier	540	The accessible stall lacks compliant accessible parking signage, or existing signage is not 60" min. high measured to the bottom of sign.	Citation	2010 ADA Stds. 502.6, 703.7.2.1, 216.5				
<b>ITEM 1: ACCESSIBLE PARKING STALL</b>	Remount / raise existing stall signage.	Signs shall be 60" min. AFF or ground surface, measured to bottom of the sign. Existing condition: Sign is mounted with bottom at 57" above paving.	P	O	1	1	EA	\$72

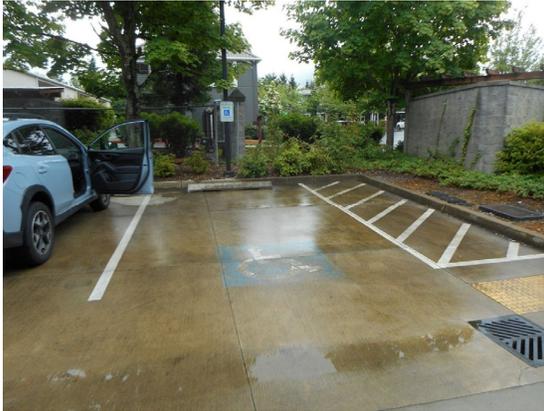
- Upper Left: Accessible parking sign is mounted too low.
- Upper Right: AED cabinet is mounted too high and is a protruding object.
- Lower Left: Bench does not have an accessible clear floor space at one end.

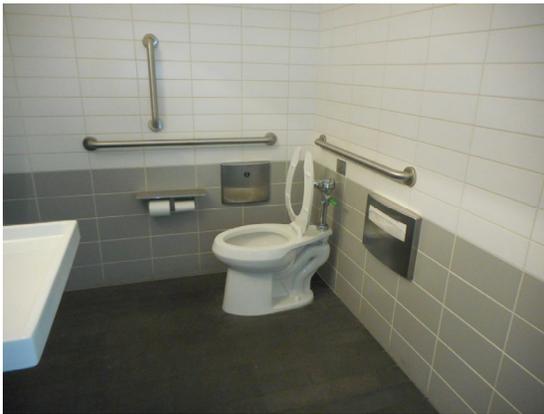
- Upper Left: Toilet is installed at a skewed angle, and located too far from side wall. Grab bars are mounted too high.
- Upper Right: Lavatory encroaches on toilet clearance and door maneuvering space. Also, lavatory rim is too high.

ITEM 5: ALL-GENDER RESTROOM	Revise toilet to be 18" max. from the side wall to the toilet centerline.	Existing condition: toilet installation is skewed - 17-1/2" from side wall to toilet rear area and 18-1/2" at toilet front. Owner/maintenance item.	P	O	1	3	1 EA	\$0
Barrier	681	The existing grab bars are non-compliant in size, configuration, or mounting height.	Citation	2010 ADA Stds. Fig. 604.5.2, 609.2, 604.9

ITEM 6: ALL-GENDER RESTROOM	Remount the existing grab bars.	Grab bars should be 1-1/4"- 2" in diameter, 33" to 36" AFF, with 1-1/2" min. between the wall and the grab bar. 2010 Standards: Rear grab bar min. 24" long from centerline of toilet at transfer side. Existing condition: grab bars are mounted at 36-3/4" to 37" AFF to the top.	P	O	1	3	1 EA	\$410

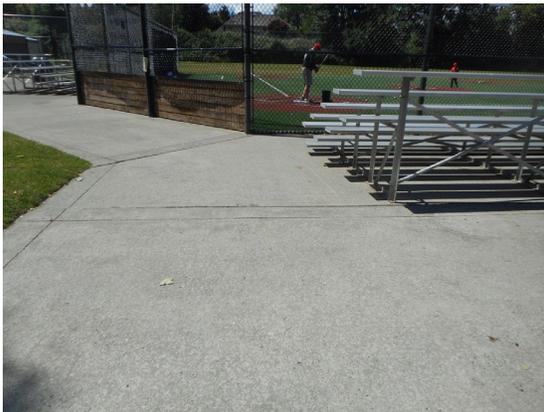
- Upper Left: Bleachers require wheelchair seating (with signage).
- Upper Right: Hose bib under low level drinking fountain requires relocation.
- Lower Left: Ground surfaces of all play areas must be compliant and require periodic inspections & maintenance

LOCATION	RECOMMENDATION	COMMENTS	TYPE	RESP CODE	PRI	QTY	UNITS	BUDGET	
<b>Assembly Areas - Indoor / Outdoor</b>									
Barrier	563	The assembly area lacks the minimum quantity of wheelchair seating areas with adjoining companion seats.	Citation	2010 ADA Stds. 221.2.1					
<b>ITEM 1: NORTHEAST BALLFIELD</b>	Move both sets of bleachers away from the fencing to provide min. 5'-8" clearance. Costs are for 4 signs, not for moving the bleachers or wood borders.	Each set of existing bleachers provides seating for approximately 40 people. 2 wheelchair spaces are required per bleacher set, one at each end of the bleachers, next to a companion seated on the lowest bleacher row. Due to the proximity of the bleachers to the ballfield fencing, bleachers need to move back, 68" min. away from the ballfield fencing, to provide an accessible route. Quantity required: For (4 to 25) fixed seats = 1 space; (26 to 50) = 2 spaces; (51 to 150) = 4 spaces; (151 to 300) = 5 spaces; (301 to 500) = 6 spaces; (501 to 5000) = 6 plus 1 for each 150 of fraction thereof between 501 through 5000 spaces; (5001 and over) = 36 plus 1 for each 200 or fraction thereof over 5000 spaces.	P	O	1	2	4	EA \$204

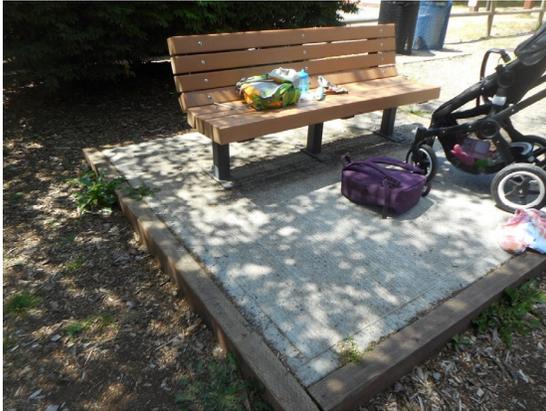
- Upper Left: 30"x48" clear floor space is required on one side of bench, and an accessible route to bench is required.
- Upper Right: Picnic table requires an accessible seat & accessible route.
- Lower Left: Accessible route is required to play area.

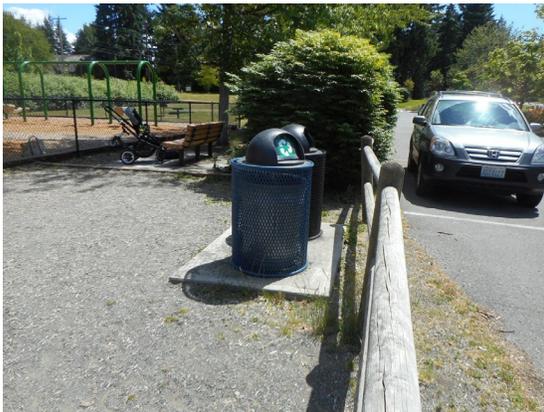
- Upper Left: Accessible route and clear floor space is required at trash receptacles.
- Upper Right: BBQ grill requires an adjacent clear floor space.
- Lower Left: Paved accessible route and door maneuvering space is required at play area.

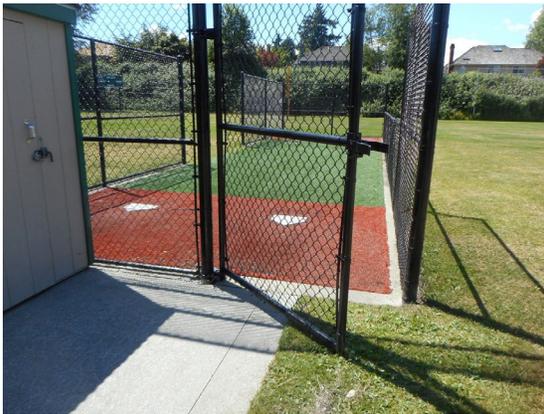
- Upper Left: Accessible route and door maneuvering space is required at practice area.
- Upper Right: Accessible route and door maneuvering space is required at batting cage structure.
- Lower Left: Accessible route and door maneuvering space required at practice area.

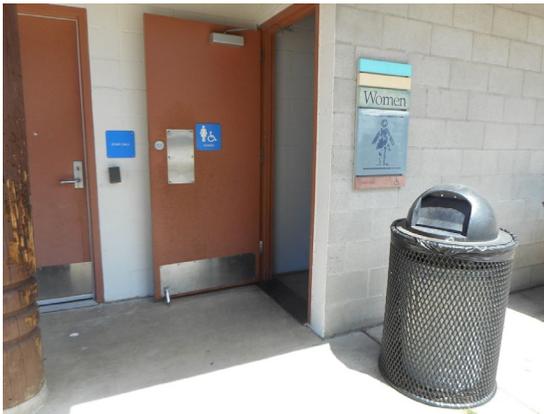
- Upper Left: Restroom signage should be compliant.
- Upper Right: Accessible stall size is non-compliant. Dispensers require relocation.
- Lower Left: Soap dispenser and hand drying operation button are mounted too high.

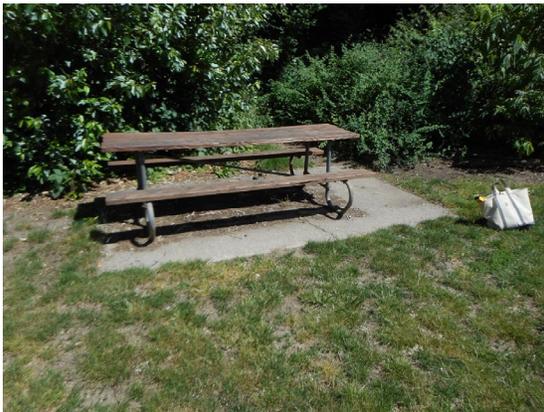
Upper Left: Picnic table does not provide an accessible seat and clear floor space.

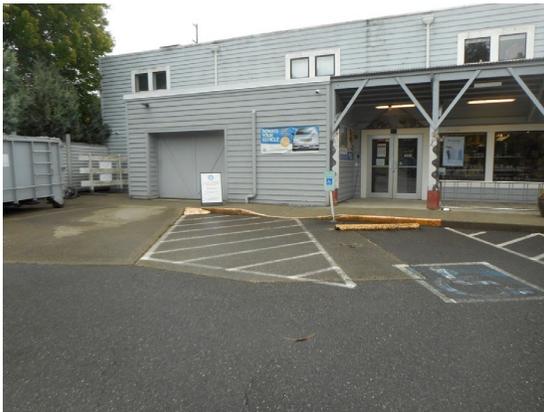
- Upper Left: Accessible parking sign is mounted too low. Bottom edge of sign to be 60" min. above pavement.
- Upper Right: Exit door has a column blocking the required door clearance and maneuvering space.
- Lower Left: Exit door from first floor lacks a paved clear floor space on exterior side.

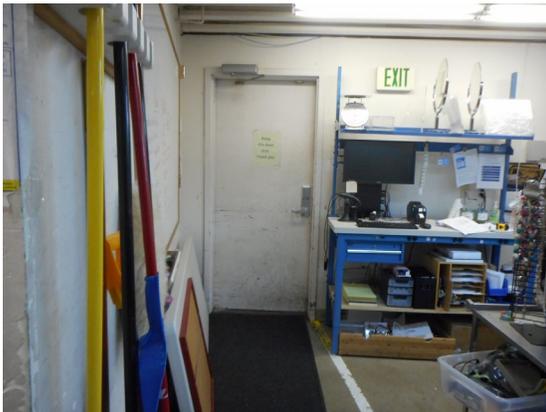
- Upper Left: Countertop blocks the 12" min. required maneuvering space on the latch/push side.
- Upper Right: The vision panel on the door is too high. To be 43" max. AFF.
- Lower Left: One accessible dressing room is required with a bench and turning space.

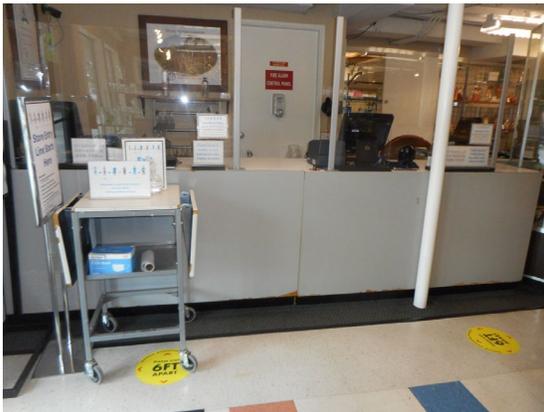
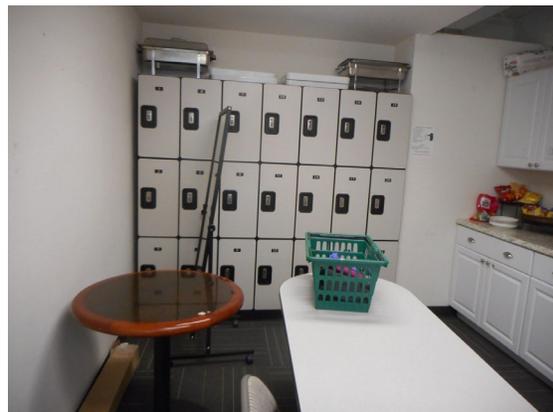
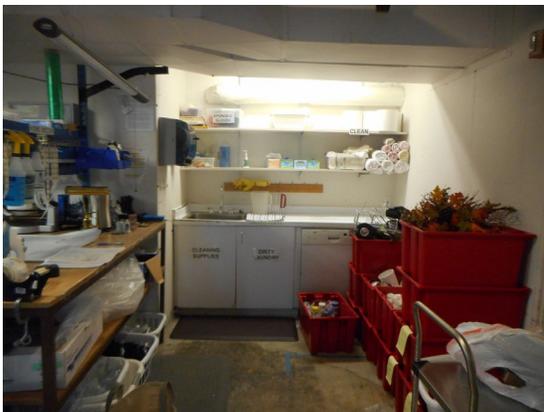
**Youth and Family Services Thrift Shop**

LOCATION	RECOMMENDATION	COMMENTS	TYPE	RESP CODE	PRI	QTY	UNITS	BUDGET
<b>Storage / Lockers</b>								
Barrier	742	The lockers lack the required 5% accessible lockers.						
			Citation	2010 ADA Stds. 225.2.1, 811				
ITEM 34: SECOND FLOOR - KITCHEN	Replace 5% of the existing lockers with ones that are accessible.	A clear space at least 30"x48" that allows forward or parallel approach, accessible hardware, and storage elements that are within a 15" - 48" reach range are required. Existing condition: The second row of lockers has hooks at 50" AFF with shelf below (48" max. required). The first row of lockers has a bottom shelf below 15" AFF (15" min. height required). Locker opening devices require tight pinching to open.	P	O	5	4	2	EA \$640
<b>Total for Building: Youth and Family Services Thrift Shop &amp; Recycling Center</b>								<b>\$29,975</b>

- Upper Left: Check-out counter lacks a 36" high max. x 36" min. in length accessible counterspace.
- Upper Right: Lockers do not provide the min. 5% required to be accessible, due to height of hooks & bottom shelf.
- Lower Left: Sink is 36" AFF (should be 34" max.) and lacks knee clearance for a forward approach. Above countertop outlets are out of accessible reach. Paper towel dispenser is mounted too high.

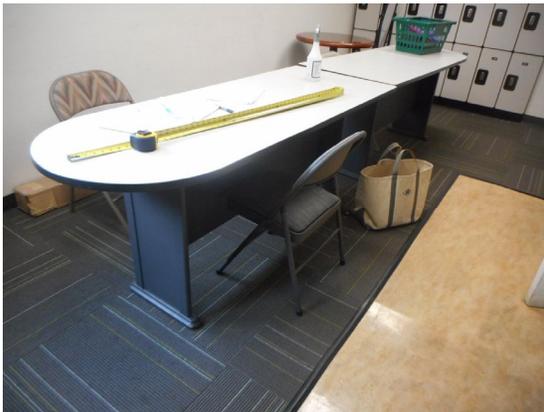
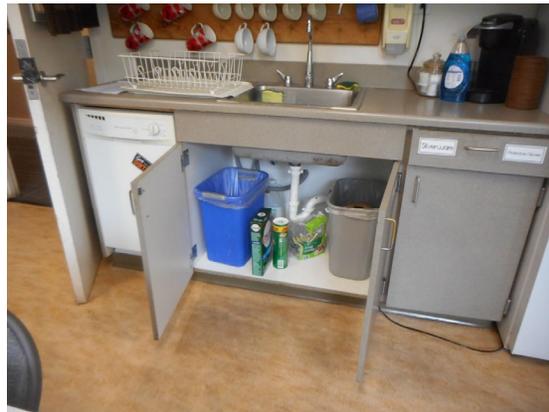
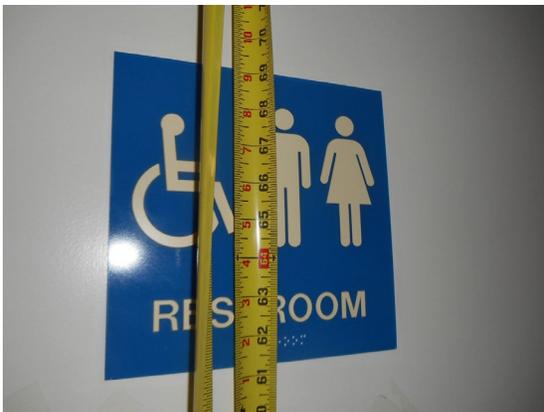
**Youth and Family Services Thrift Shop**

- Upper Left: Dining table does not provide the required knee clearance space.
- Upper Right: Countertop and sink are too high. Must be 34" AFF max. for sink height and for accessible reach to above countertop mounted outlets. Also, kitchen lacks 50% of storage at accessible height.
- Lower Left: Second level accessible restroom signage is mounted too high.

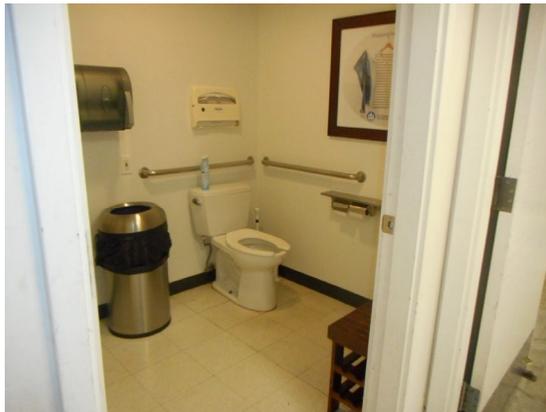
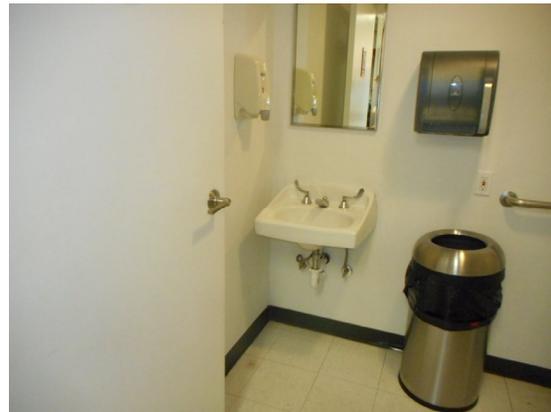
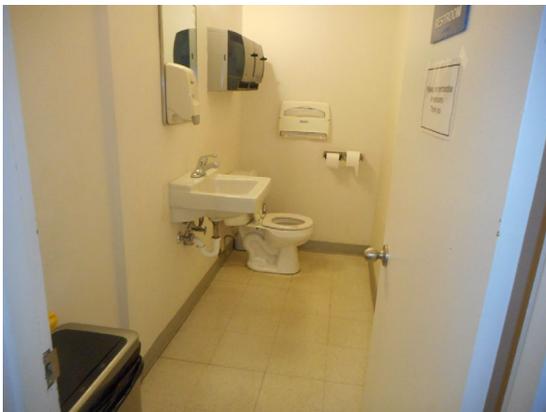
**Youth and Family Services Thrift Shop**

- Upper Left: Ground floor restroom grab bars are too short and incorrectly located. Seat cover dispenser is not accessible above the toilet.
- Upper Right: Ground floor restroom lavatory does not provide the required knee space clearance. Pipes require insulation. Mirror and towel dispenser are too high.
- Lower Left: 2nd floor restroom adjacent the kitchen is inaccessible. Provide directional signage to accessible restroom.

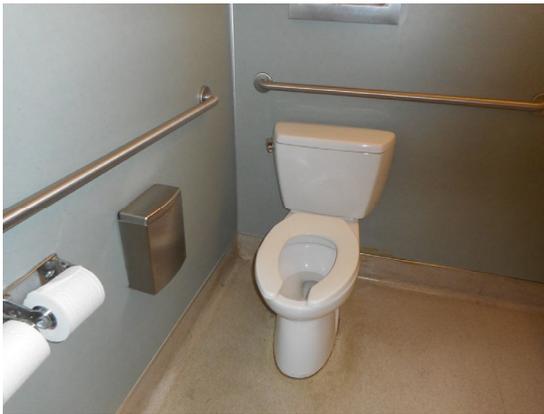
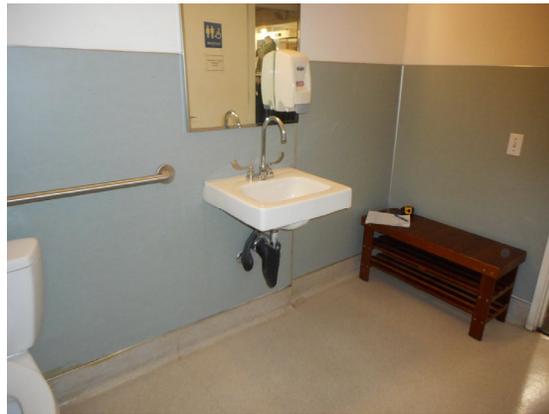
**Youth and Family Services Thrift Shop**

Upper Left: Second floor accessible restroom: grab bars are mounted too high, flush control is required on the open side, seat cover dispenser is not accessible above the toilet.
