Mercer Island Pipeline Shutdown

What Happened, Lessons Learned, Next Steps

April 2023

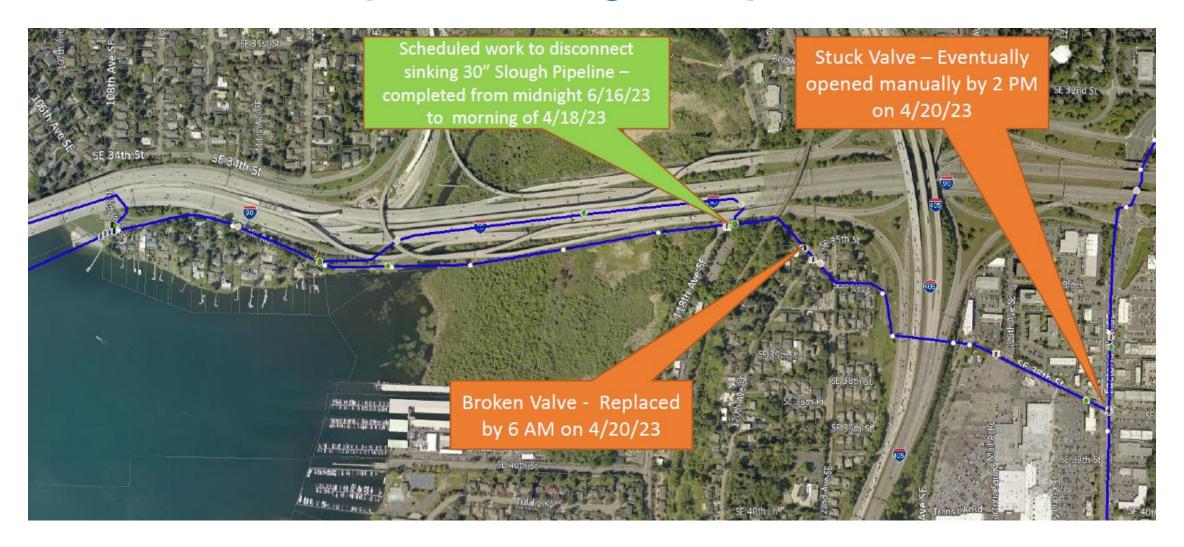
Mercer Island Pipelines Subregional System - Valve Issues

- Valve at SE 120th Ave did not open on Tuesday morning
- Took crews several hours to diagnose that actuator was OK, gearing was OK – valve body and stem were not moving
- It's a ball valve without a bypass line no way to provide even a little water around it if it fails
- We had opened and closed that valve twice in 2022, no issues

- Plan A: close upstream valve at Factoria, dig up and remove the vault lids, remove valve, replace with another valve
- Plan B: provide some bypass pumping from Bellevue at Enatai to Mercer Island
