Mercer Island Pipeline Shutdown

What Happened, Lessons Learned, Next Steps

April 2023

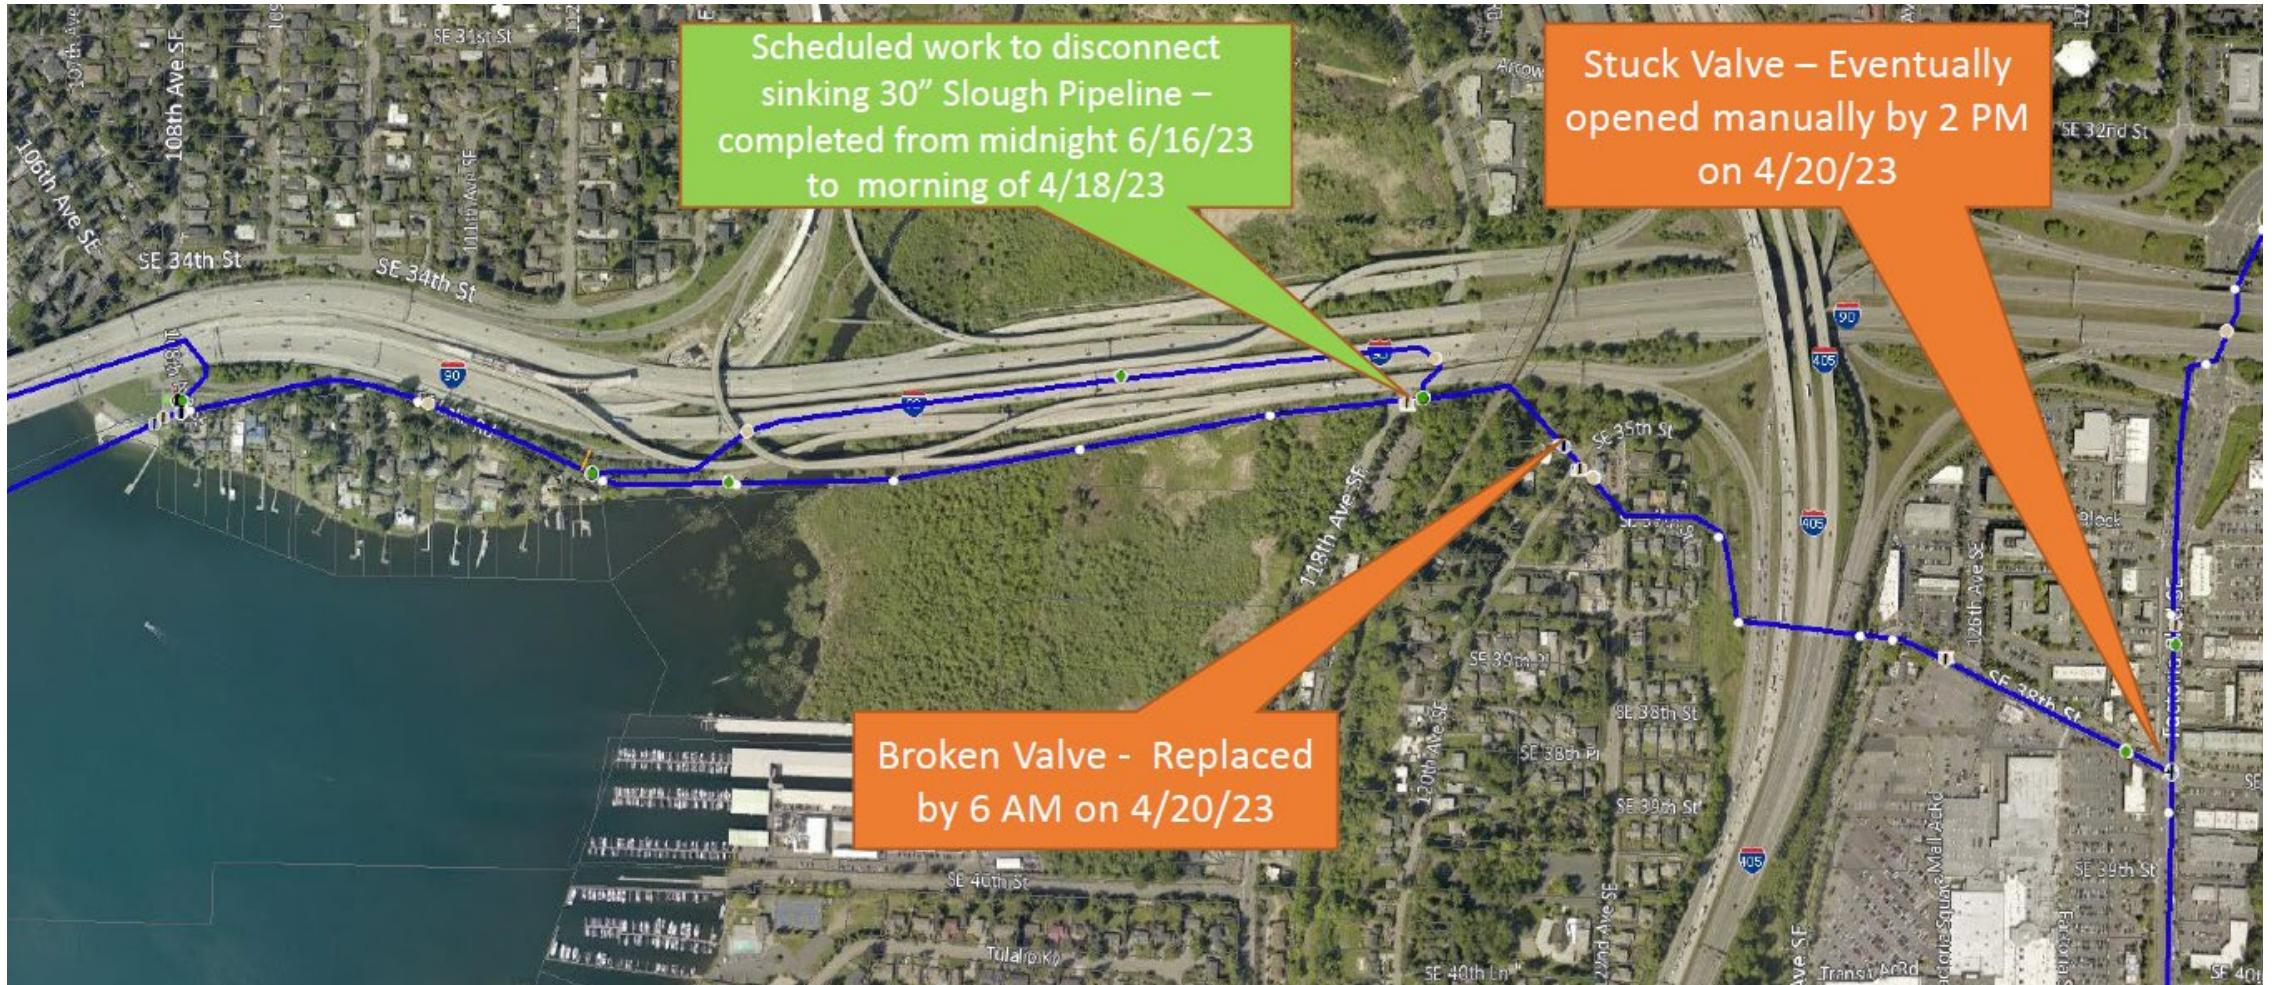
Mercer Island Pipelines Subregional System – Valve Issues

- Valve at SE 120th Ave did not open on Tuesday morning
- Took crews several hours to diagnose that actuator was OK, gearing was OK – valve body and stem were not moving
- It's a ball valve without a bypass line – no way to provide even a little water around it if it fails
- We had opened and closed that valve twice in 2022, no issues

- Plan A: close upstream valve at Factoria, dig up and remove the vault lids, remove valve, replace with another valve
- Plan B: provide some bypass pumping from Bellevue at Enatai to Mercer Island
