**ARBORIST REPORT
2885 78th Ave SE.
Mercer Island, WA**

January 16th, 2020

2885 78th Ave SE

Date of Field Examination: **January 8th, 2020**

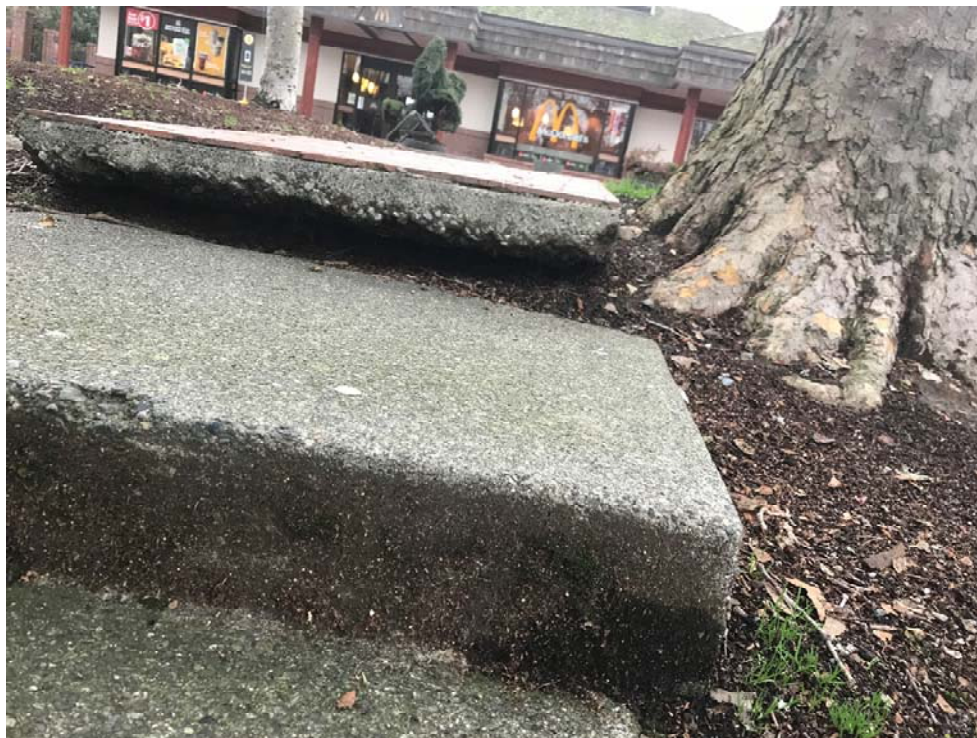
Expanding the adjacent planting areas around #203 and 204 and avoiding soil disturbance in this area will minimize the impacts to these trees. The concrete steps joining the brick path to the north will likely need to be replaced, and a new concrete path is proposed within the critical root zone of #207. There are large structural roots in the area of the steps. A diagram showing removal and replacement of these steps should be developed to instruct crews of the process for completing this work without damaging the structural roots.

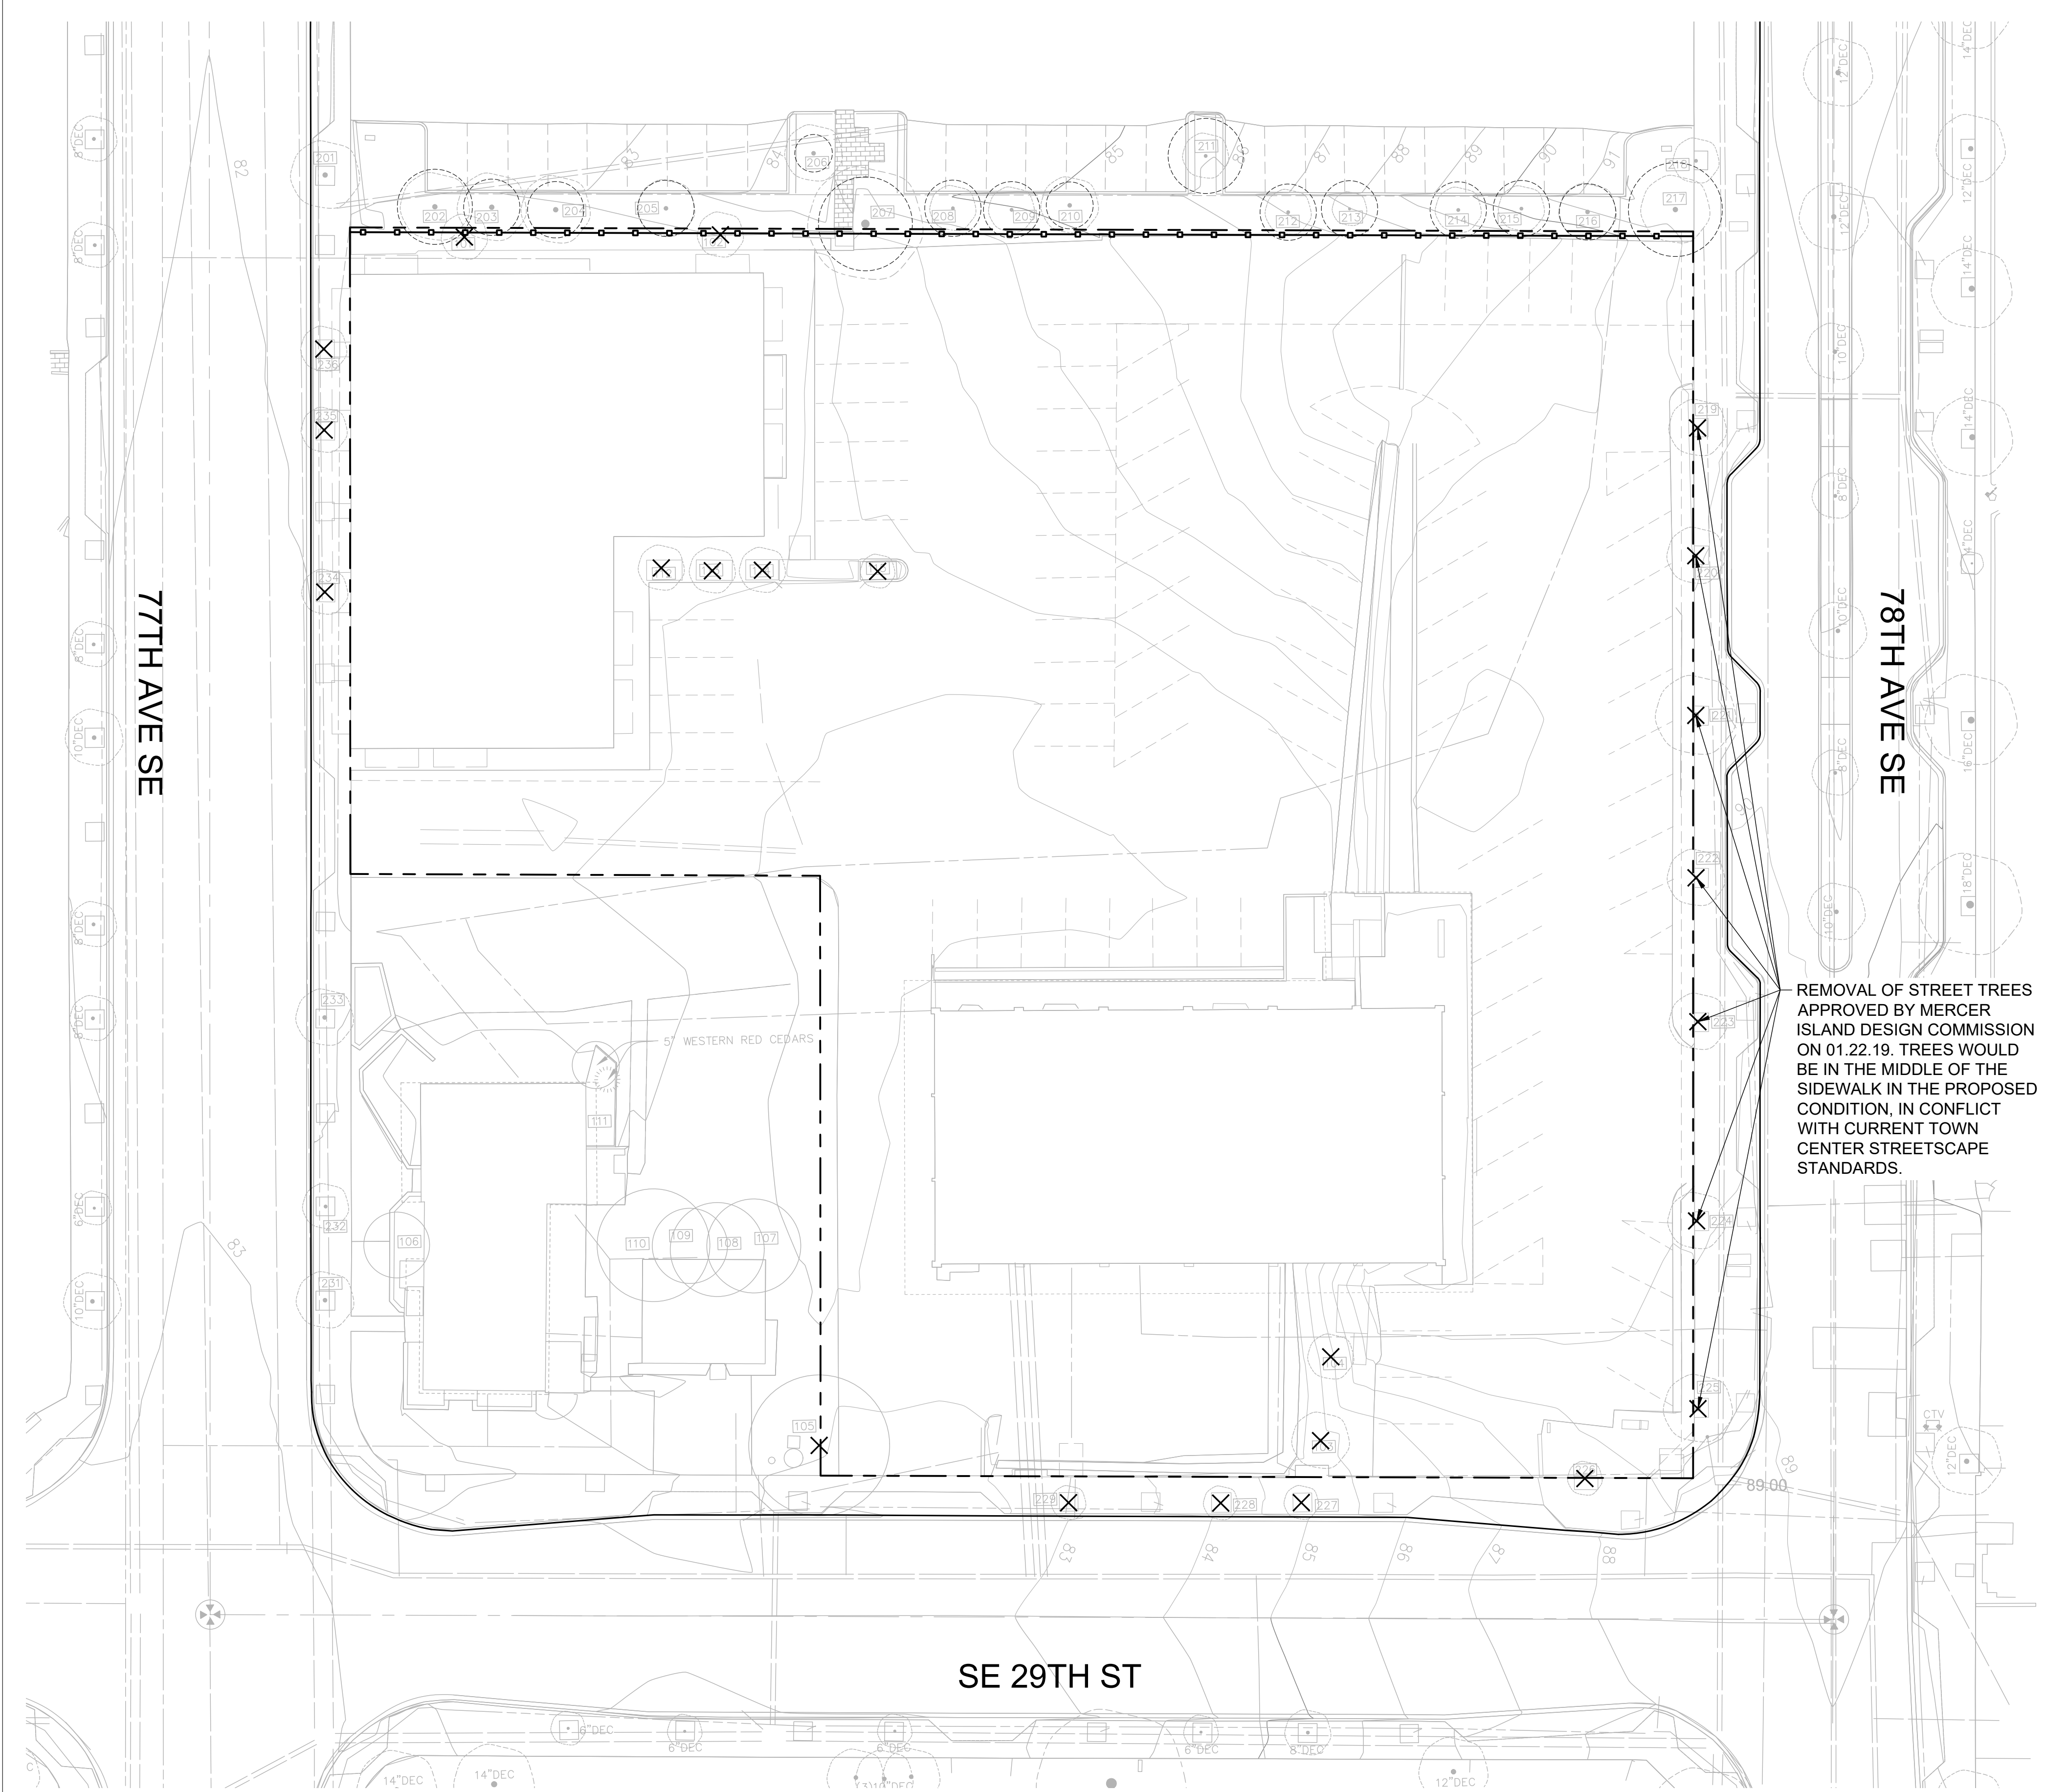
1 EXISTING TREE PLAN

- — — — — PROPERTY LINE
- - - - - CRITICAL ROOT ZONE
- o — o — o — TREE PROTECTION FENCE
- (E) TREE - PROTECT IN PLACE
- ⊗ (E) TREE - TO BE REMOVED
